# New Forest SSSI Ecohydrological Survey Overview

Annex V: Ma 5 Wet Part 3 (including Acres Down and Warwick Slade Bog)

First published 06 March 2014

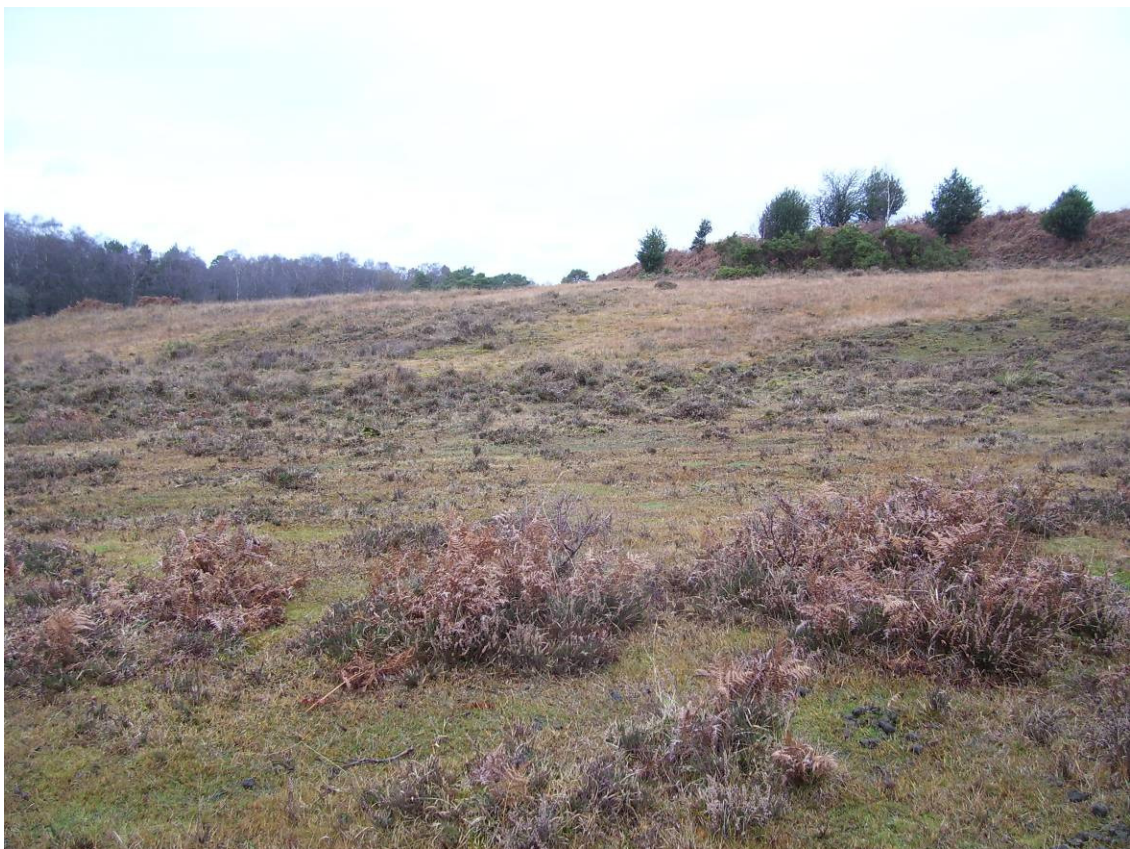
**Figure 1-2: General view of valley mire in the north-western part of the area (Area A, NGR 426802 108833)**

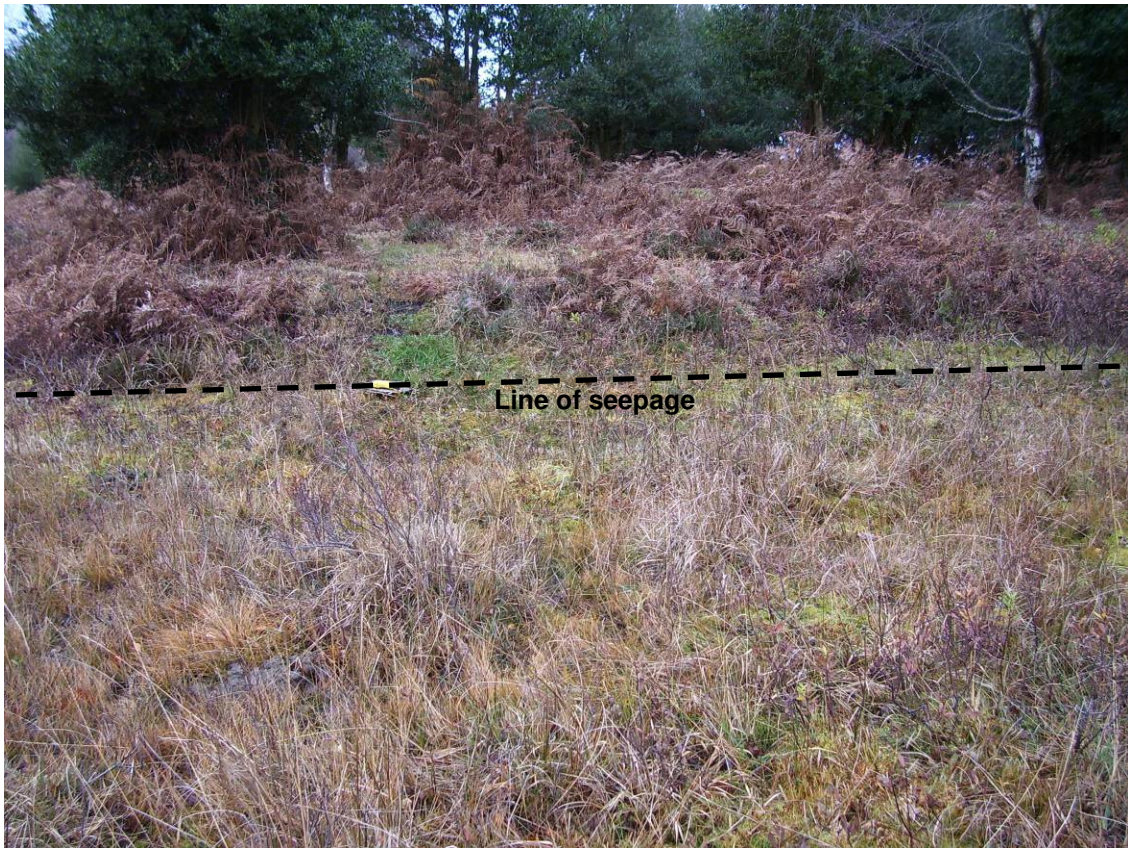
**Figure 1-3: Mire vegetation developed below seepage step southwest of Corbet's Hat (Area C) - interpreted as the edge of a river terrace (NGR 426822 108650)**

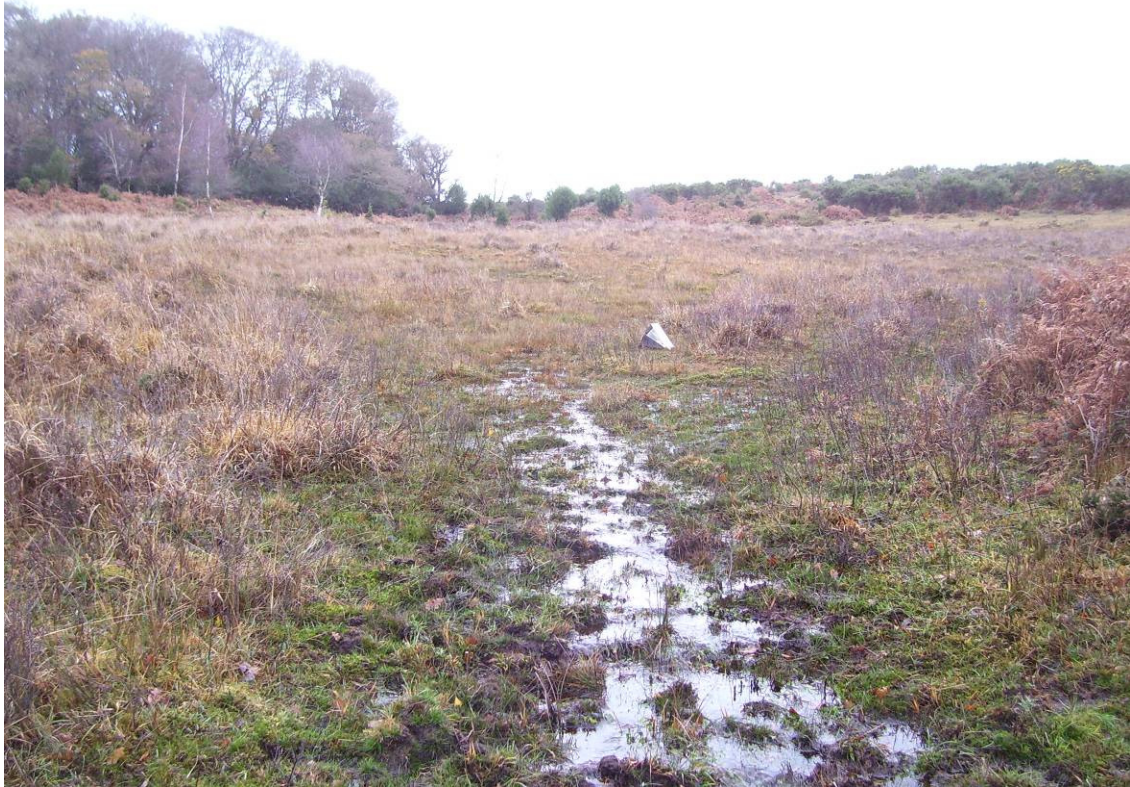
**Figure 1-4: Groundwater Flushed Flow Track (Soakway) south of Corbet's Hat (Area C, NGR 426908 108646)**

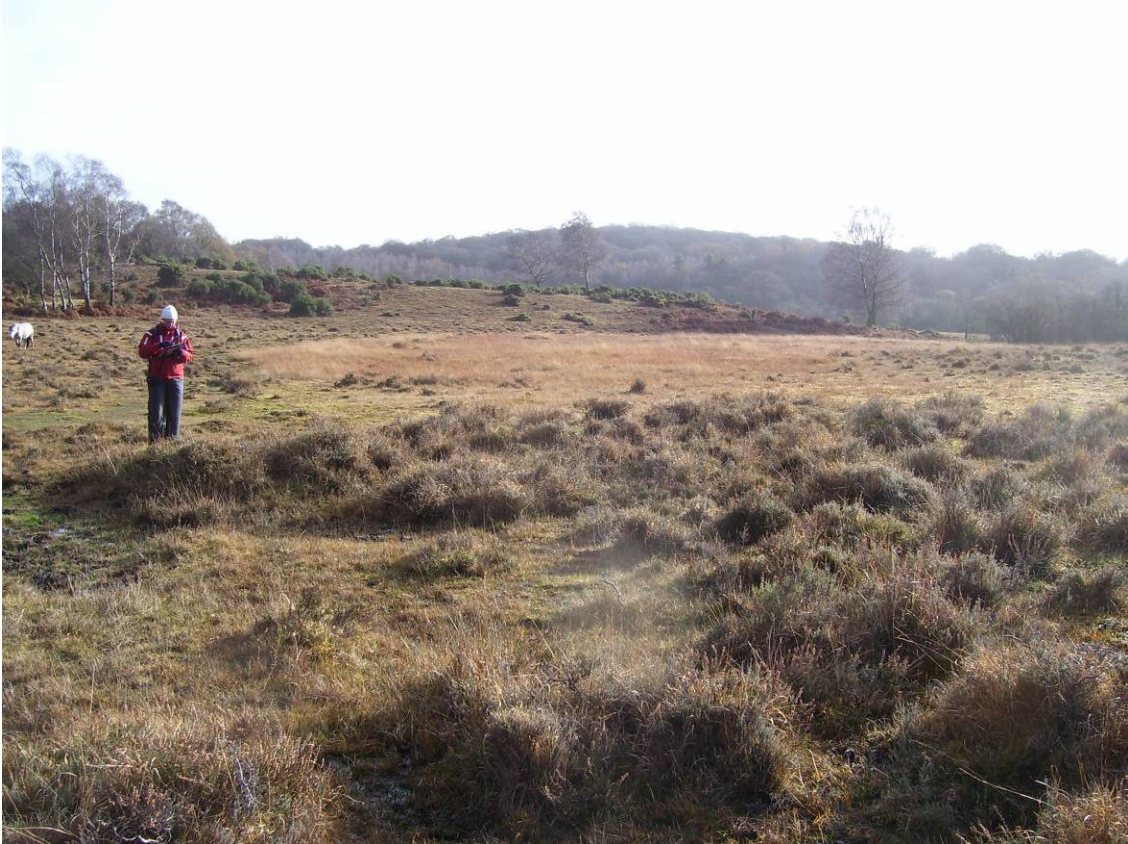
**Figure 1-6: View of valley mire in the north-eastern part of the area (Pilmore Gate Heath) (Area D, NGR 427469 109007, looking southeast)**

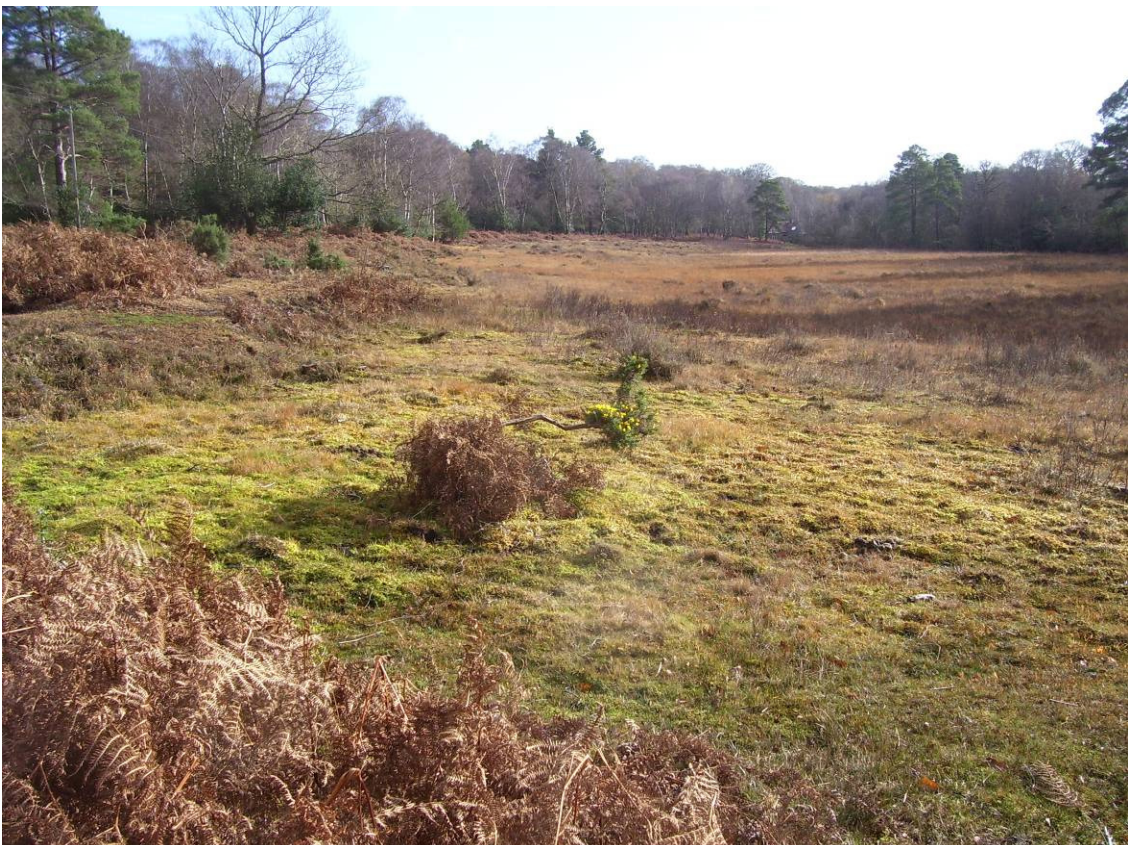
**Figure 1-9: General view of Warwick Slade Bog showing the seepage step along the left-hand side (southern part of Area F, NGR 427449 106861, looking southeast)**
