# New Forest SSSI Ecohydrological Survey Overview

## Annex F: Whiteshoot Bottom

First published 06 March 2014

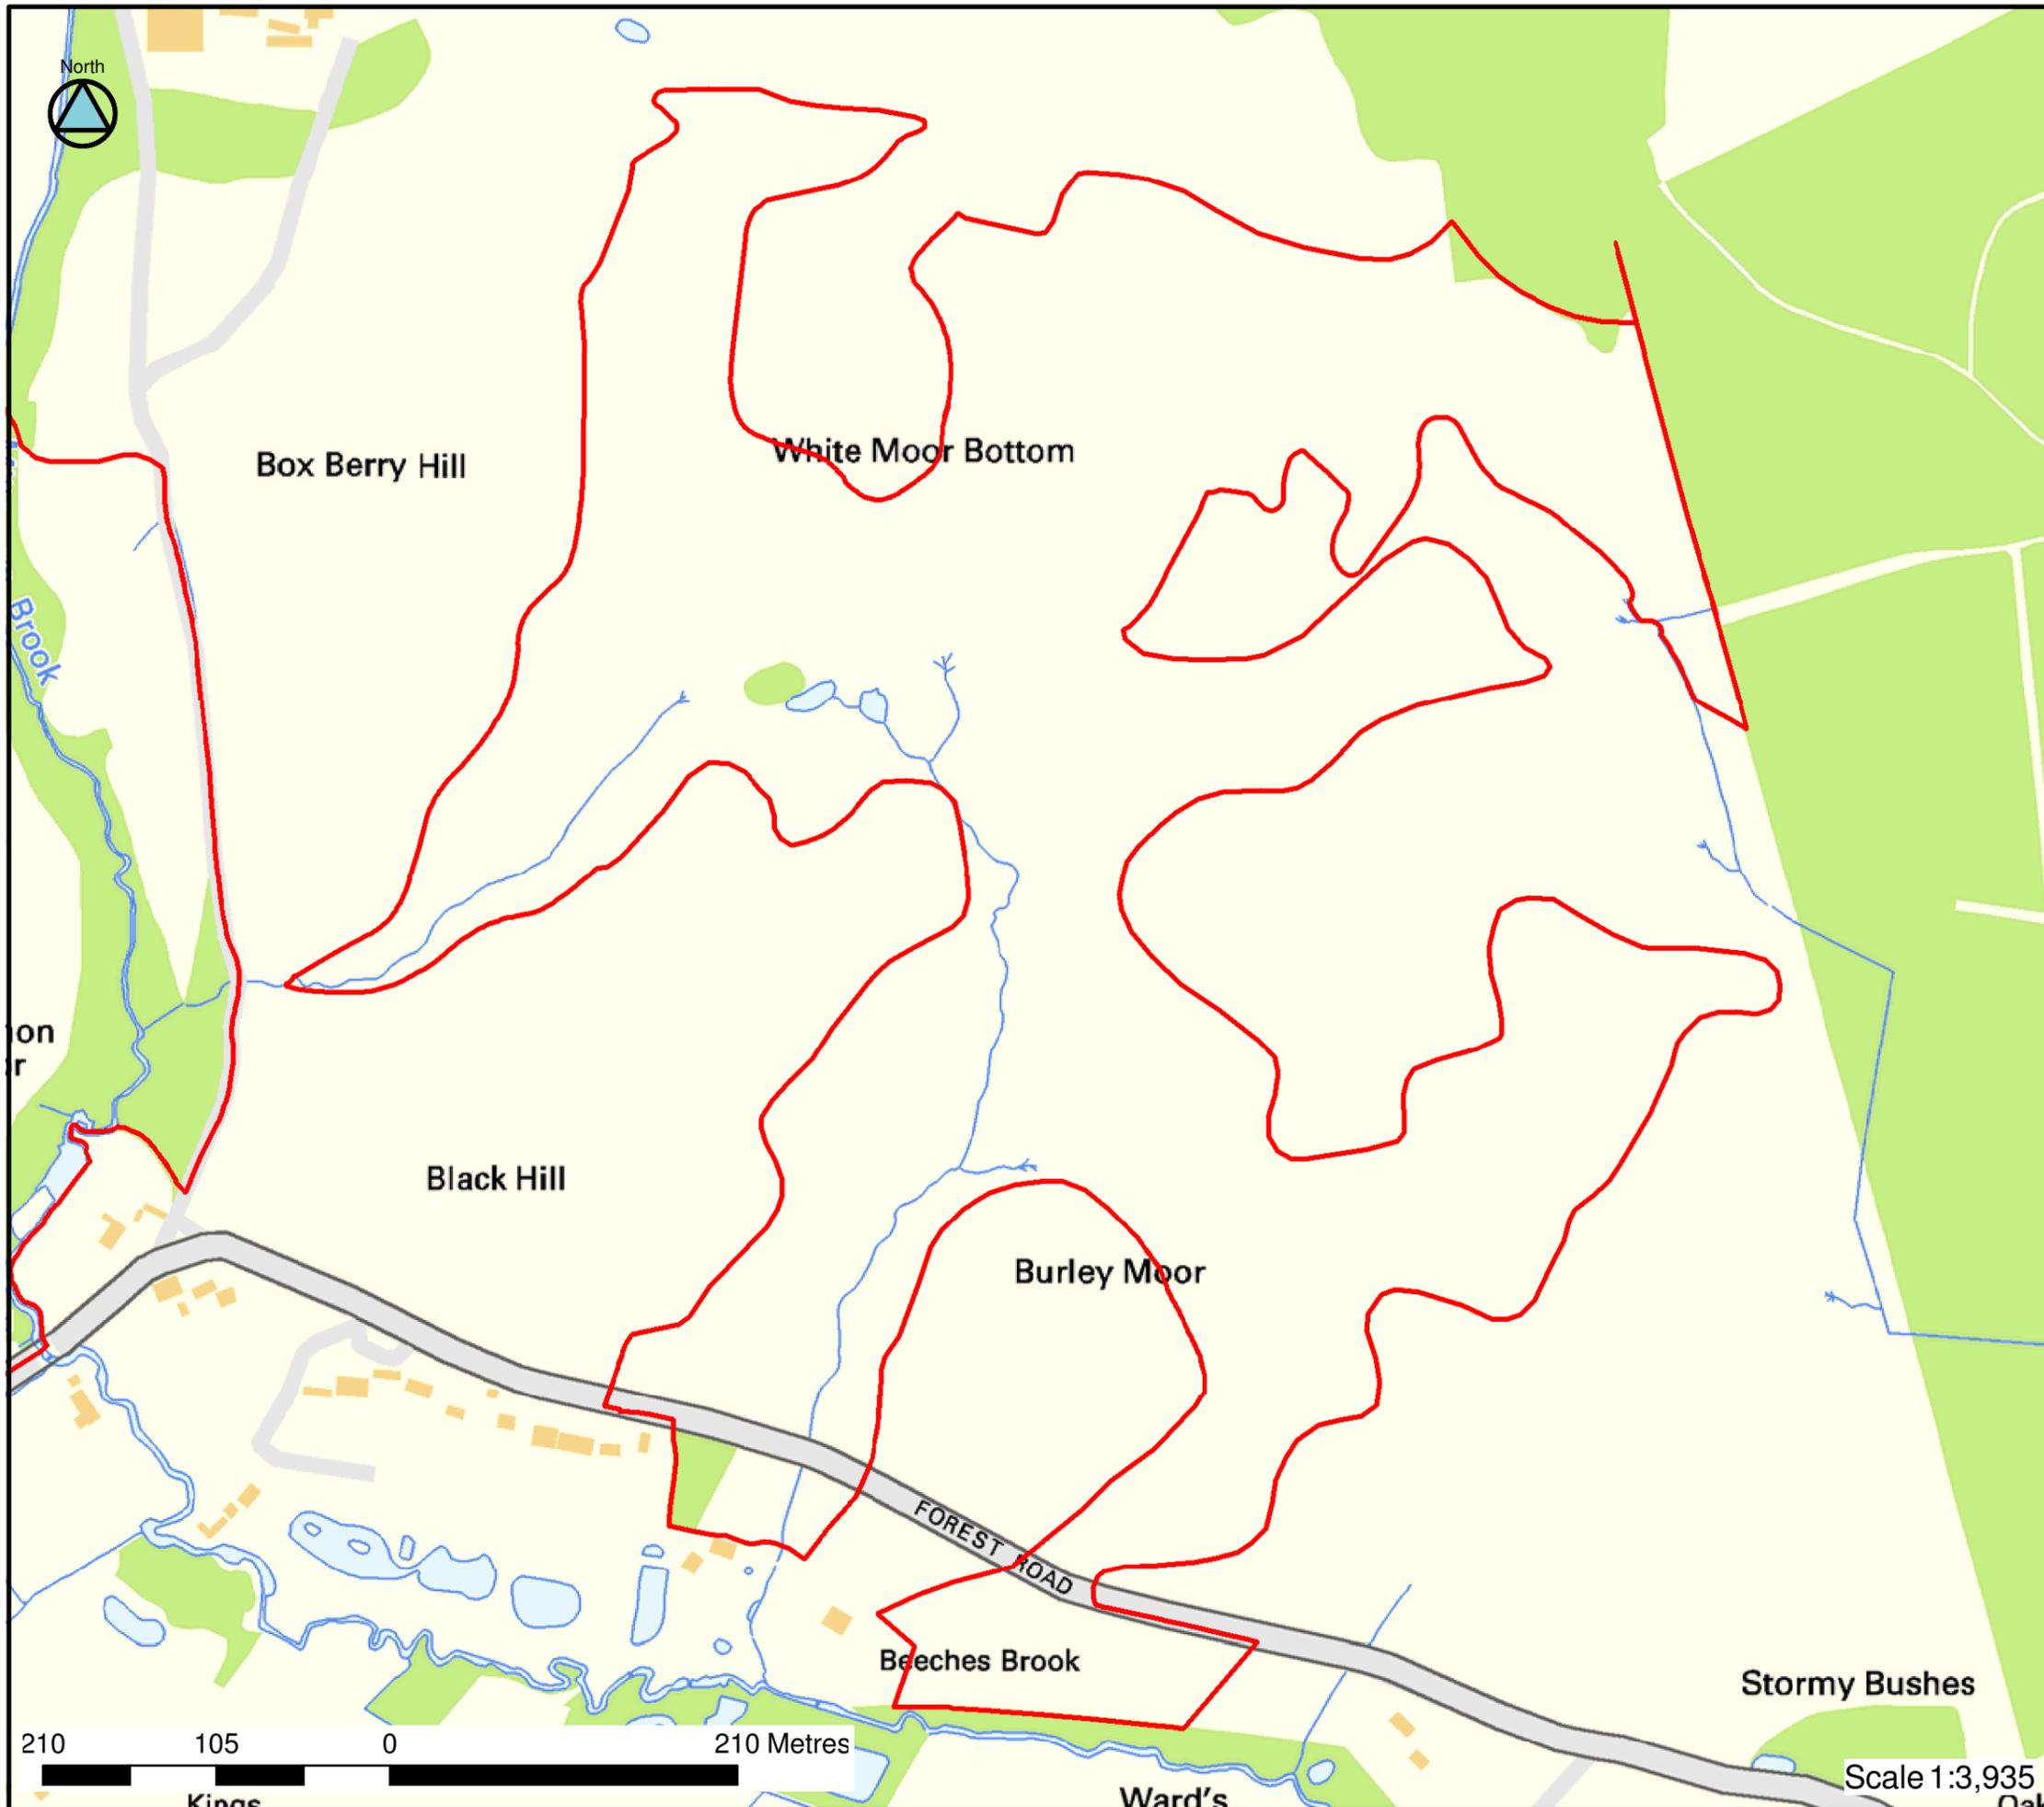
**Map 8: Restoration Plan**

Recreational pressures and grazing were identified as having a localised impact, particularly in the centre of the site. Improvements to the culvert (e.g. upsizing or replacement with a boardwalk) at this location should allow water to flow more readily and reduce the localised ponding around the crossing point. This should help to alleviate the poaching and footpath erosion issues.

Restoration Area	Damage Type	Restoration Proposals	Improvement	Constraints and Issues
Crossing point in centre of unit	Ponding of water around crossing point exacerbated by poaching and recreational pressures	Modification of footpath (e.g. boardwalks) and/or culvert (e.g. upsizing) to remove impediment to flow	Localised restoration of valley mire and wet heath habitats	Footpaths are an important amenity resource which could suffer from short-term disruption
