Natural England Commissioned Report NECR140

New Forest SSSI Geomorphological Survey Overview

Annex L: Parkhill Lawn (Pondhead) Restoration Plan - SSSI
Unit 386

1 Parkhill Lawn (Pondhead) Restoration Plan - SSSI Unit 386

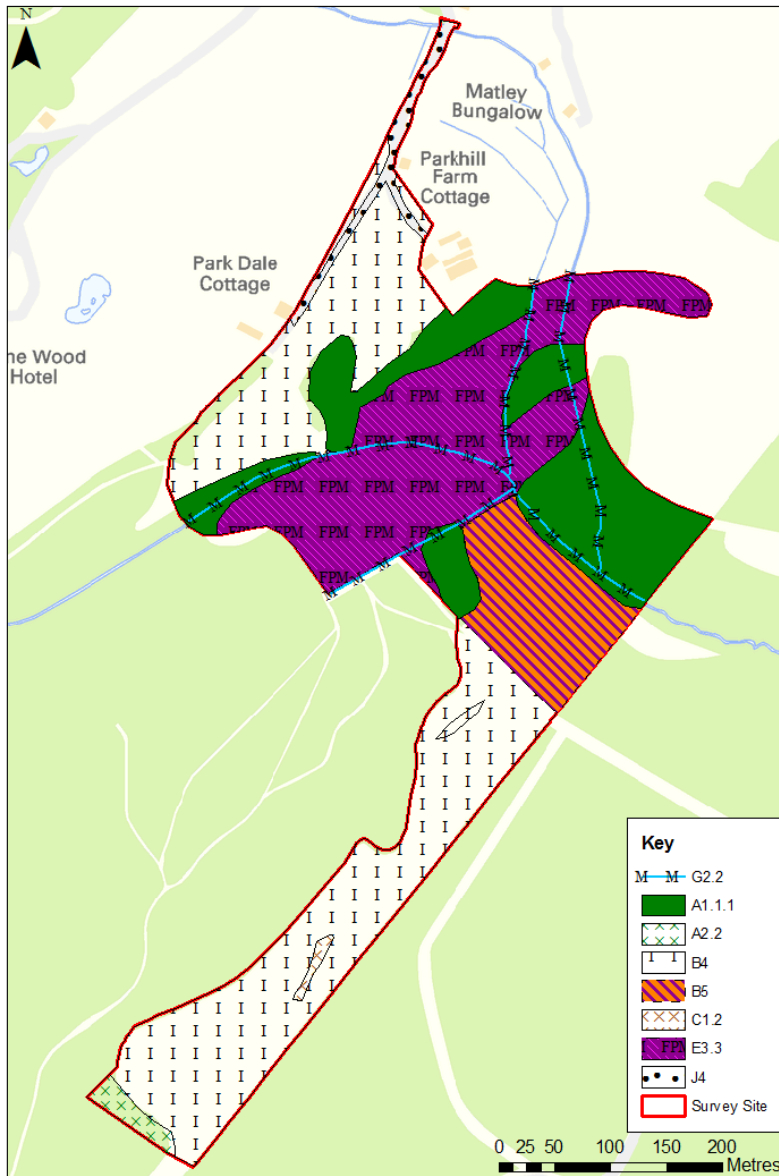
Figure 1-7: Phase 1 Habitat Map

In the eastern area of the site the two drains merge into one. The area immediately south of the merged drain consists of a wet lawn area containing *Sphagnum* tussocks, Deer-grass *Trichophorum cespitosum* and Purple Moor-grass *Molina caerulea*. This indicates the area is usually wet, but in previous times may have been wetter due to the characteristic mire vegetation recorded. This area of wet lawn is not extensive and does not continue into the southern area of the site. The long southern section of the site is bordered by mixed woodland with semi-improved grassland present in the centre. This area of the unit is drier and contains areas of Bracken scrub encroachment and scattered trees throughout.
