Natural England Commissioned Report NECR141

New Forest SSSI Ecohydrological Survey Overview

Annex E: Common Moor

First published 06 March 2014

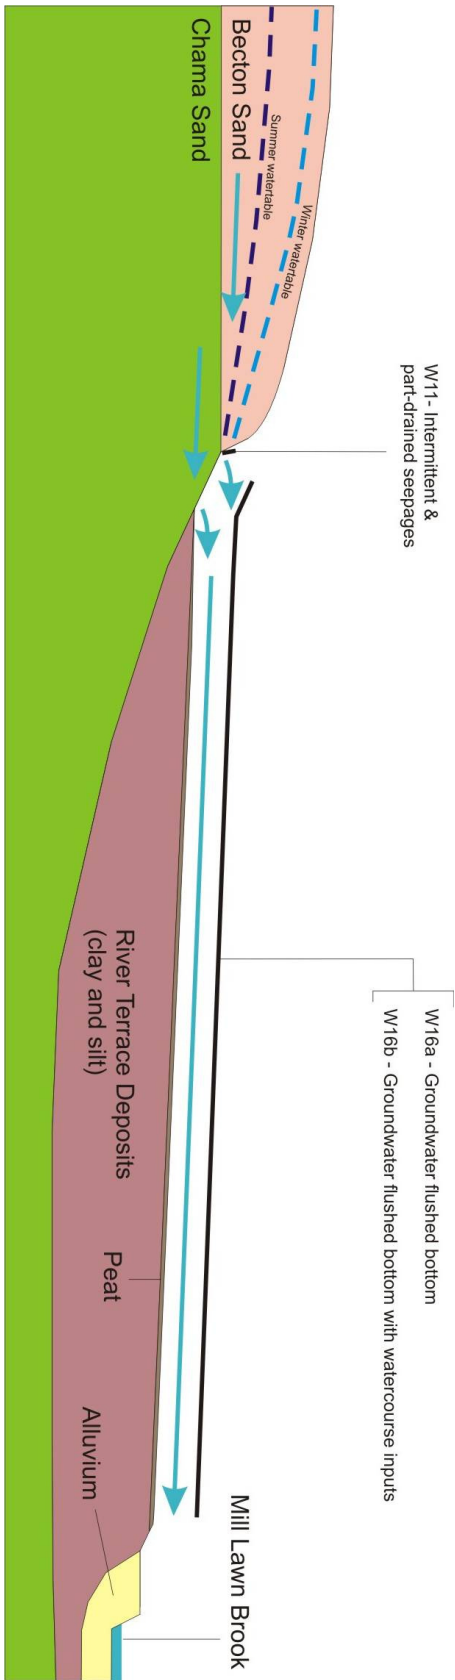
Figure 1-4: Conceptual Model Diagram

The wetlands on site are flush-dominated (see Figure 1-4). They are sourced mainly by groundwater seepage from two closely-spaced geological boundaries: (i) the contact between the Becton Sand Formation and underlying Chama Sand Formation and, (ii) the contact between the Chama Sand Formation and adjacent/overlying river terrace silt and clay deposits. As these boundaries are closely spaced, there is effectively a single seepage line.
