Natural England Commissioned Report NECR140

New Forest SSSI Geomorphological Survey Overview

Annex M: Cowleys Heath East Restoration Plan - SSSI Unit 422

First published 06 March 2014

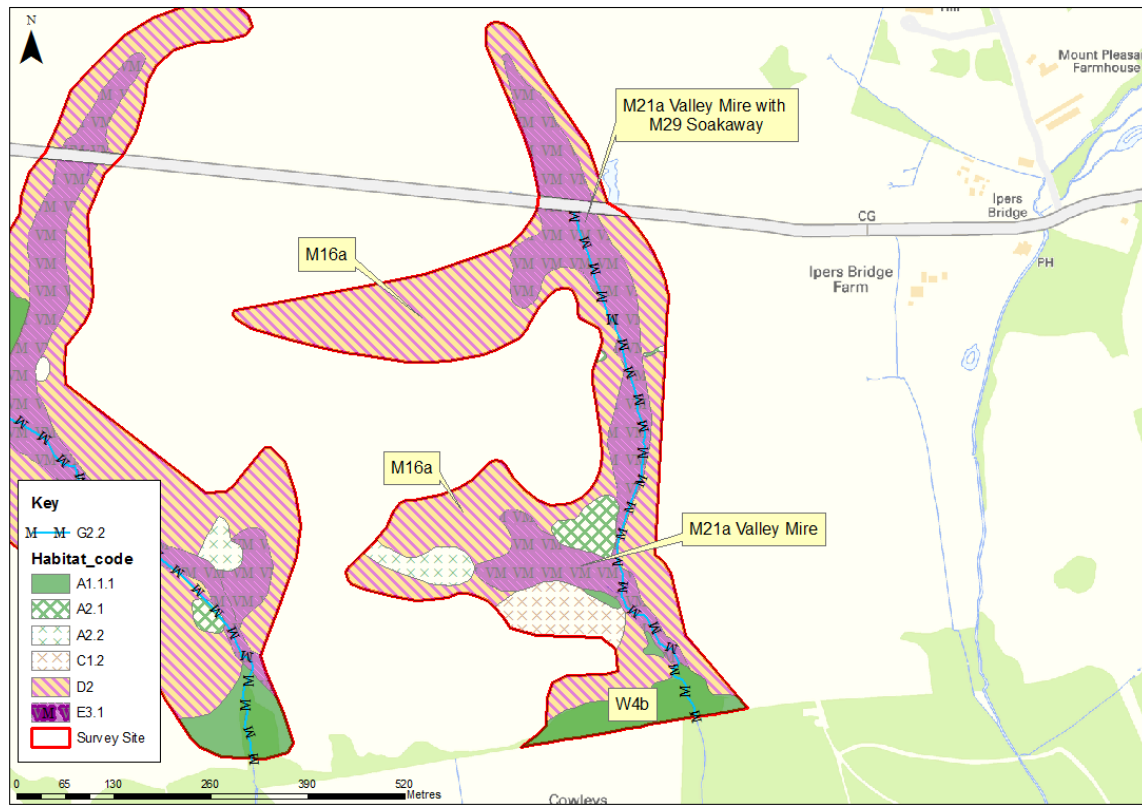
Figure 1-14: Phase 1 Habitat Map

The unit consists of valley mire which is dominated by Purple Moor-grass *Molinia caerulea* with abundant Cross-leaved Heath *Erica tetralix* and Bog Myrtle *Myrica gale* (M25a). In the wetter areas, White Beak-sedge *Rhynchospora alba* and Deergass *Trichosporum germanicum* were noted (M21a). The valley mire grades into wet heath, moving away from the central valley bottom, with Cross-leaved Heath more abundant and Heather *Calluna vulgaris* (M16a) also present. Within the wet heath there are patches of Gorse dominated scrub (W23), and scattered Bracken (W25).

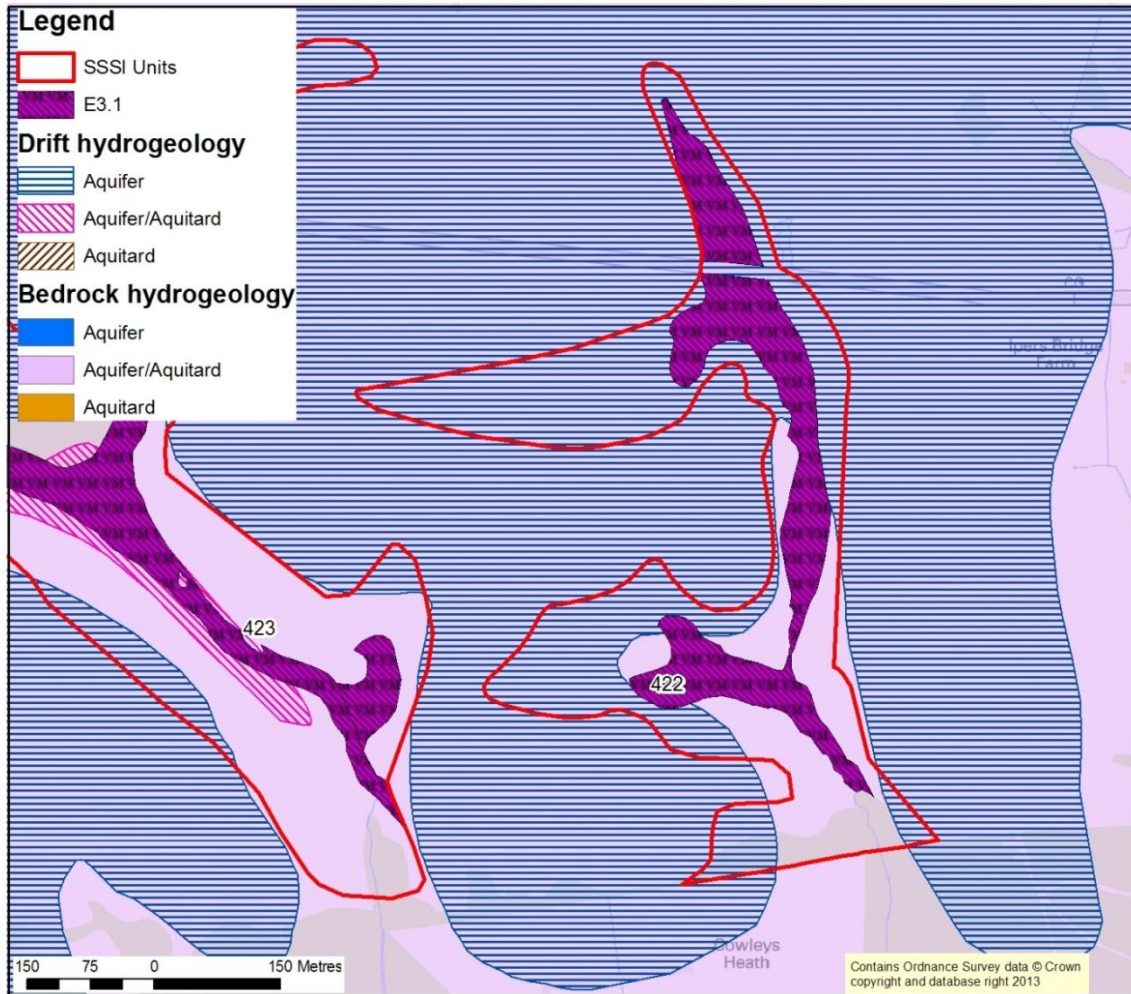
Figure 1-15: Ecohydrology Map

The site is underlain by the Headon Formation which BGS borehole logs (available online) show is locally formed from Clay (likely to act as an aquitard). The plateau above and surrounding the mires is covered by river terrace deposits which are formed of sandy gravels (likely to act as an aquifer). The mires are likely to be flush dominated, supported by a seepage face at the junction between the river terrace gravels and Headon Formation.

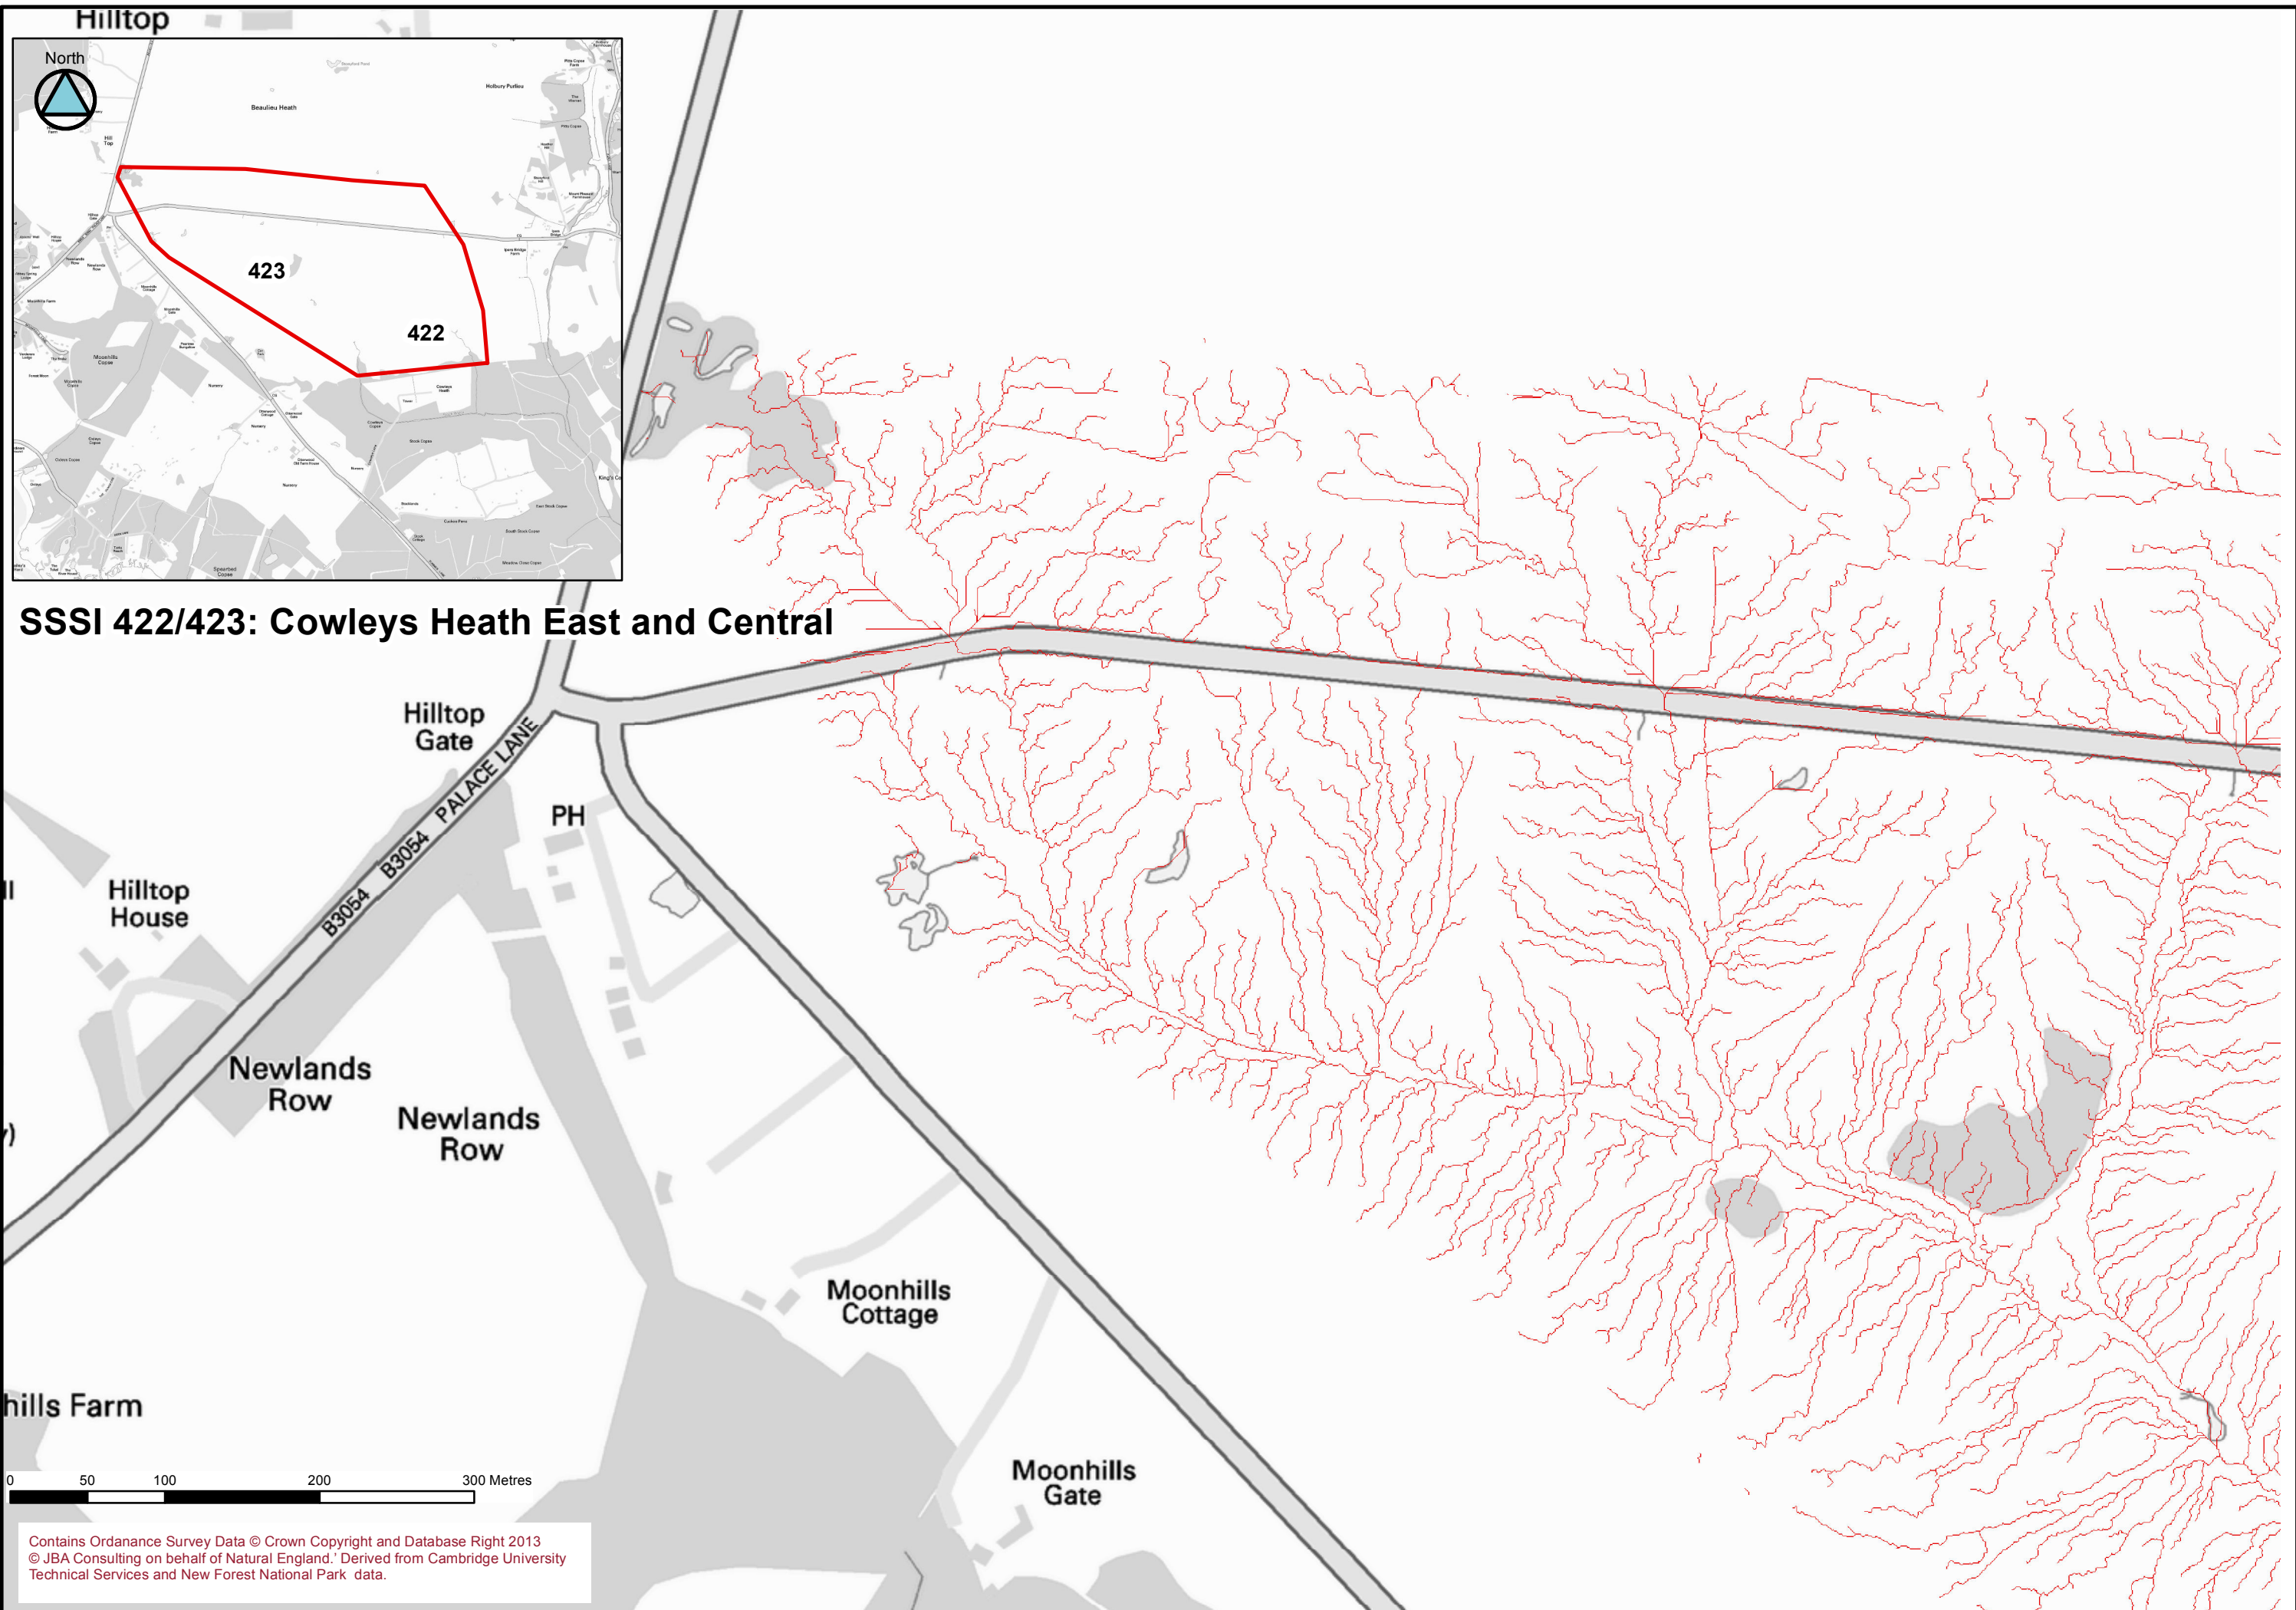
Appendix A - Artificial drains and flow lines - SSSI Unit 422

Engineering	Stream section possibly straightened and overdeepened. Road provides barrier to natural flow routes as do the drains alongside them. Heather bailing restoration in mire section, ok condition at present.
	Bank activity	Some lateral activity in downstream stream section, also bank collapse associated to incision. Little activity in mire section as spread in most locations
Floodplain Condition	Flow type (s)	Flows impacted by upstream mire and road drains at upstream end which prevent natural flow paths. Flood peaks concentrated in stream due to floodplain connectivity and incision at downstream end. Heather bailing is raising u/s water levels in floodplain.
	Main source of water	Seepage, drains / overland flow, out of bank flows
	NVC communities	M29, M21a, M16a, W4b
	Key habitat types	Wet heath, Valley mire, Broadleaved woodland
	Drainage	The flow routes into the main mire section appear in reasonable condition and do not appear to be over-deepened. The road and drains along them do alter natural flow route paths. Small dug drains at upstream end could be infilled.
