New Forest SSSI Geomorphological Survey Overview

Annex A: Black Gutter Bottom Restoration Plan - SSSI Unit 35

1 Black Gutter Bottom Restoration Plan - SSSI Unit 35

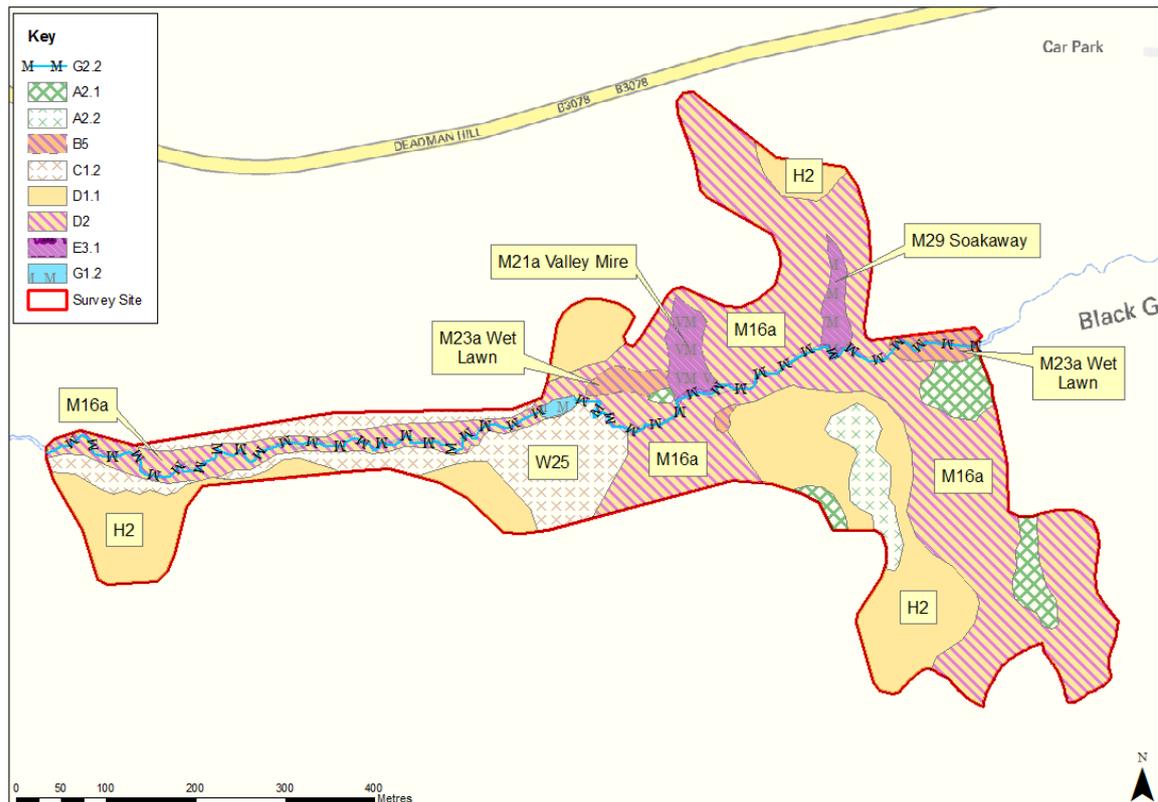
Figure 1-9: Phase 1 Habitat Map

Figure 1-9 shows the Phase 1 Habitat Map for Unit 35.

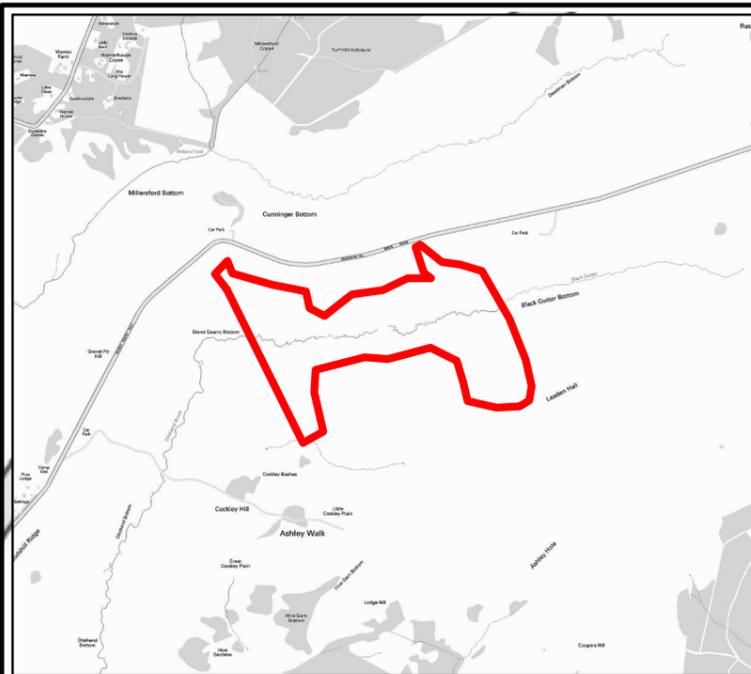
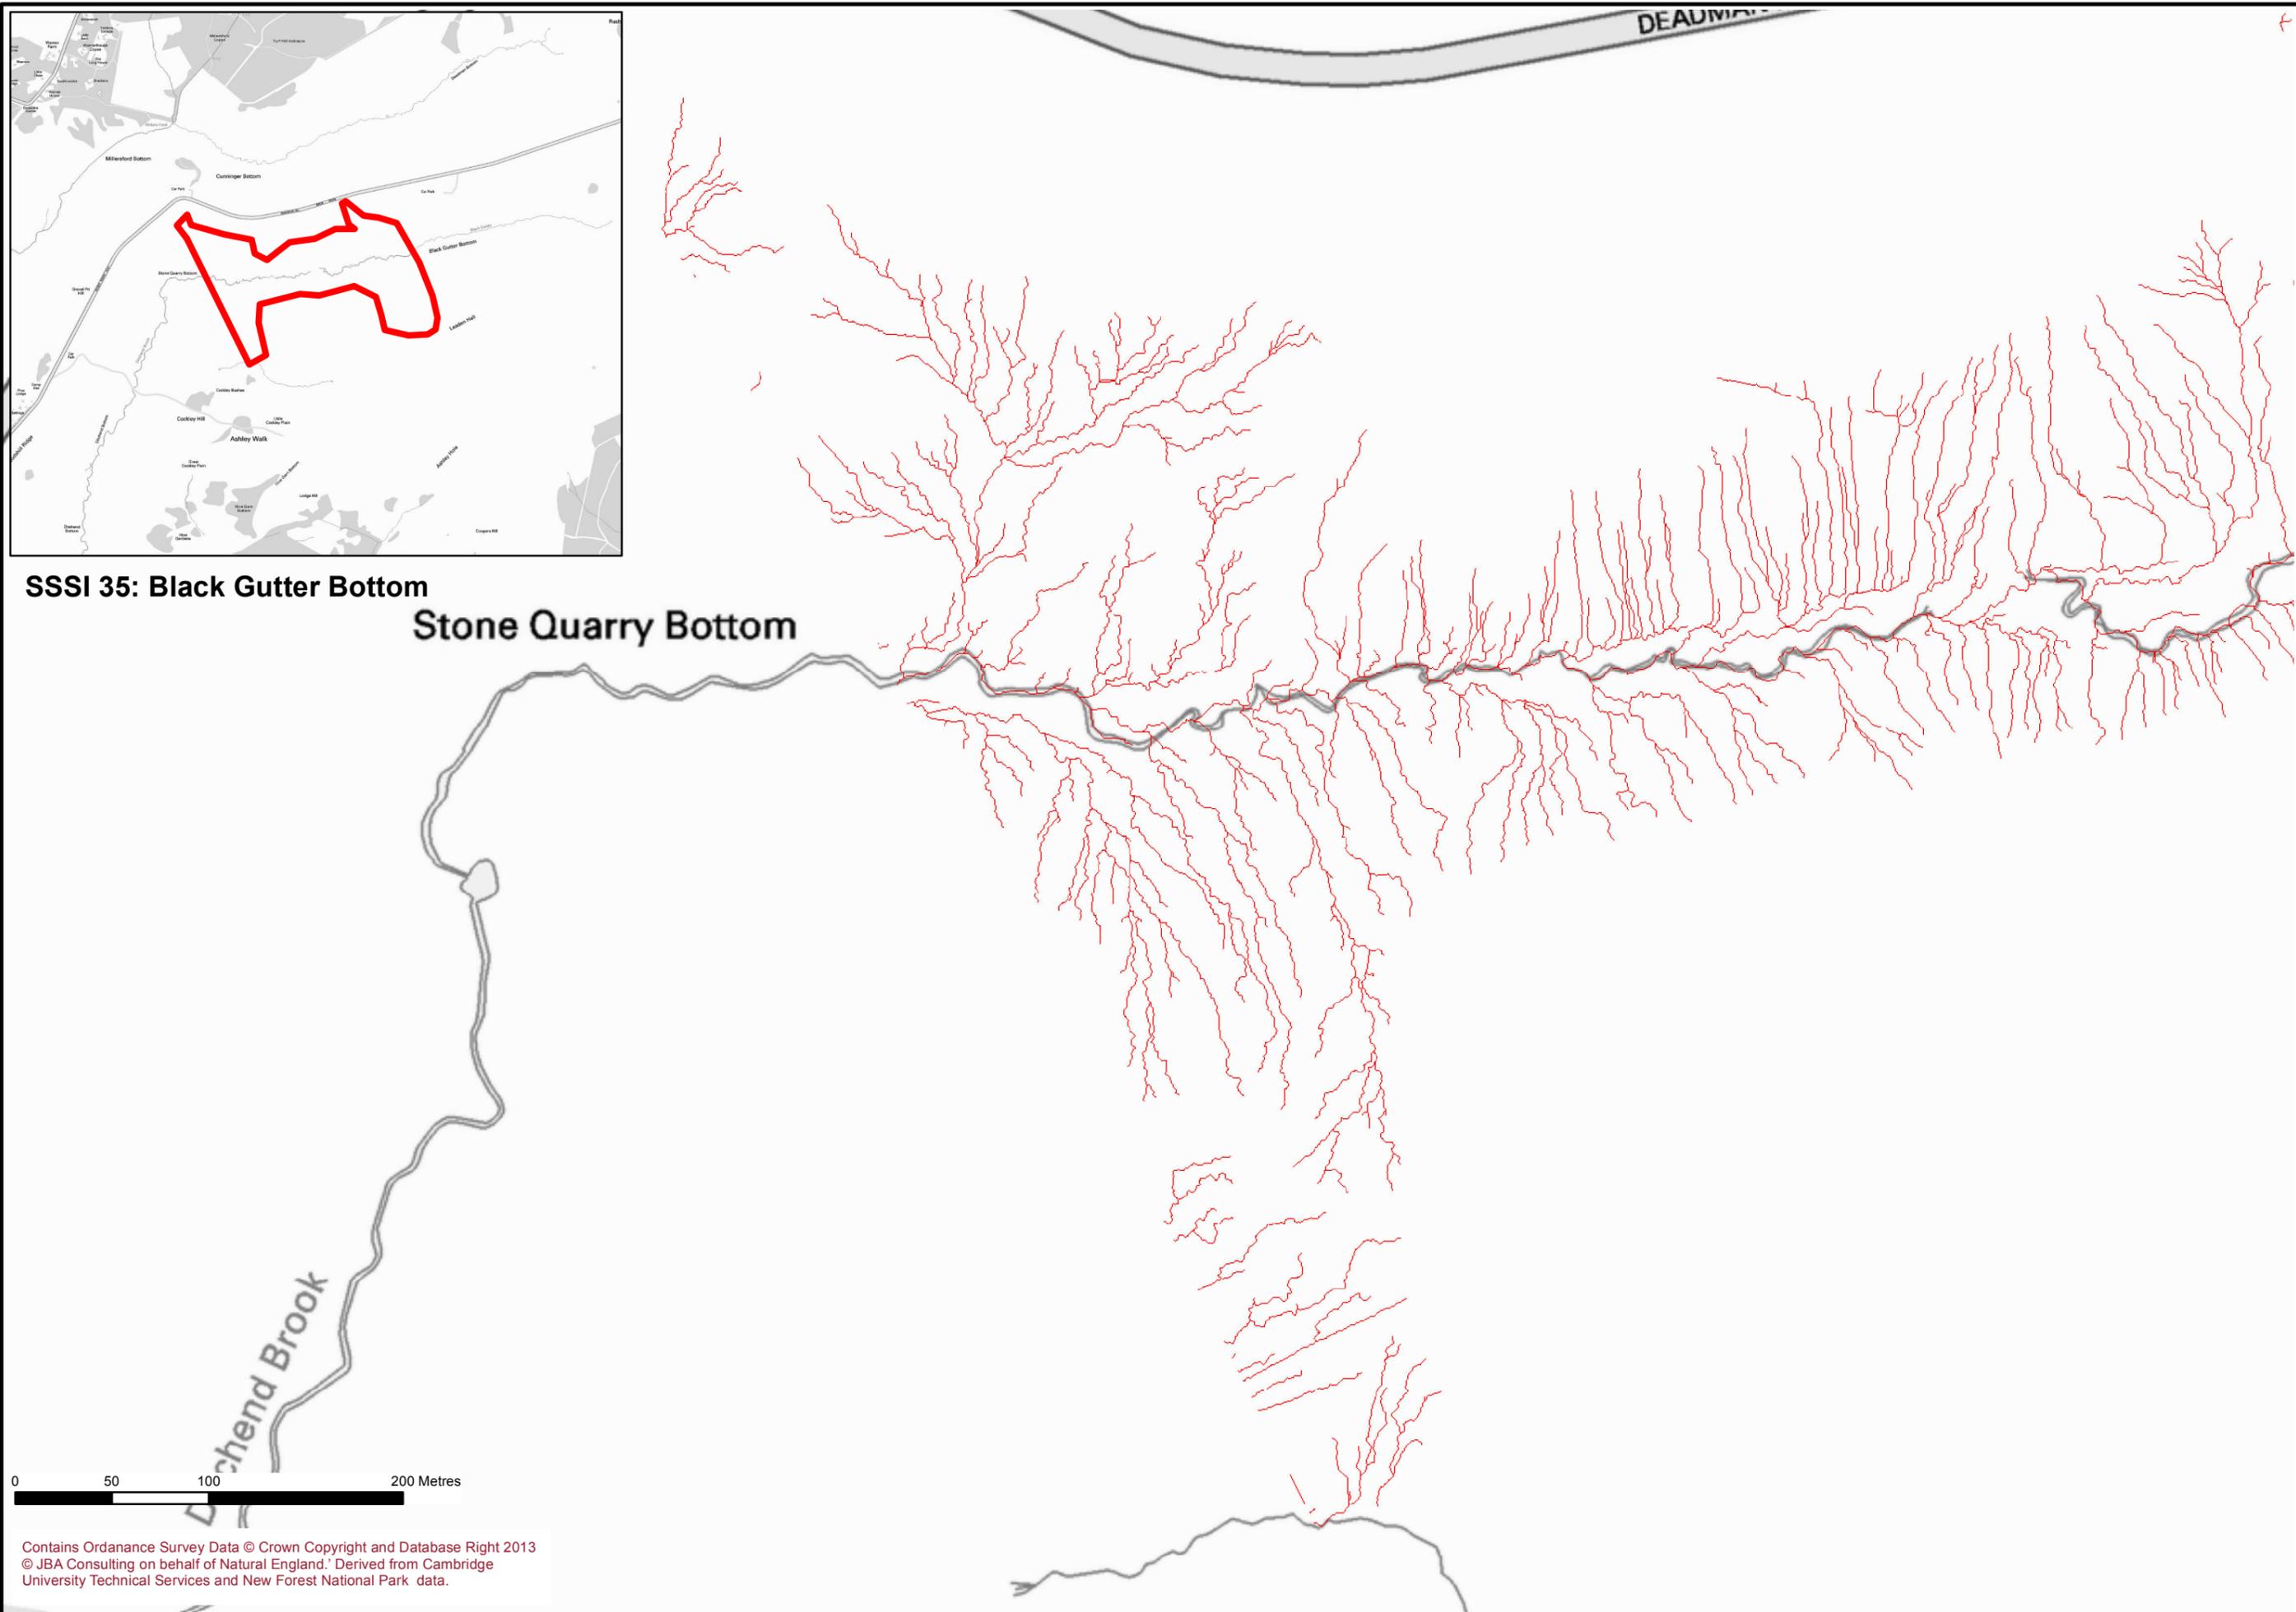
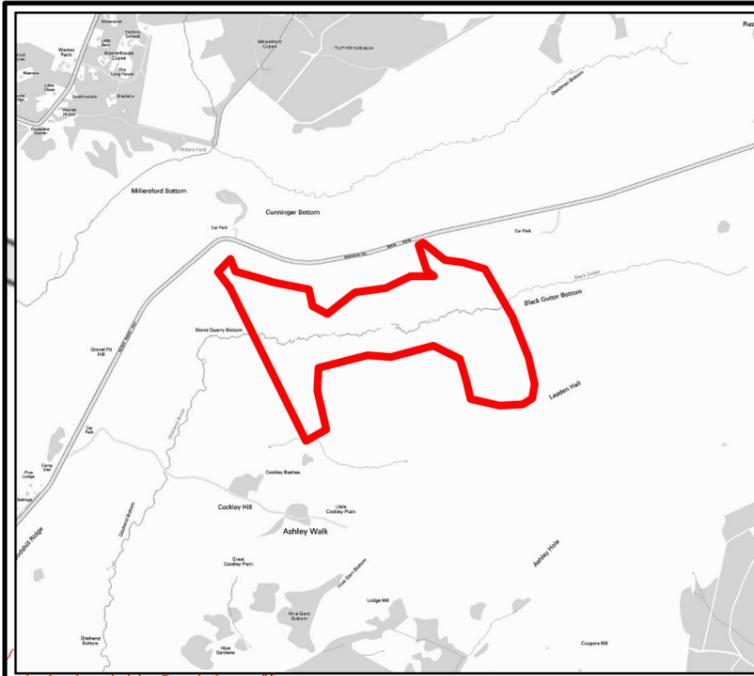
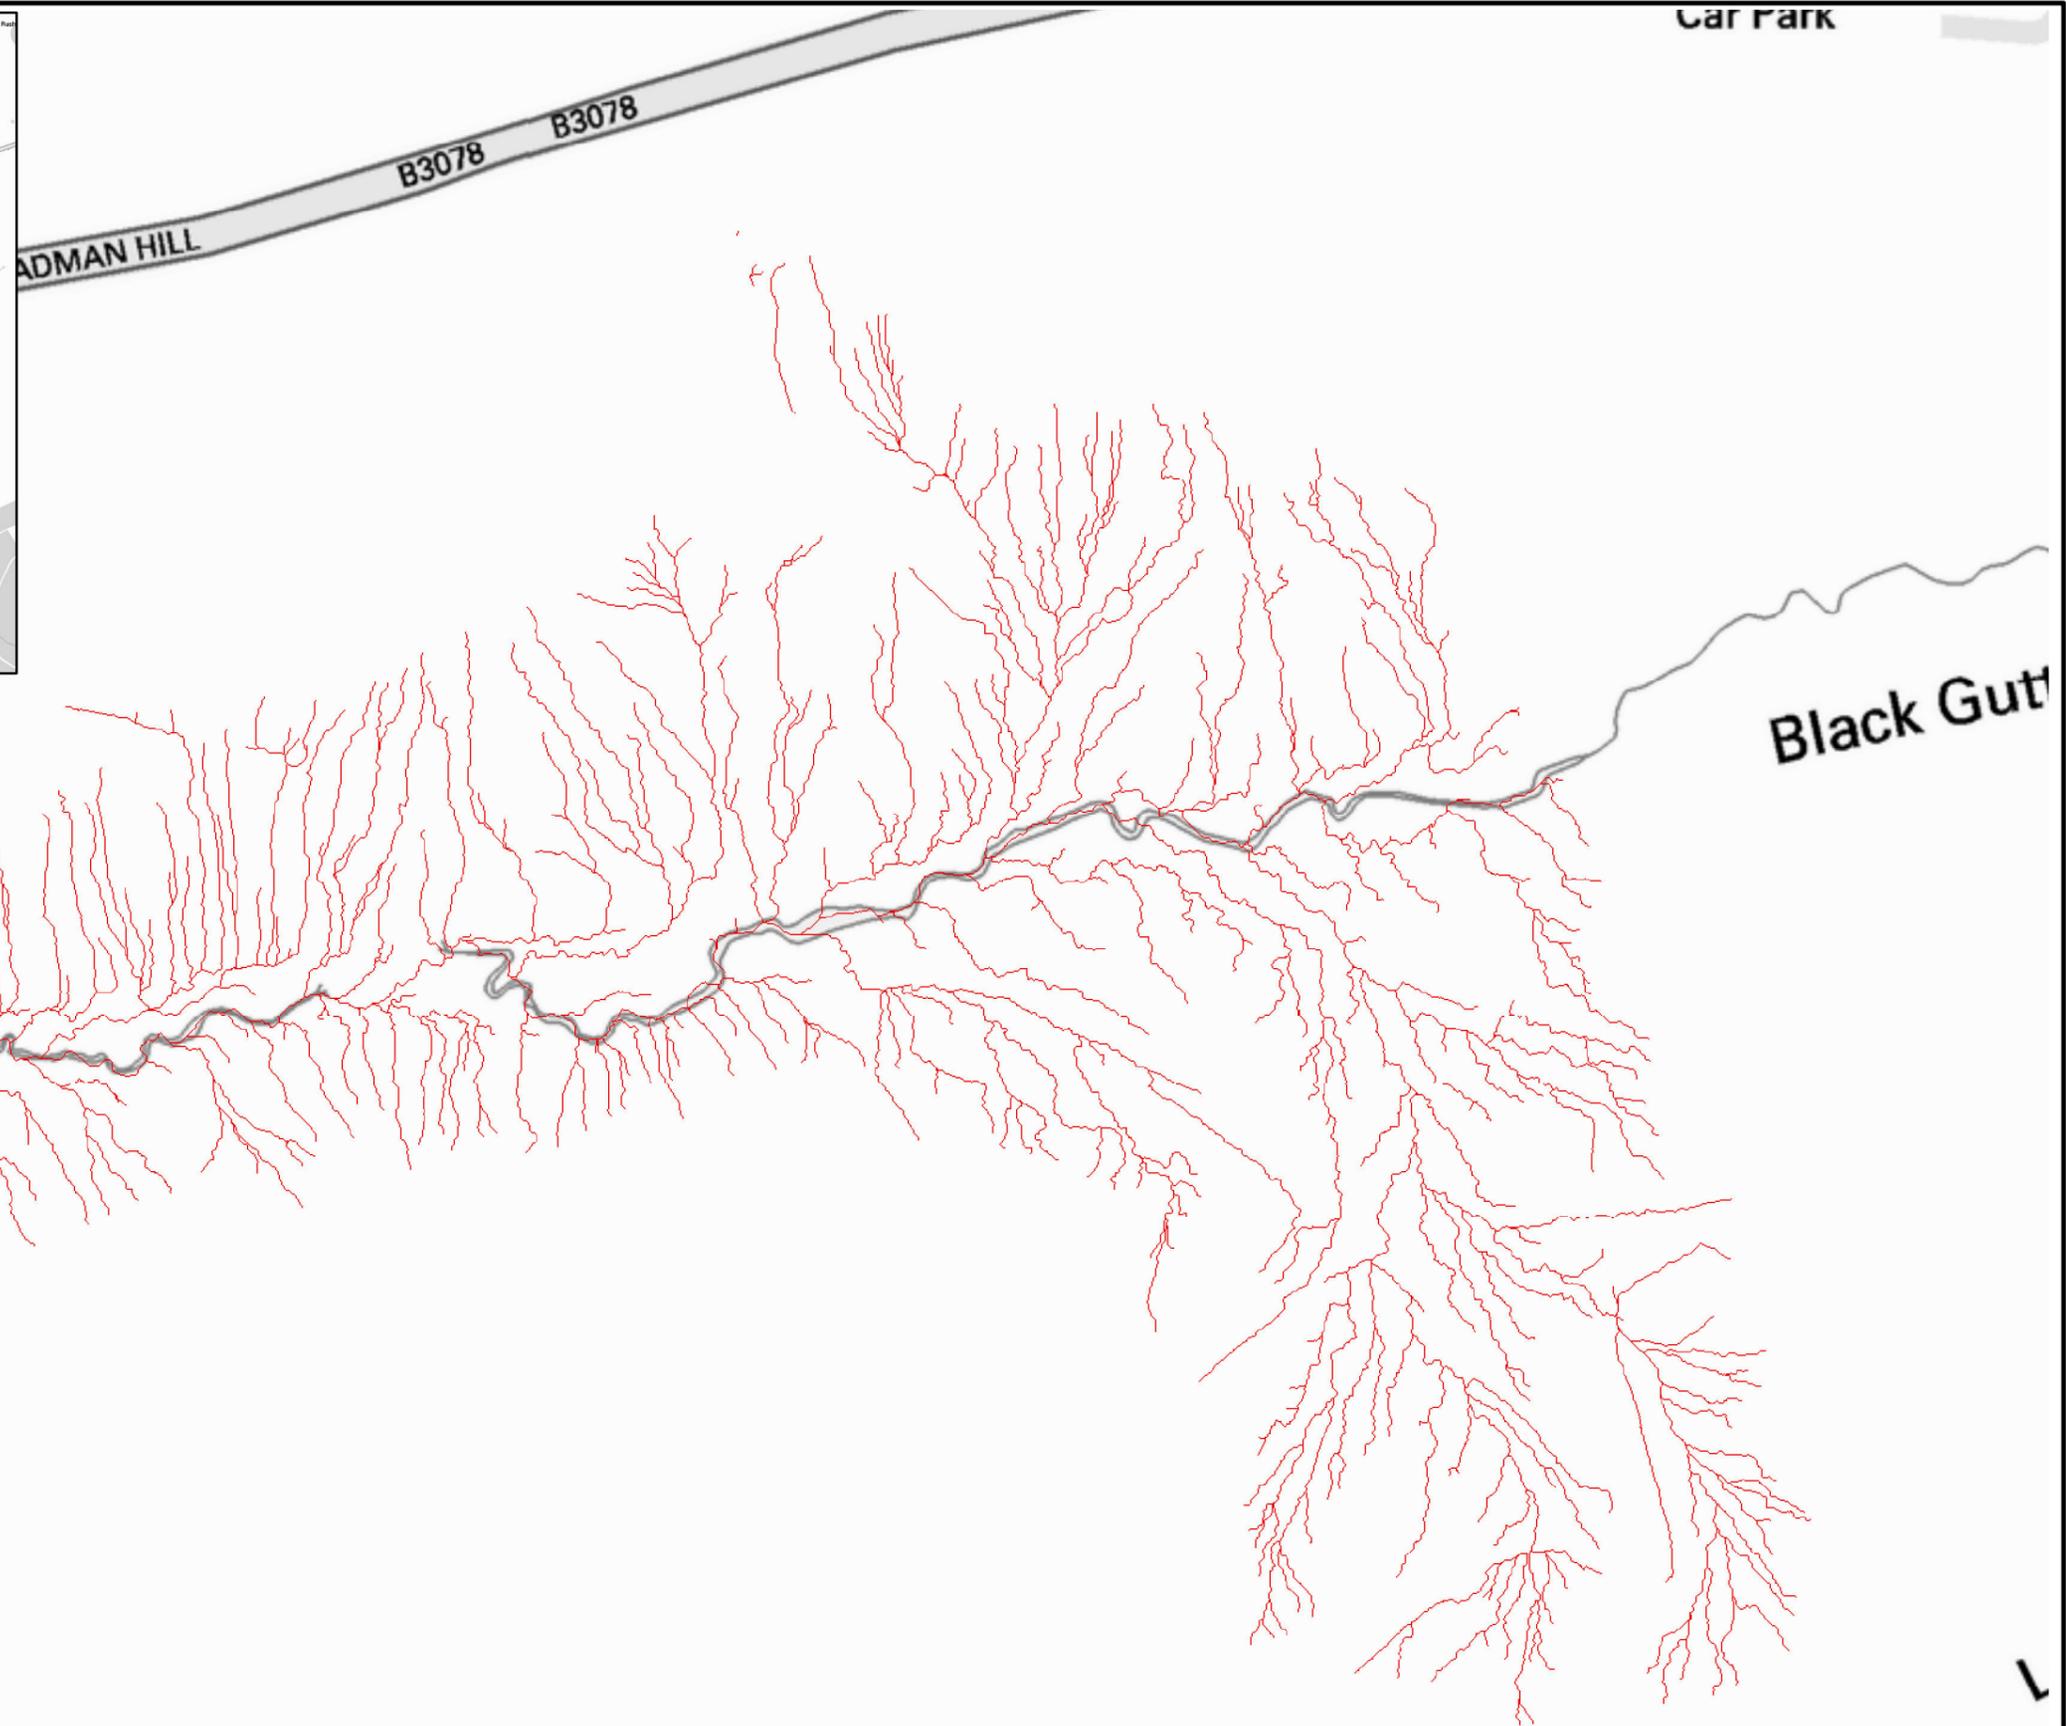
Appendix A - Artificial drains and flow lines - SSSI Unit 35

The flow and drainage lines in Appendix A confirm that there is little evidence of significant artificial drainage within this unit. There are very few straightened drains and both the audit and LIDAR confirm no presence of embankments along either the main channel or the drains.

Some of the flow lines in the mid to upper sections of the unit appear to join a palaeo channel before rejoining the main channel further downstream. This is unlikely to be impacting the flow regime significantly however.
