Natural England Commissioned Report NECR141

# New Forest SSSI Ecohydrological Survey Overview

Annex D: Dibden Bottom and Noads Mire

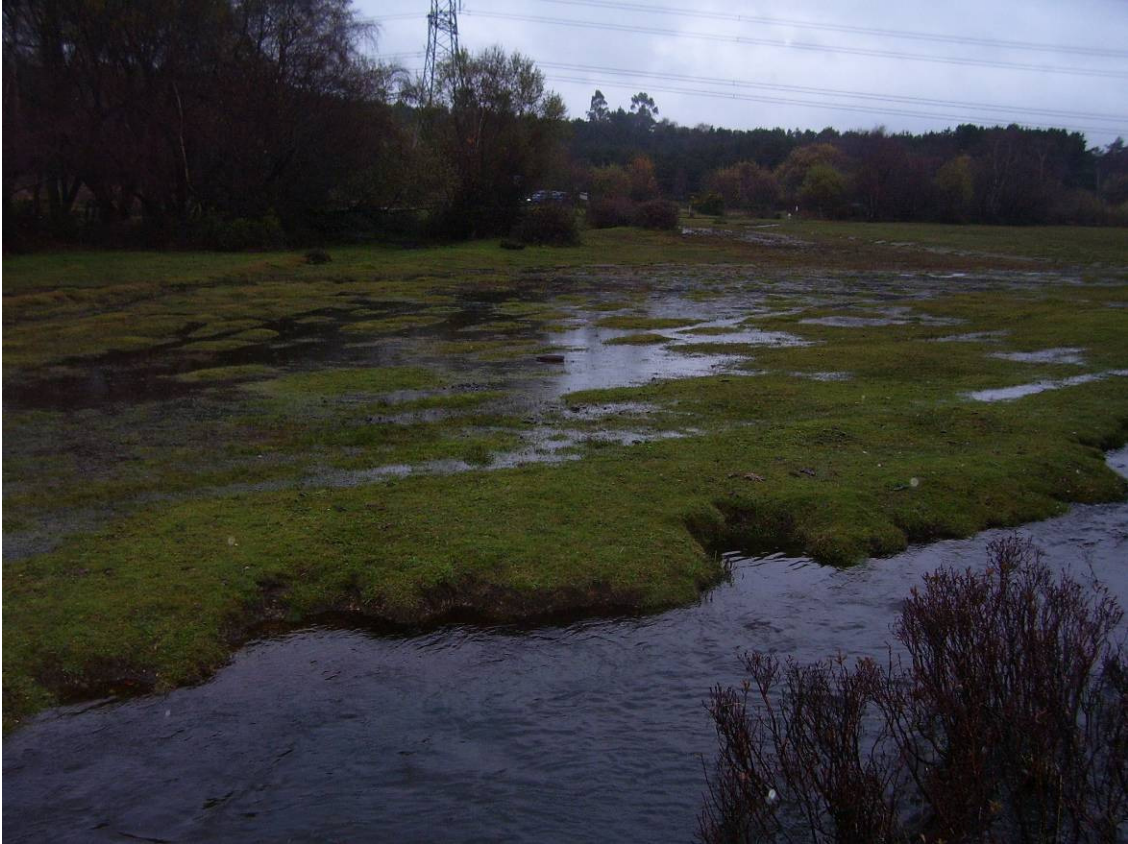
**Figure 1-2: Marshy grassland in the north-eastern part of the site (Unit 417, NGR 439599 107170)**

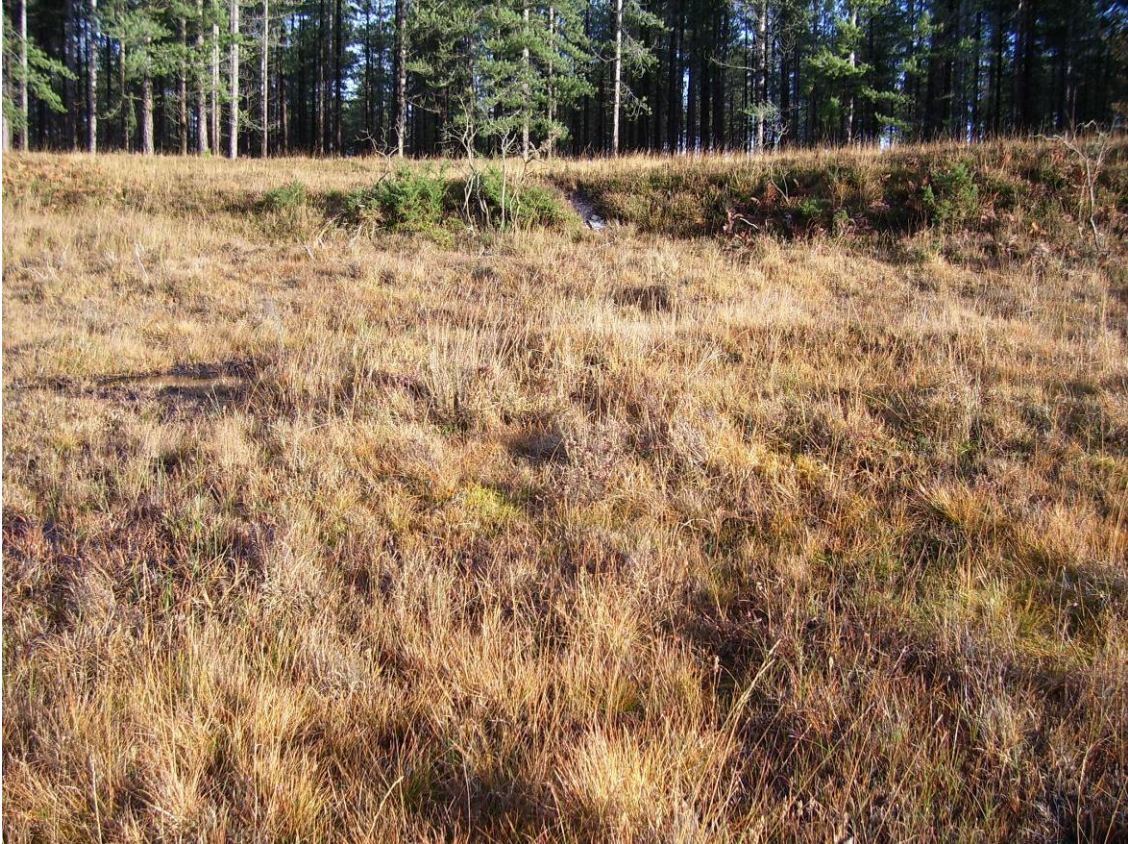
**Figure 1-8: Seepage step feeding valley side mire in the southern part of the site - the step represents the edge of a river terrace (Unit 419, NGR 439901 105328, looking east)**

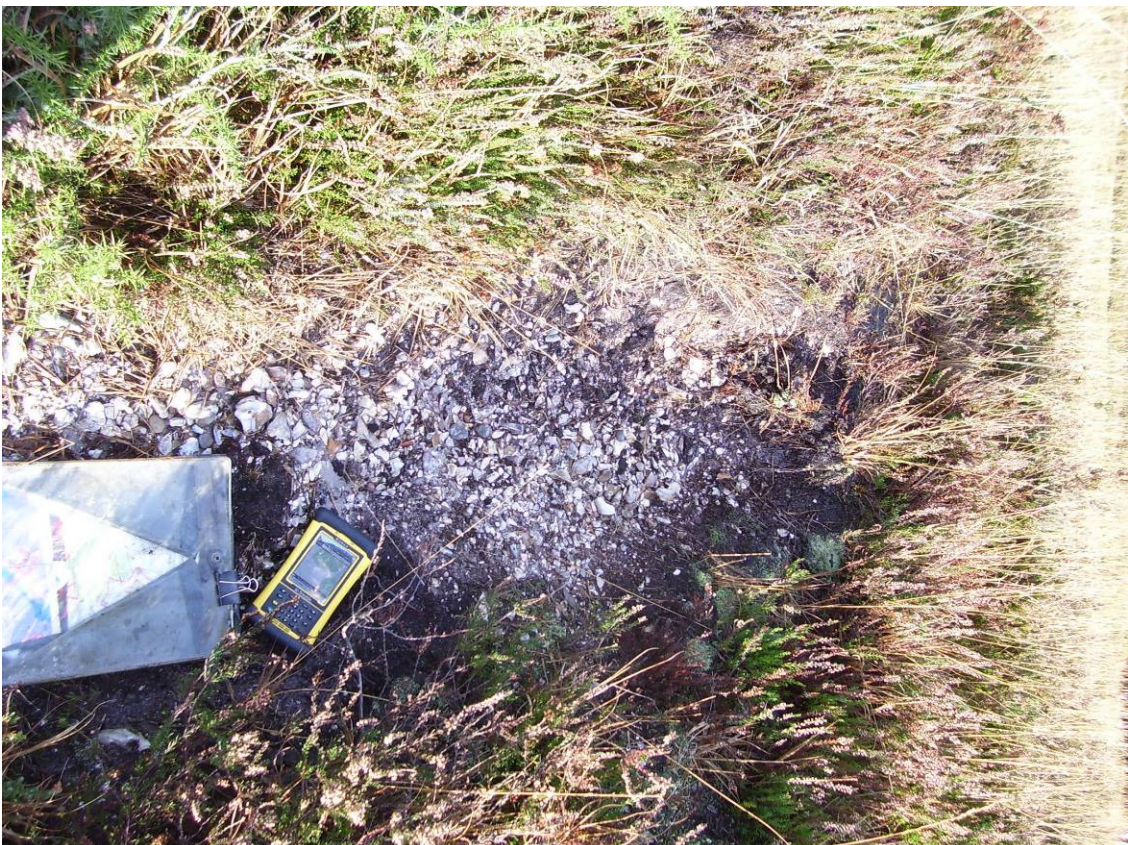
**Figure 1-9: River terrace sand and gravel deposits exposed at seepage step (Unit 419, NGR 439901 105328) - the Trimble computer is about 0.15 m long**

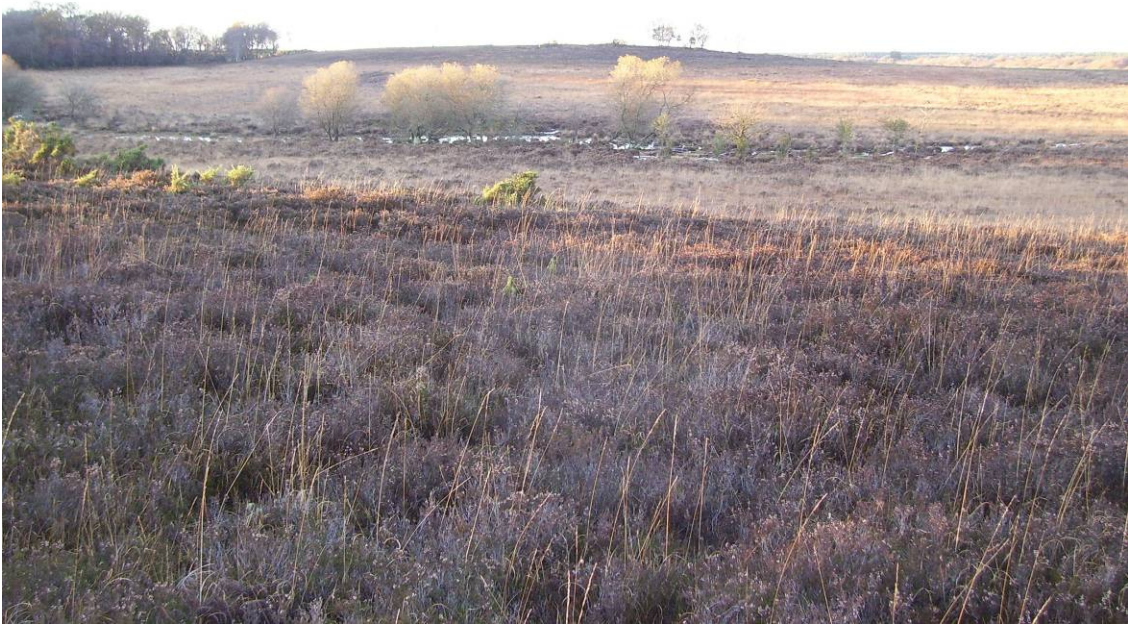
**Figure 1-10: View of valley mire near Ferny Crofts, in the western part of the site (Unit 425, NGR 437271 105802)**
