Natural England Commissioned Report NECR141

New Forest SSSI Ecohydrological Survey Overview

Annex P: Longdown Mire

First published 06 March 2014

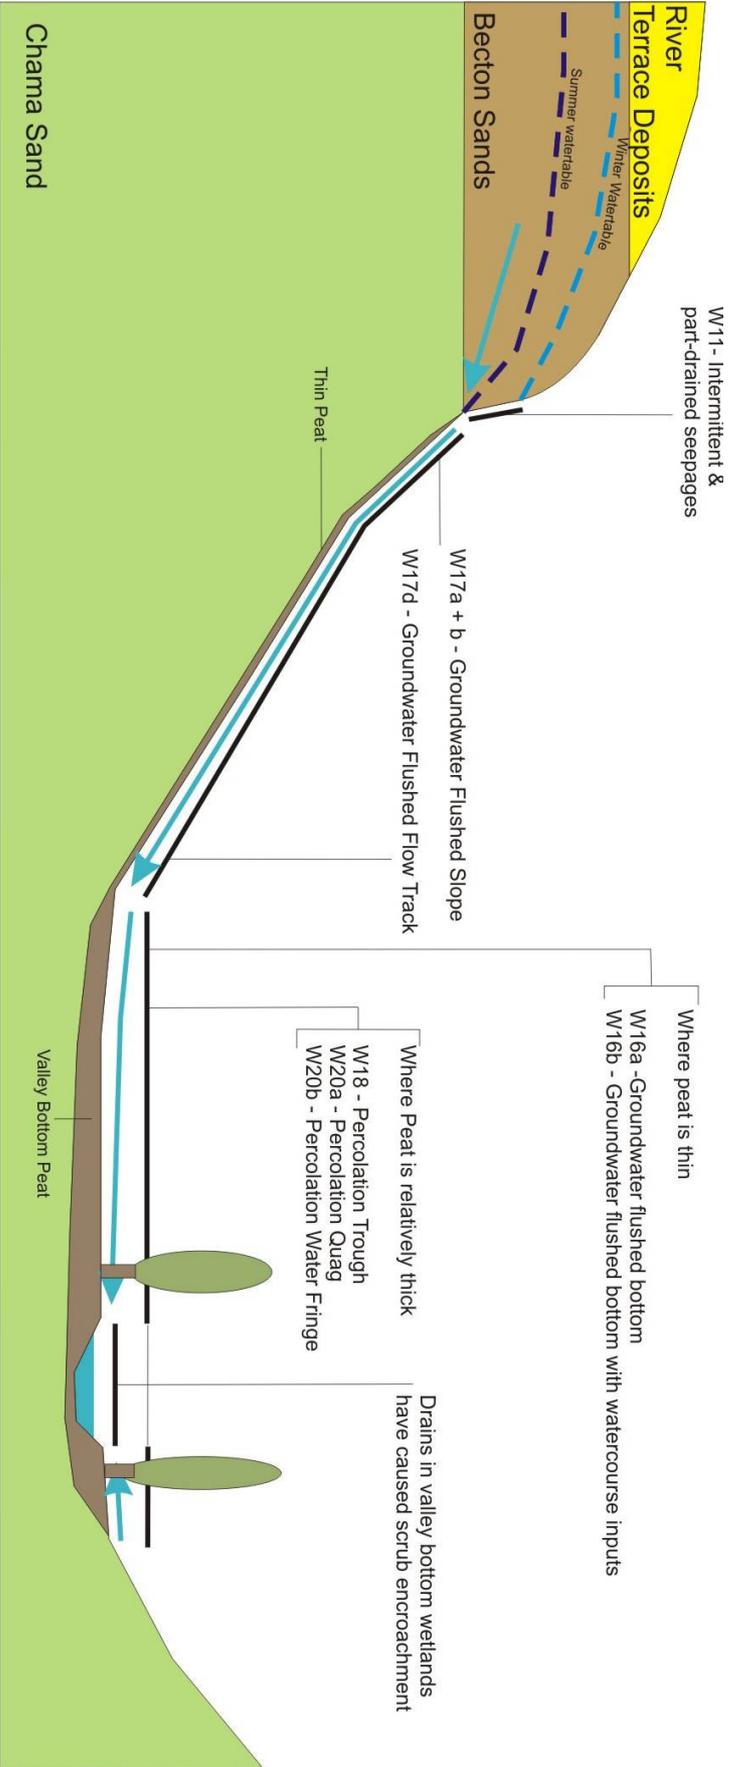
Figure 1-8: Conceptual Model Diagram

The wetlands on site are flush dominated (see Figure 1-8). They receive water from a weak seepage face at the junction between the Becton Sands (aquifer) and the underlying Chama Sands (aquitard). The water runs over the surface of the low permeability Chama Sands Formation, forming flushed slopes before reaching the shallow valley bottoms.

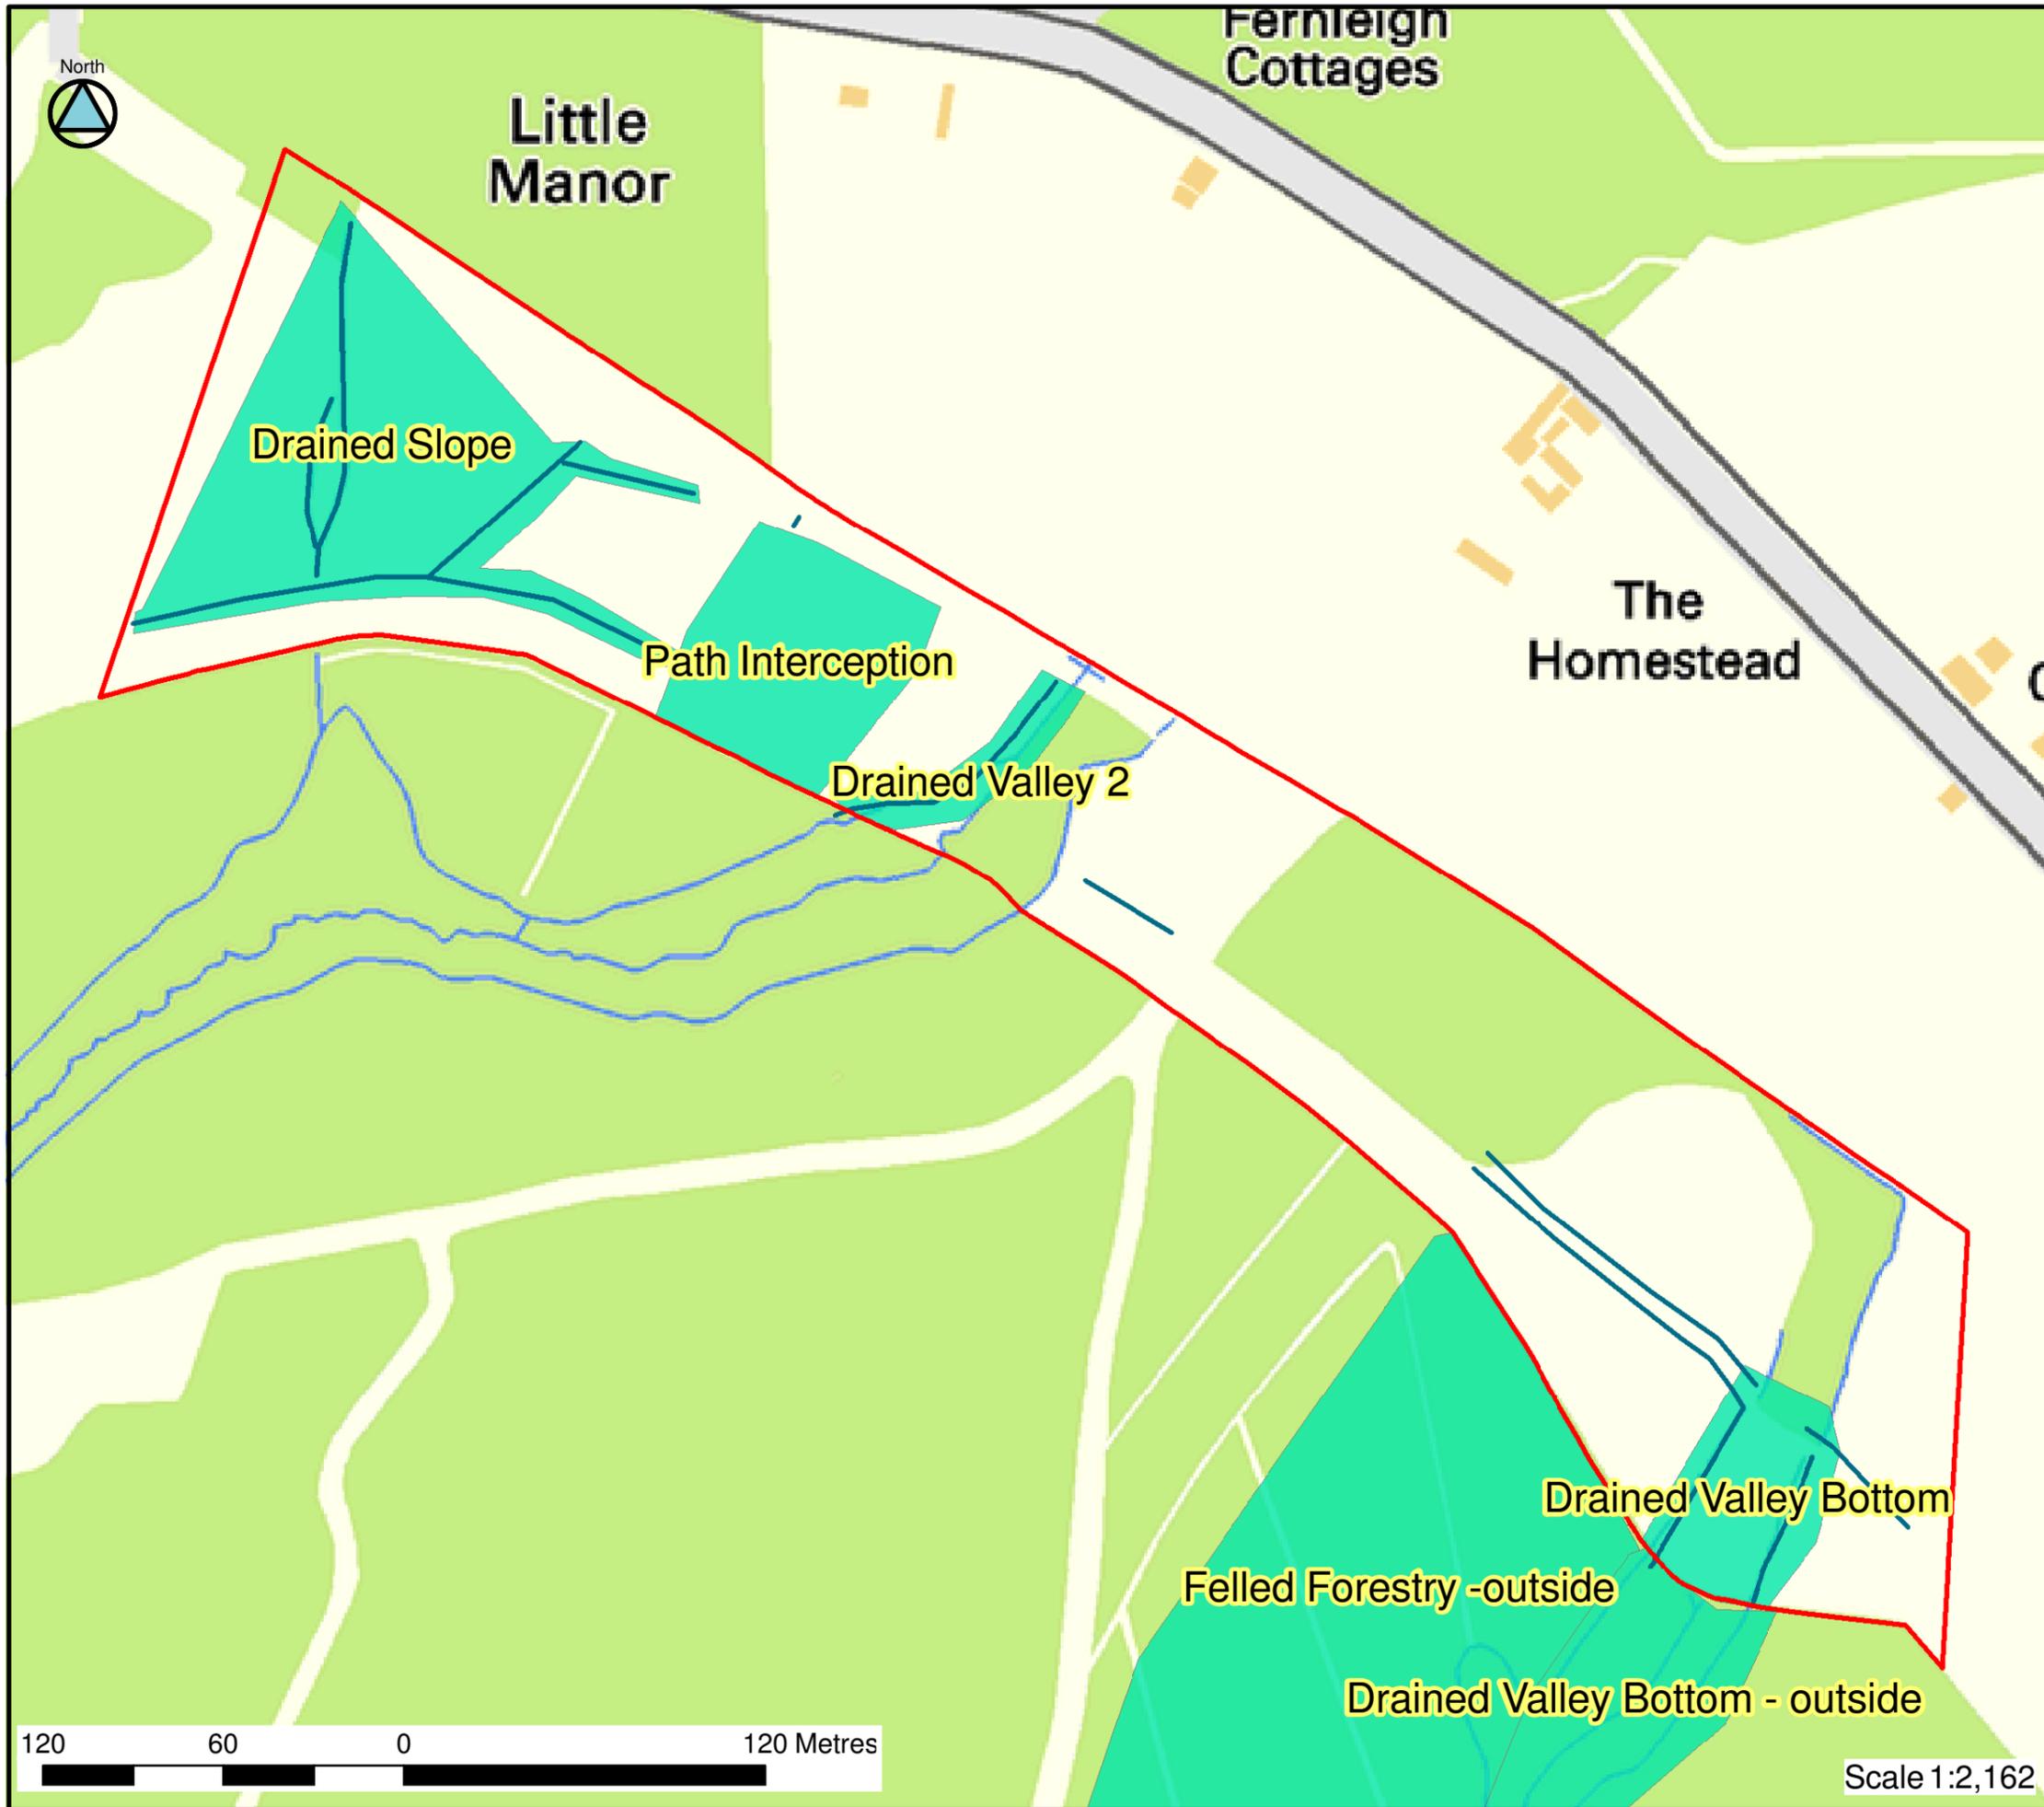
Map 8: Restoration Plan

There are 4 areas of damage within the unit and two areas just outside the unit boundary which will also be discussed (see Figure 1-9):

- Drained Slope - in this area there are a small number of drains on the valley side wetland. These are intercepting flush water to an extent and so drying out areas of the flushed slope;
- Path Interception - in this area the path that runs the length of the site is intercepting flush water channelling into culvert. The ground surface below the path therefore does not have water spread over its whole surface;
- Drain Valley Bottom - in this area some choked drains have led to the replacement of a mire area with scrub. This area continues outside the survey area boundary along the valley to the south;
- Drained Valley 2 - in this area a single drain has led to the replacement of a valley bottom mire with scrub.

- Drained slopes - where effective these drains should be blocked with earth plugs or infilled;
- Path Interception - as the line of the path is at the top of the site along this section, it appears impossible to move the path above the seepage face. The path however could be replaced with a path of more permeable material which would allow the flush water to pass through it, from north to south. This material would ideally be formed of imported uncompacted granular material such as a DTp type 1 hardcore;
- Scrub clearance - particularly of the pine that is encroaching into several areas across the site. Control of Rhododendron stands (or at least monitoring of them) should be a priority to prevent further encroachment into mire and wetland areas;
- Grazing control - there are poaching issues particularly associated with the wetter areas of the site which are most prone to damage.

Restoration Area	Damage Type	Restoration Proposals	Improvement	Constraints and Issues
Drained Slope	Valley Side Drainage	Infilling or plugging the effective drains	Improvement in water supply to parts of the flush slope Increase in quality and extent of adjacent mire and wet heath	Negligible

Restoration Area	Damage Type	Restoration Proposals	Improvement	Constraints and Issues
			habitats	
Path Interception	Valley Side Drainage	Replacement of the path with a new path made of more permeable material	Improvement in water supply to parts of the flush slope Increase in quality and extent of adjacent mire and wet heath habitats	The footpath may need to be closed during part of the works.
Longdown Mire	Scrub/pine encroachment	Eradication of Pine seedlings and other scrub Monitor Rhododendron along northern boundary	Removal of all non-native invasive species	Possible requirement for on-going management
Drained Slope and Unit middle	Poached Ground	Grazing management	Prevents sensitive mire habitat becoming trampled and damaged continuously	May be constrained by current grazing rights
