Natural England Commissioned Report NECR140

New Forest SSSI Geomorphological Survey Overview

Annex I: The Grove - SSSI Unit 286

First published 06 March 2014

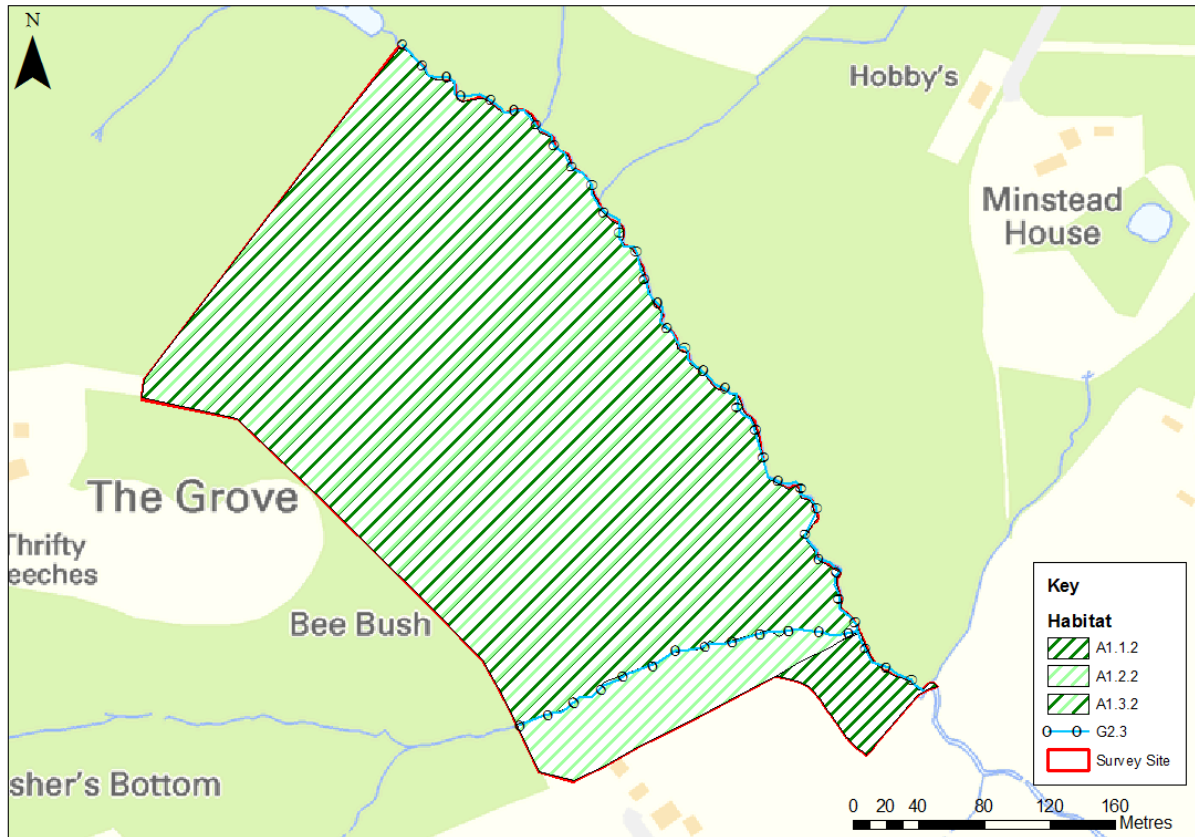
Figure 1-10: Phase 1 Habitat Map

The ground flora is very poor and the watercourse contained no aquatic vegetation, however, there were a few fern species alongside the watercourse, in particular Hard Fern *Blechnum spicant* with an occasional Broad Buckler fern *Dryopteris dilatata*.

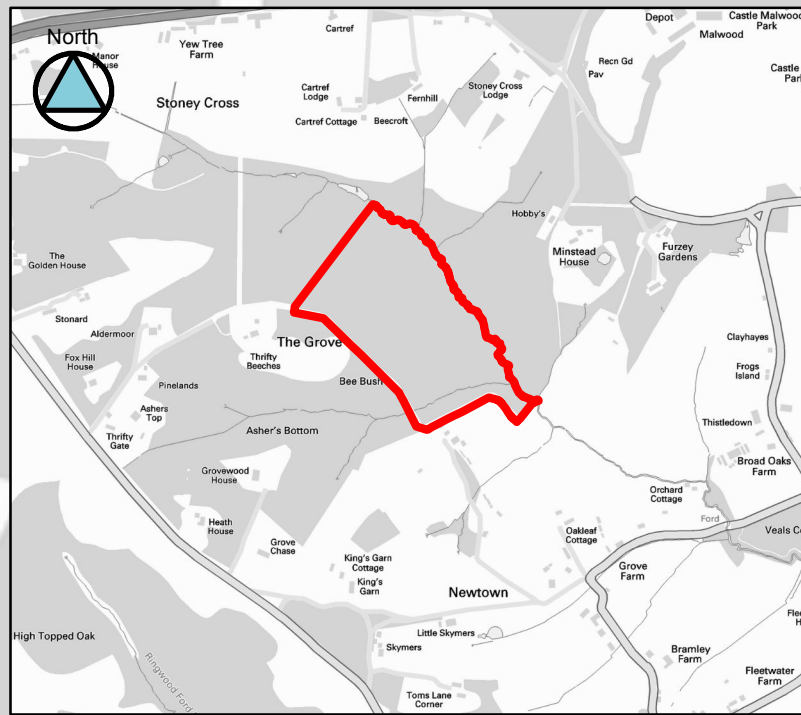
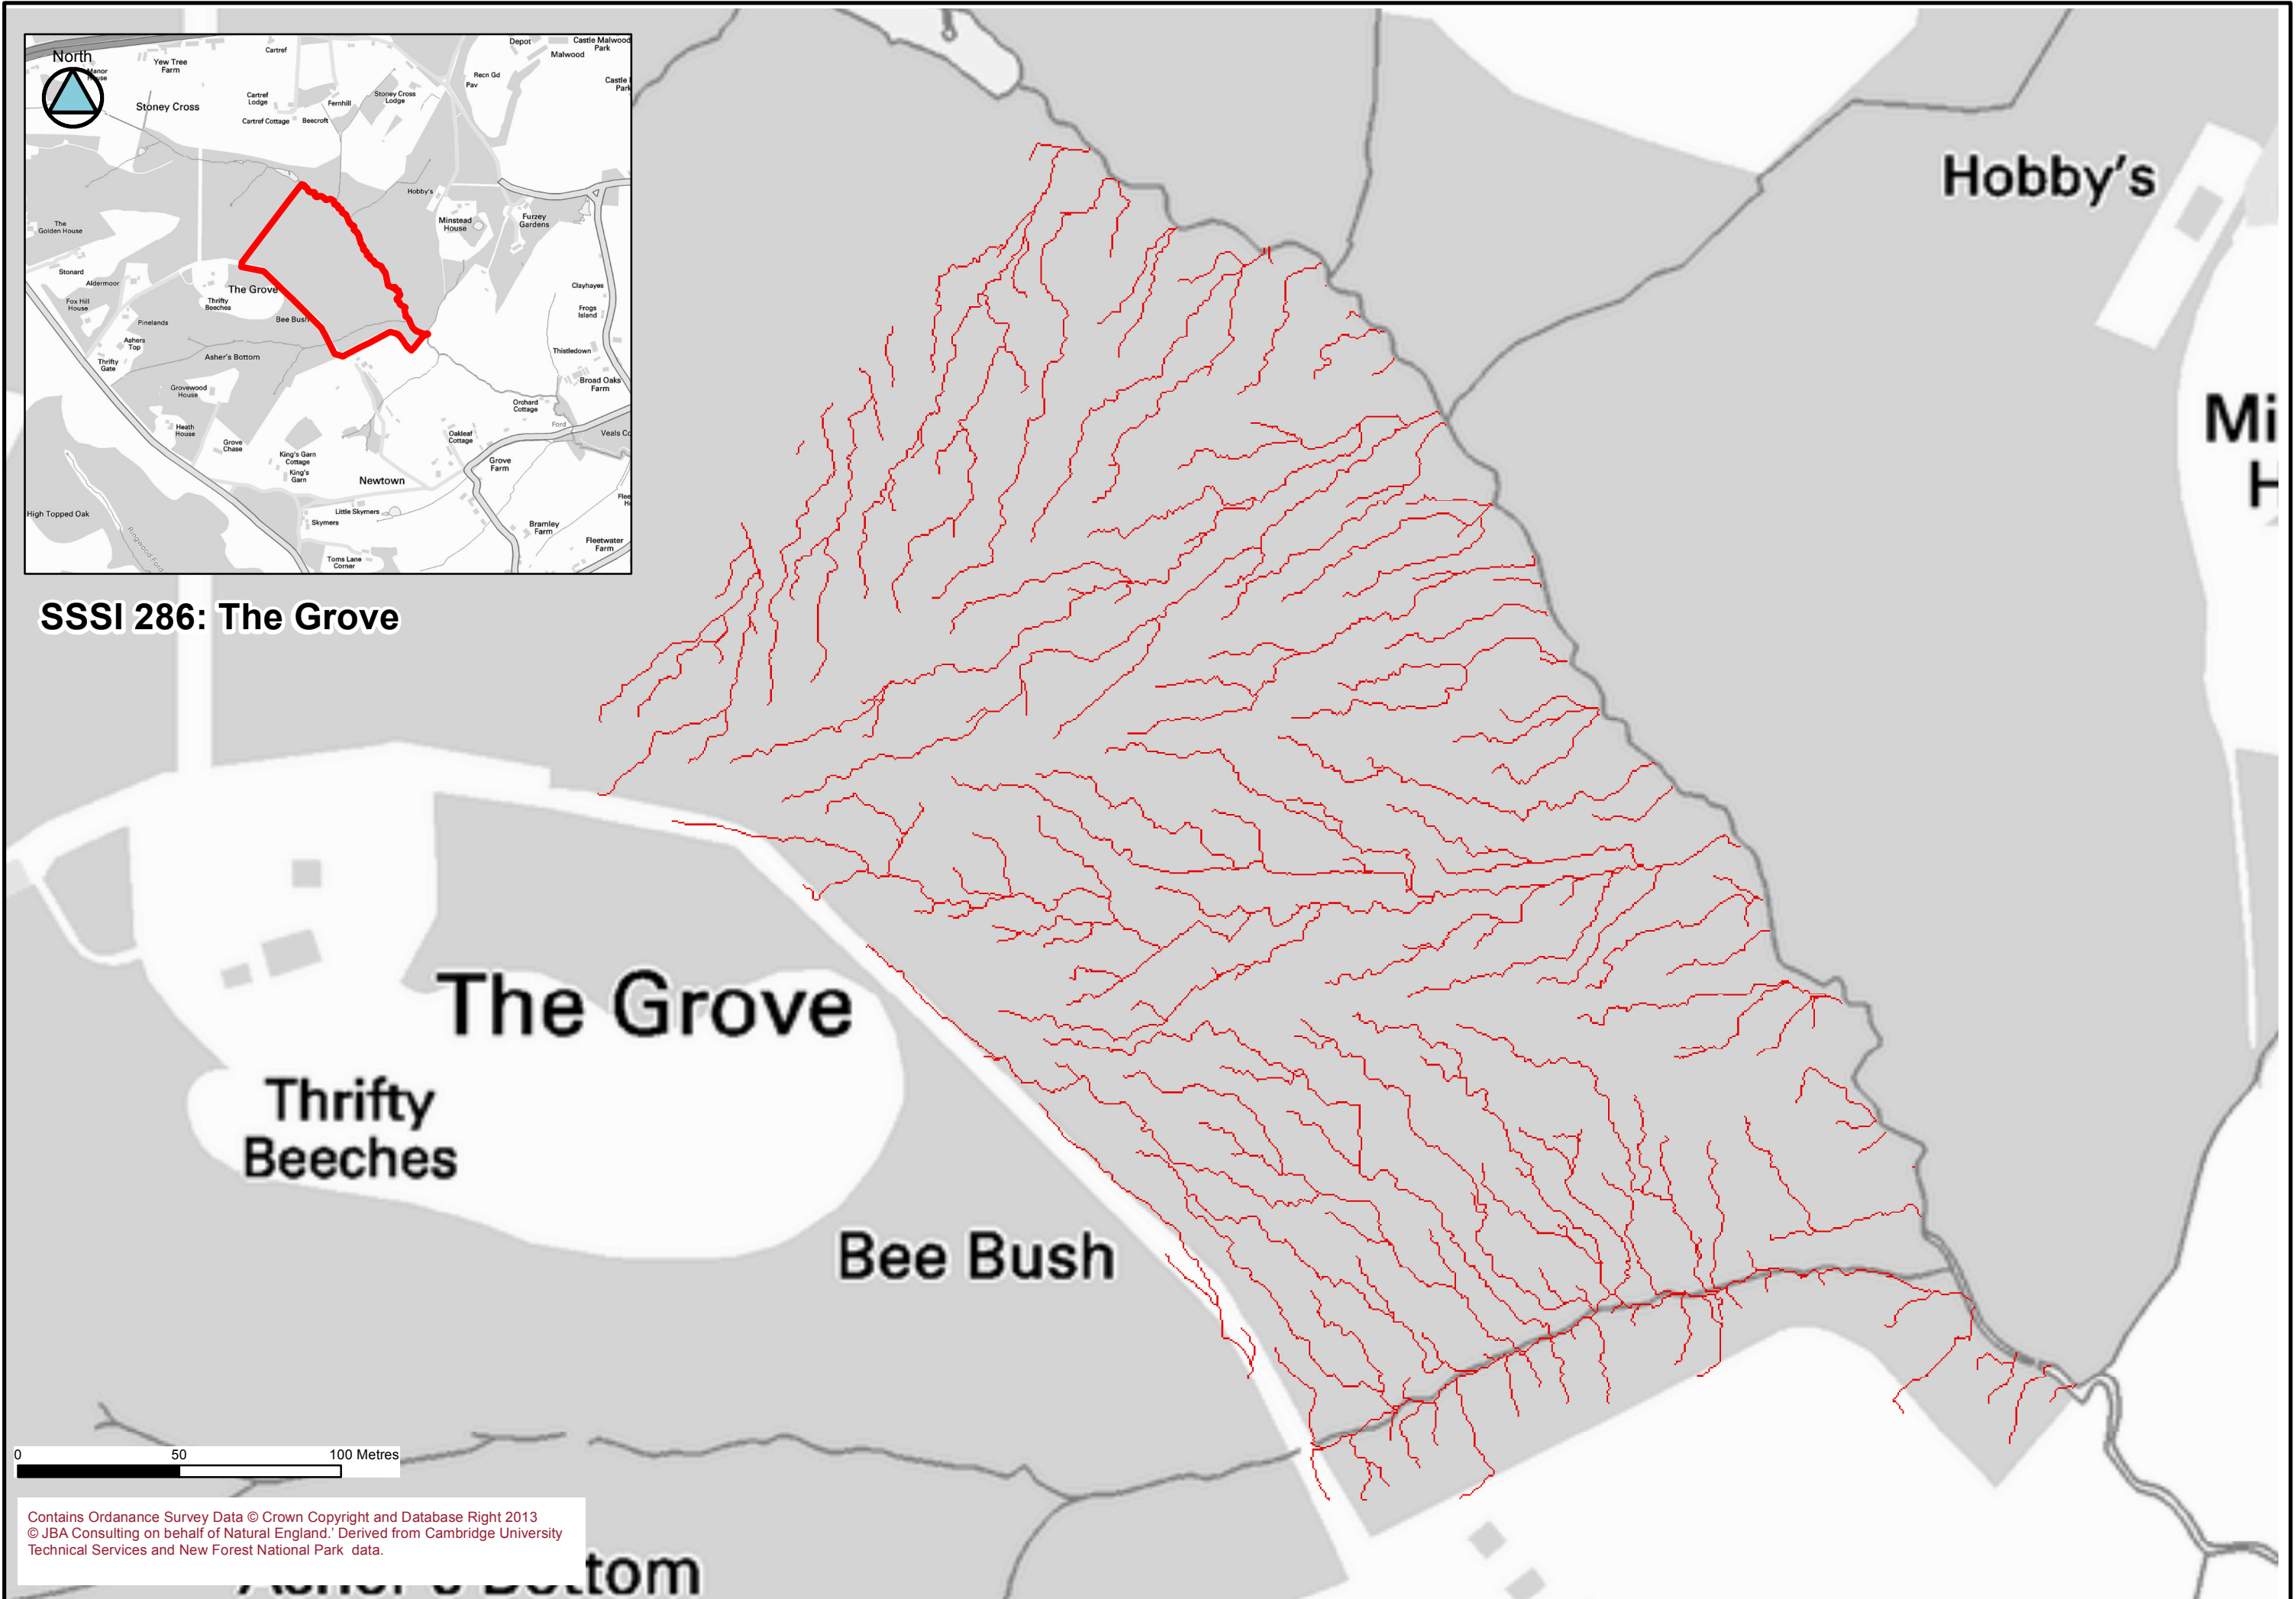
Appendix A - Artificial drainage and flow lines - SSSI Unit 286

The major drains within this SSSI unit show evidence of past straightening and over-deepening, although they have no significant embankments along the bank tops. The smaller flow routes show some signs of artificial modification through straightening and realigning, as shown in the flow line maps in Appendix A. The modifications to the main drains marked in Figure 1-5 are likely to be concentrating flows at local points in the main channel, leading to elevated erosive conditions. This is likely to be a contributing factor to the mild to moderate incision within this unit (Figure 1-6). The pond upstream of the SSSI unit (Figure 1-5 - B) is likely to be acting as a sediment sink, starving the reach of some sediment, resulting in some bed incision.

The major straightened / modified drainage channels are identified in Figure 1-11. Other minor modifications could be considered for infilling and Appendix A should be used for reference.
