Natural England Commissioned Report NECR141

# New Forest SSSI Ecohydrological Survey Overview

Annex C: Furzey Lodge Mire

First published 06 March 2014

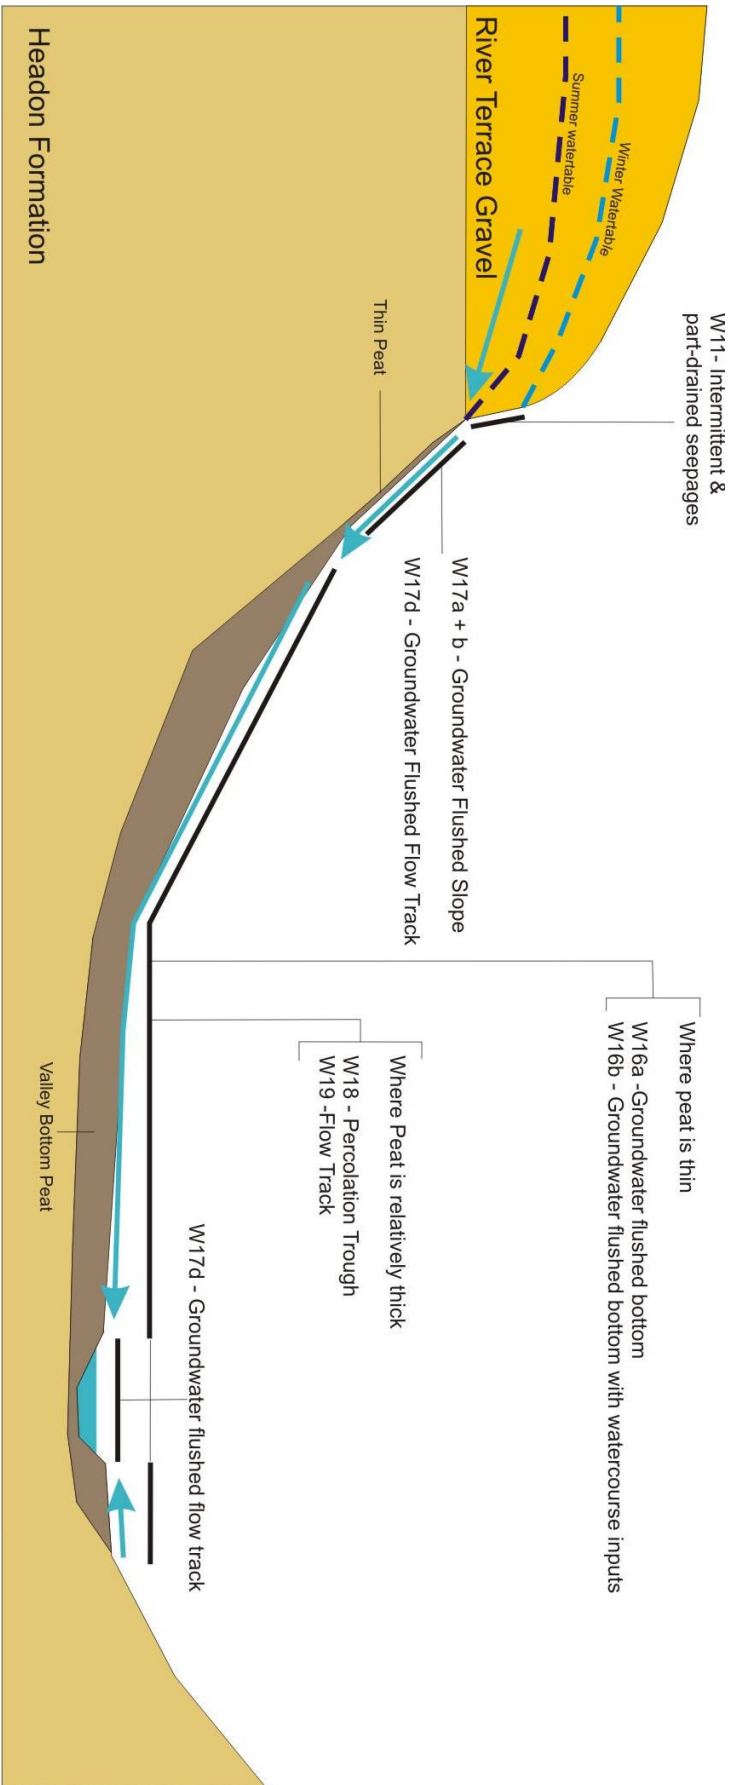
Figure 1-3: Conceptual Model Diagram

The wetlands on site are flush dominated. They receive water from a seepage face at the junction between river terrace deposits (aquifer) and the underlying Headon Formation (aquitard). The water runs over the surface of the low permeability Headon Formation, forming narrow flushed slopes before reaching the shallow valley bottoms.
