# New Forest SSSI Ecohydrological Survey Overview

## Annex B: Lodge Heath Mire

First published 06 March 2014

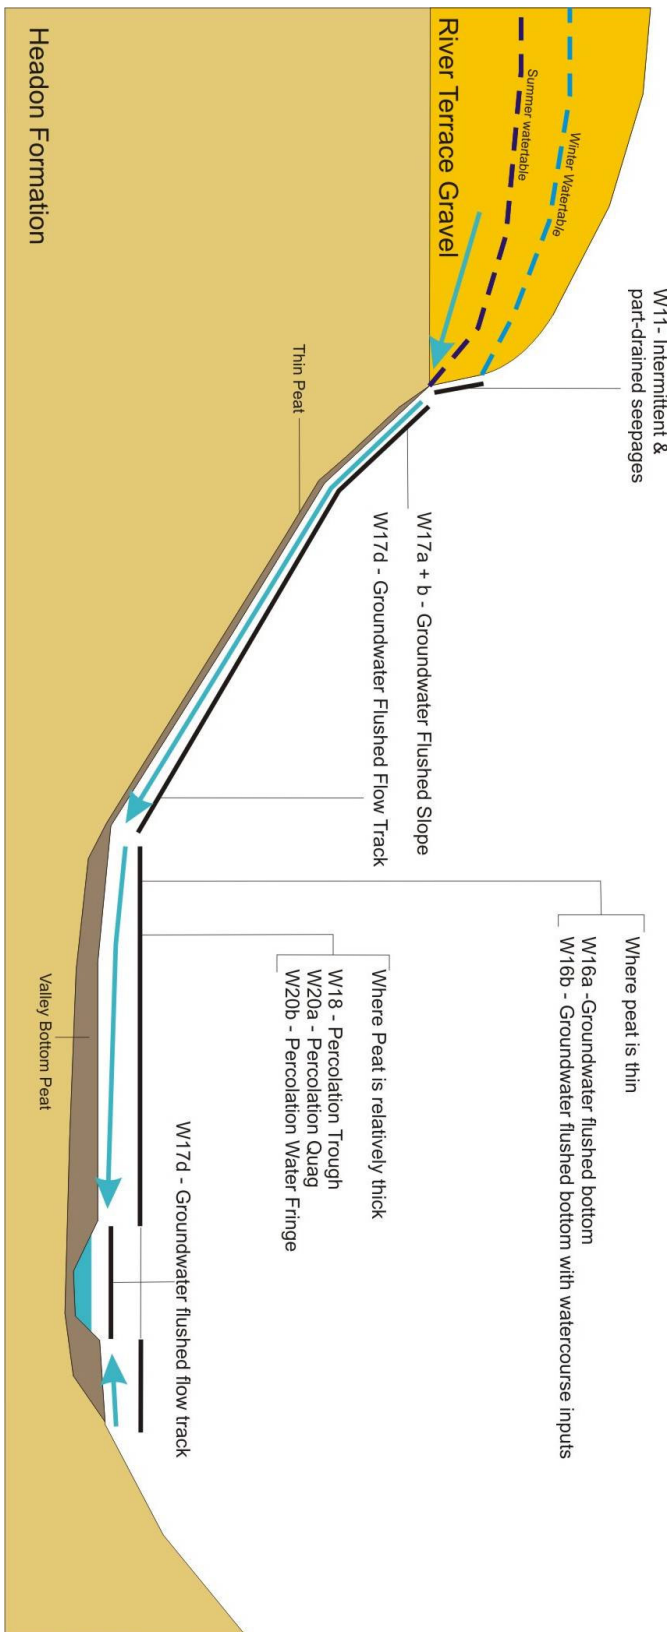
Figure 1-5: Conceptual Model Diagram

The wetlands on unit are flush dominated (see Figure 1-5). They receive water from a seepage face at the junction between river terrace deposits (aquifer) and the underlying Headon Formation (aquitard). The major seepage faces at this junction have been mapped by the survey. It appears that the seepage faces and the valley side wetlands are limited to the areas where thicker river terrace gravels intersect with the valley sides. The water runs over the surface of the low permeability Headon Formation, forming flushed slopes before reaching the valley bottoms. The length of the valley side wetlands is controlled by the difference in elevation between the seepage face and the bottom of the valley.
