# West Sussex Minerals Plan Site 10: Eartham

## Location of Auger Borings

## Agricultural Land Classification

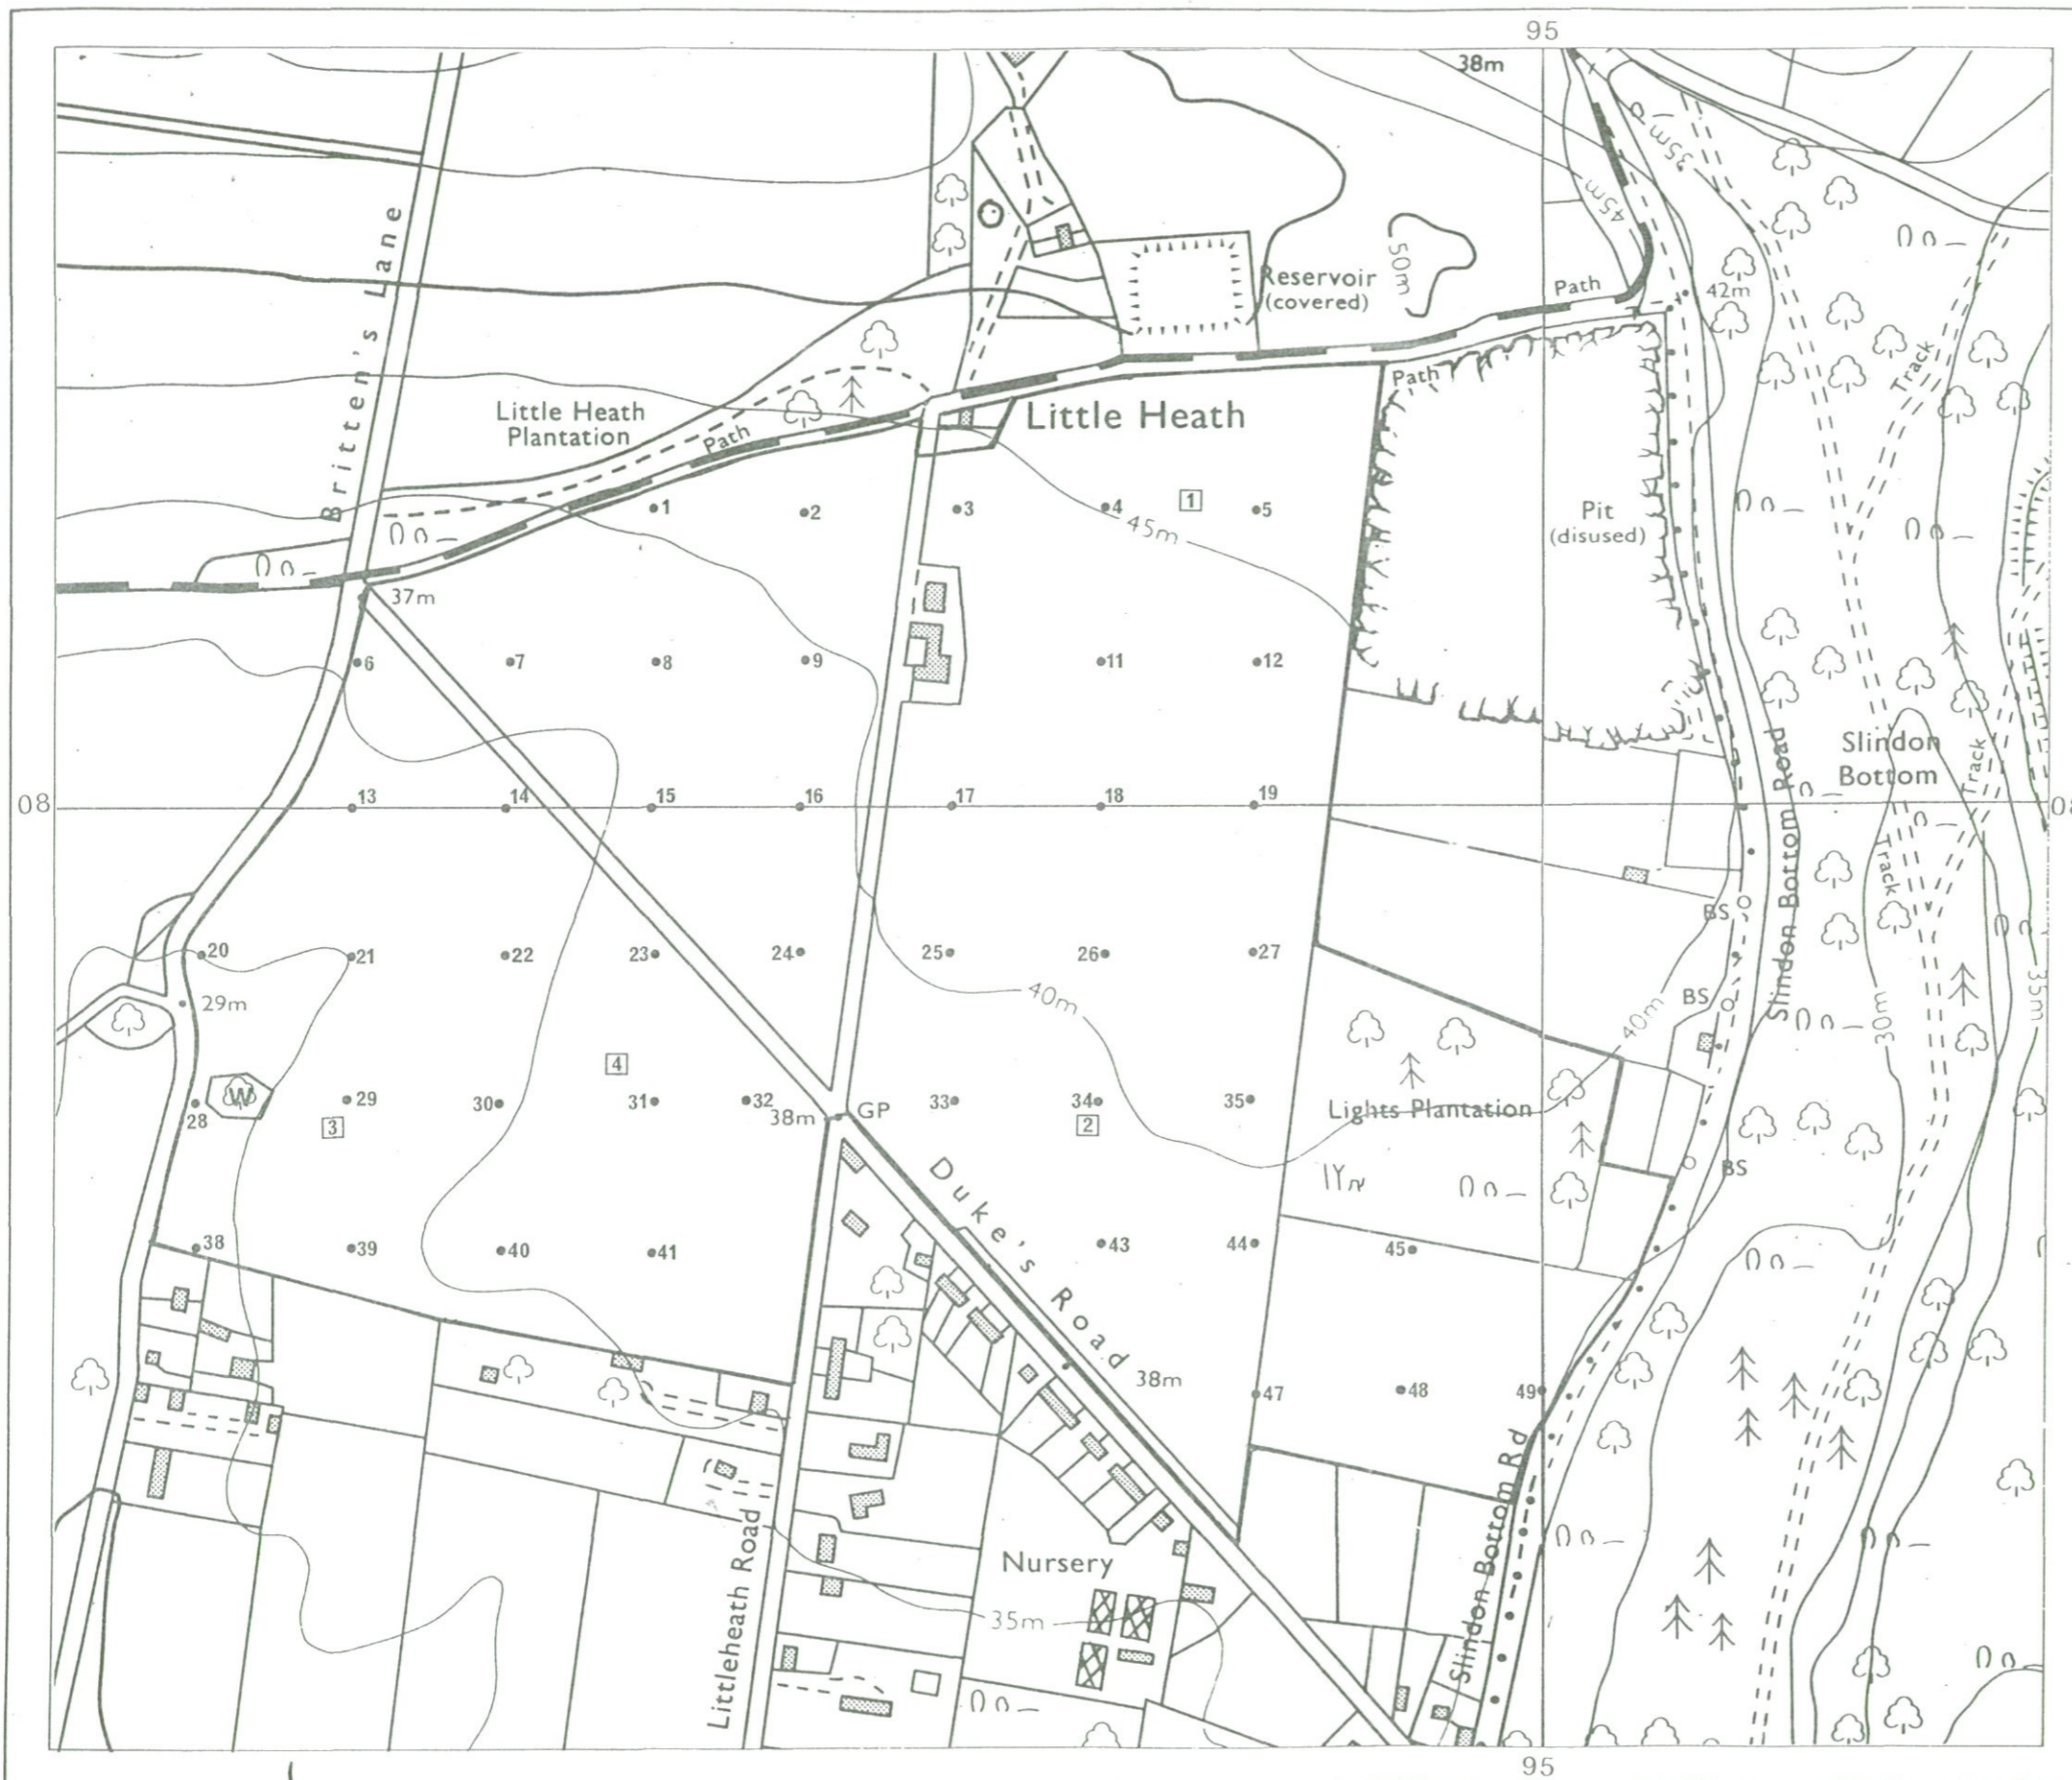
- 5 Auger boring
- 2 Profile pit

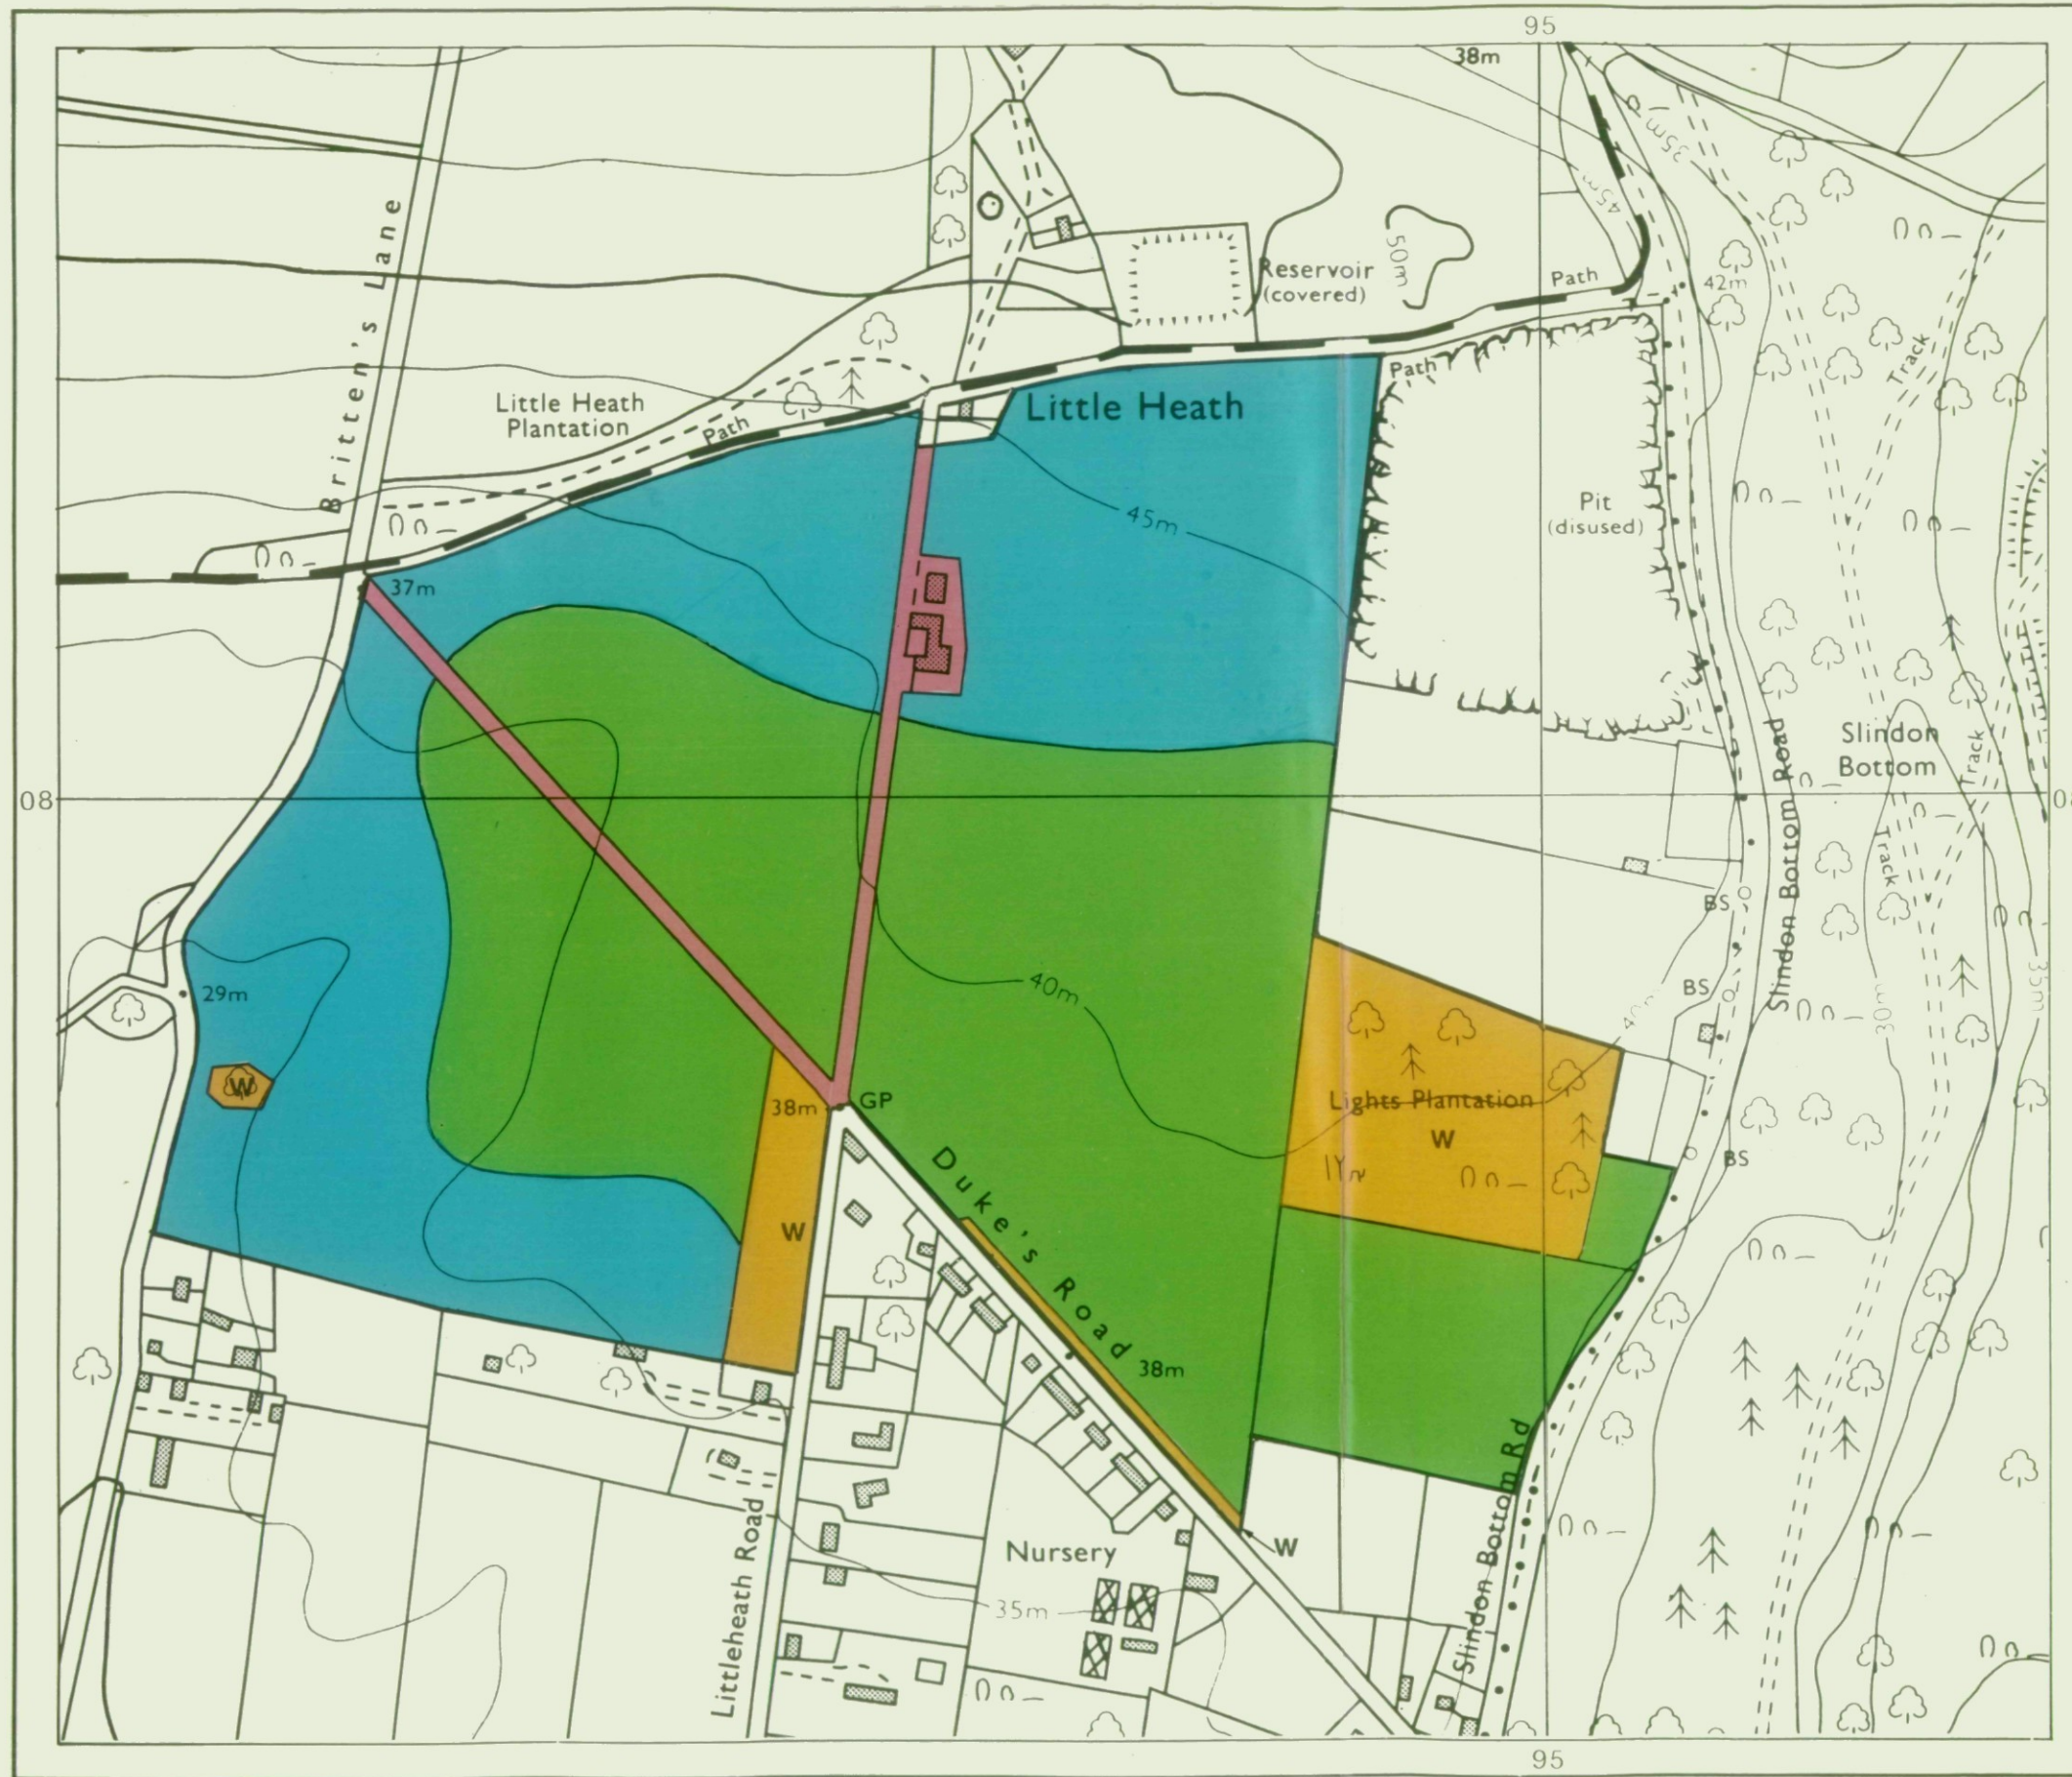
Grade	Quality	Area	% of Total
Grade 1	Not present	excellent	ha %
Grade 2	Very good	18.4ha	42.7%
Grade 3a	Not present	good	ha %
Grade 3b	Moderate	24.7ha	57.3%
Grade 4	Not present	poor	ha %
Grade 5	Not present	very poor	ha %

Total area of agricultural land surveyed 43.1ha

Woodland 4.9ha W

Land predominantly in urban use 1.5ha

Total area of site 49.5ha
