Agricultural Land Classification

Chichester District Local Plan

Site PR2 : Land to South of Fishbourne Roundabout.

Location of Auger Borings
Chichester District Local Plan
Site PR 2 : Land to South of
Fishbourne Roundabout.

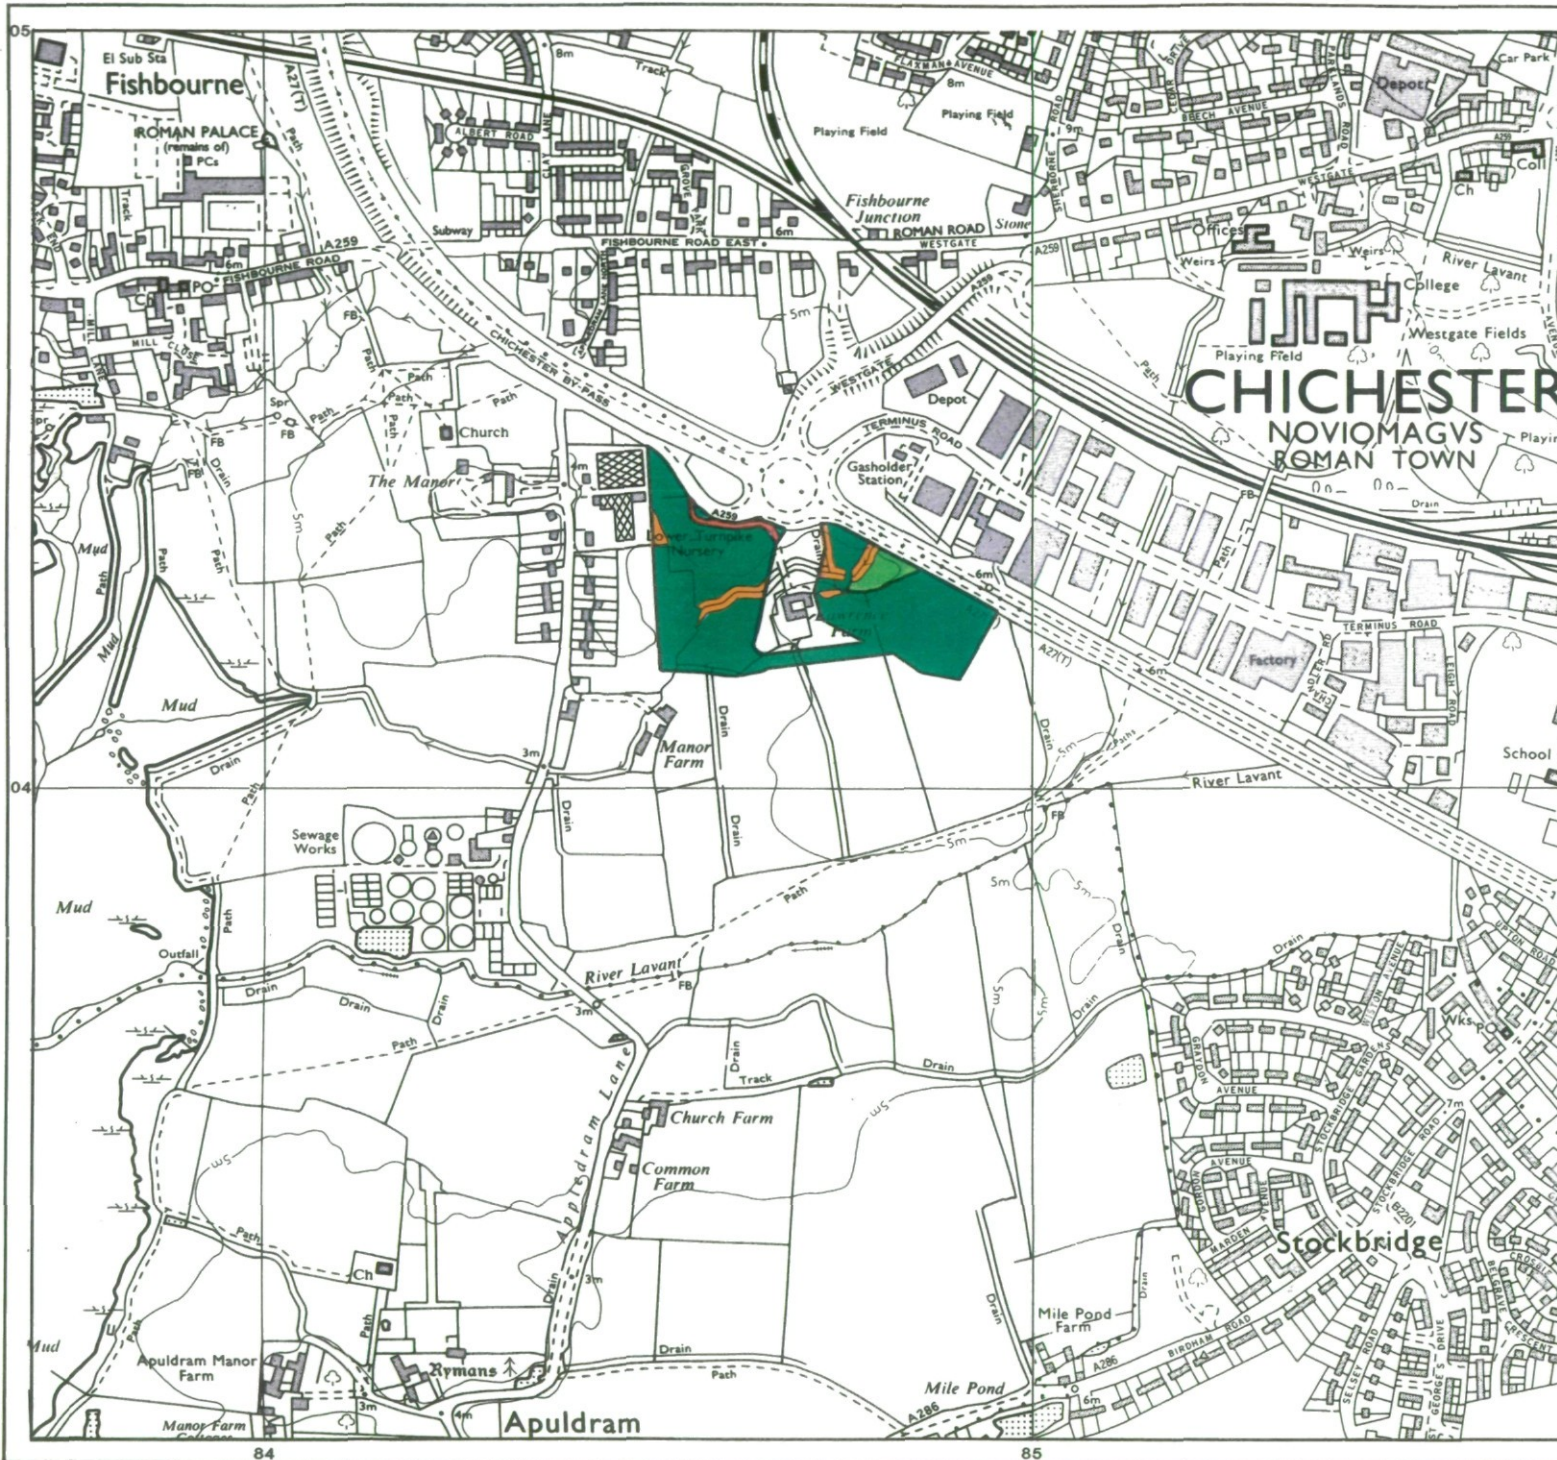
Grade	Quality	Area(ha)
1	Excellent	nil
2	Very Good	nil
3a	Good	5.3
3b	Moderate	0.3
4	Poor	nil
5	Very Poor	nil

Area (ha)
Urban	0.1
Non-Agricultural	0.5
Woodland	nil
Agricultural Buildings	nil
Open Water	nil
Not Surveyed	nil

Total agricultural land area 5.6
Total survey area 6.2

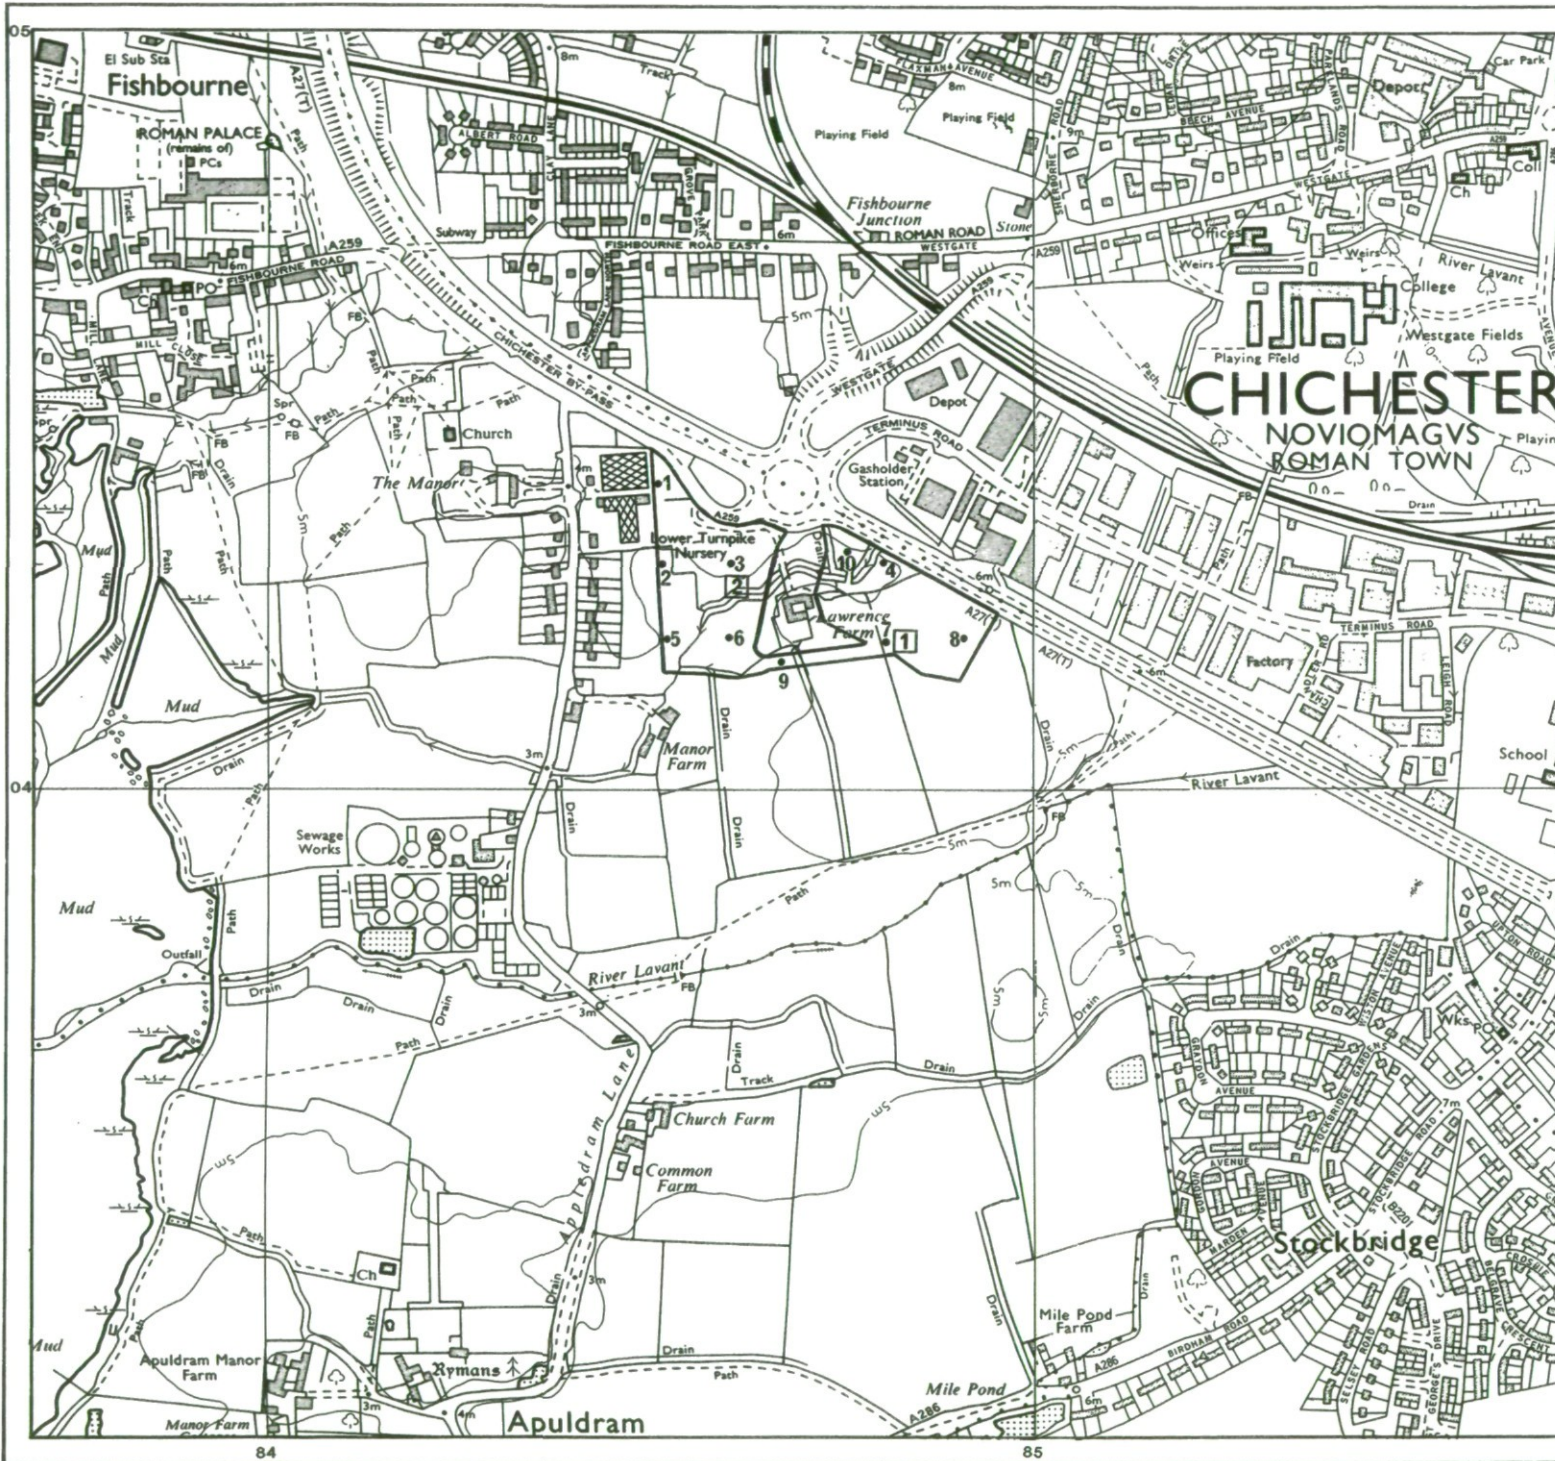
- 5 Auger boring
- ② Profile pit
