ENGLAND CATCHMENT SENSITIVE FARMING DELIVERY INITIATIVE

# Bossington Estate, Stockbridge. Hampshire

Case Study:

**Wallop Brook**

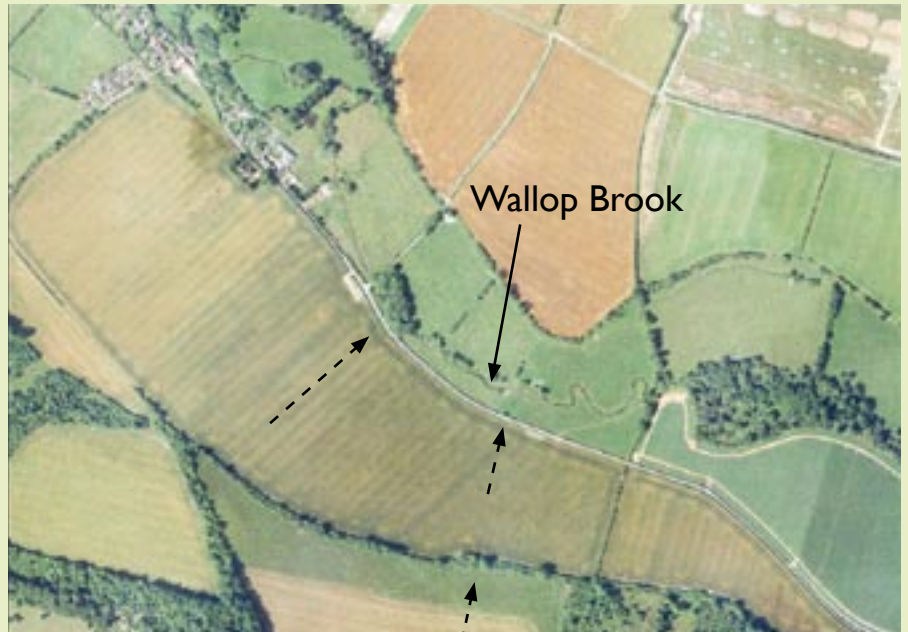
Image 1

Broughton Road field is used in the outdoor pig rotation. When pigs are present, there is a possibility of soil run-off following intense rainfall. Due to the absence of mitigation measures at the time, connectivity between the field, the road and the Wallop Brook - within 15 metres - was high, therefore a site deemed high risk due to its location was compounded by high risk due to management.

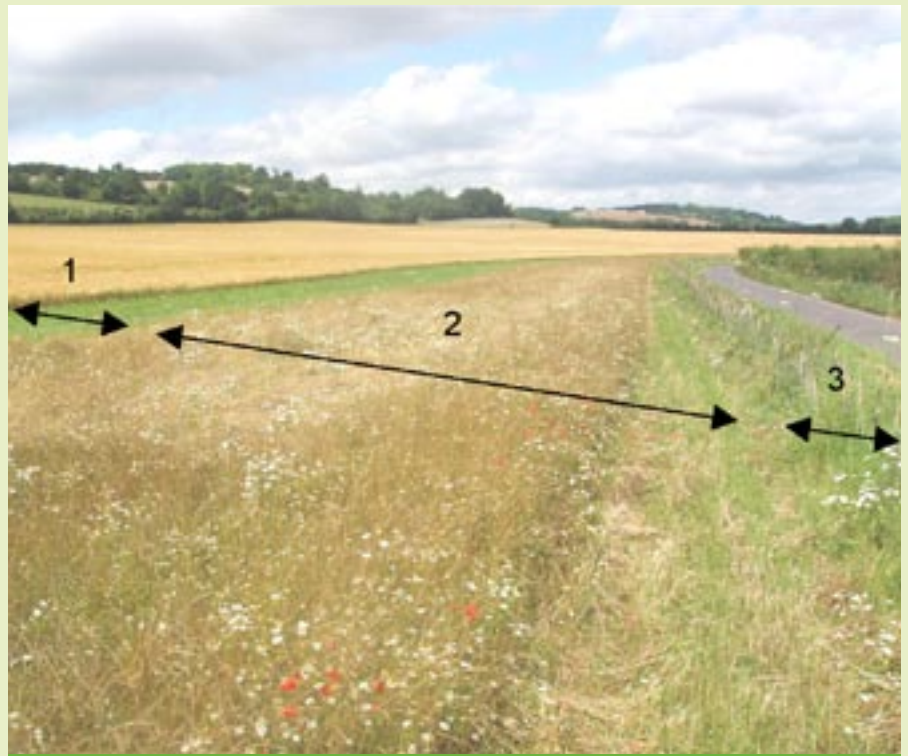
Image 2

As illustrated by image 2, the field is currently spring barley undersown with grass, with 1. an 8-metre grass strip; 2. a 12 metre conservation buffer strip; and 3. a newly planted hedgerow. This relates to the HLS application option HJ5 'In-field grass areas to prevent erosion and run-off'. It is the intention to return pigs to this field as part of the rotation in Autumn 2007, however these measures combined with a reduced stocking density will offer a reduction in connectivity and increased protection.

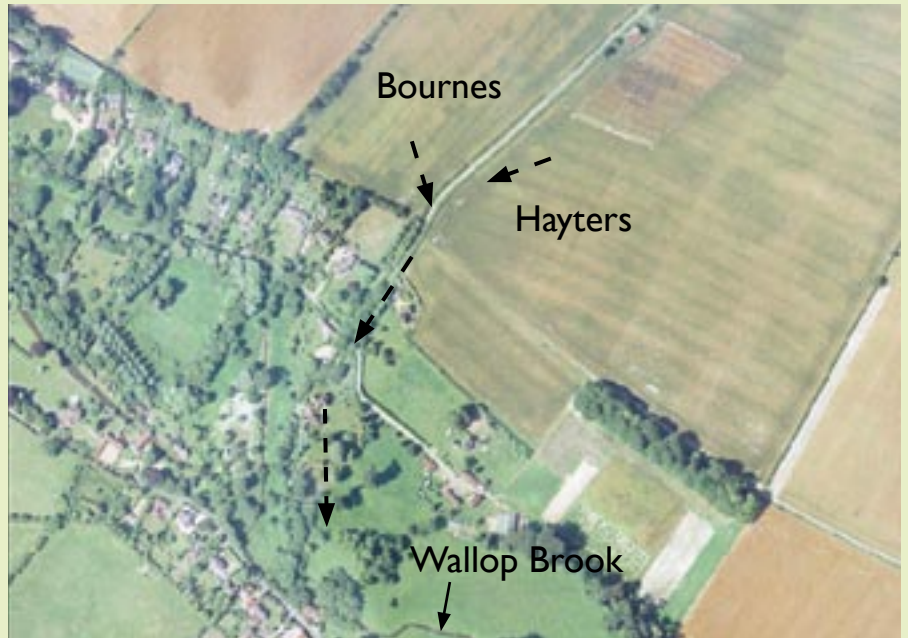
Image 4

Bournes field and Hayters field exhibited run-off in 2003-4 via a drove - an unsurfaced track with public access - to the Wallop Brook. At the time, these steep fields were managed for outdoor pigs. It was observed by Nigel that field gateways, public footpaths, tracks, and managed ditches combined to deliver sediment from field to river. Turbid water entering the river initially flowed left bank downstream, becoming fully mixed across the river by approximately 25m downstream. The river was red/brown in colour and the bed was not visible.

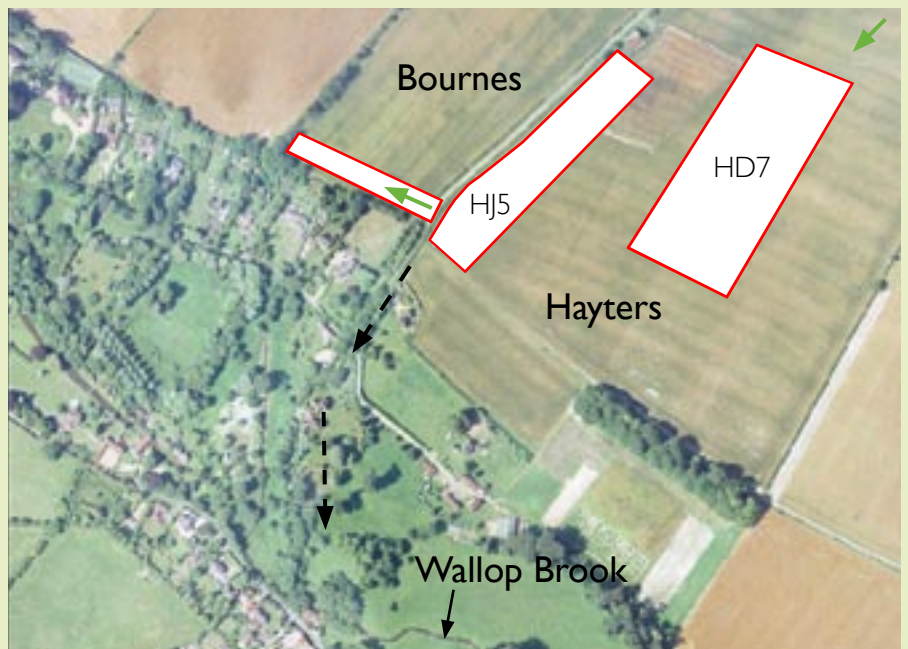
Image 5 - Green arrows show direction of photos

For Hayters field, the plan recommended the avoidance of using steeper land, the establishment of a good sward cover prior to occupation, and the layout of tracks and pens to counter run-off. As shown by photographs 5 and 7, Hayters field now incorporates HLS option HD7 'Arable reversion by natural regeneration' in addition to HJ5. The HLS handbook promotes this option to target protected features at risk of damage through the standard method of grassland

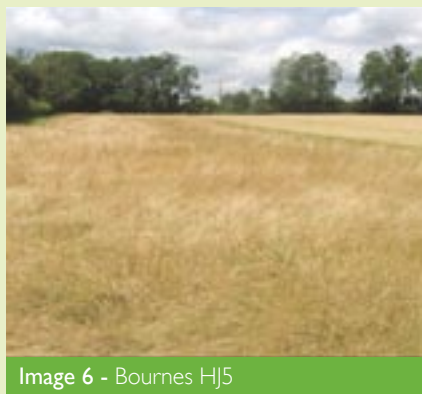
Image 6 - Bournes HJ5

The Soil Management Plan completed in 2006 by the Landcare Project for Bournes field identified the pathway between the field and properties and the Wallop Brook, signalling a high inherent risk. Removal of pigs or movement to the top of the slope in conjunction with suitable mitigation was recommended. The plan also promoted ploughing across the slope, a rough seedbed, and a buffer. As illustrated by photographs 5 and 6, Bournes field now incorporates a buffer strip under HLS option HJ5. The HLS handbook describes the aim to 'filter surface run-off and to reduce the amount of eroded soil, organic material, nutrients and pesticides reaching the watercourse.'

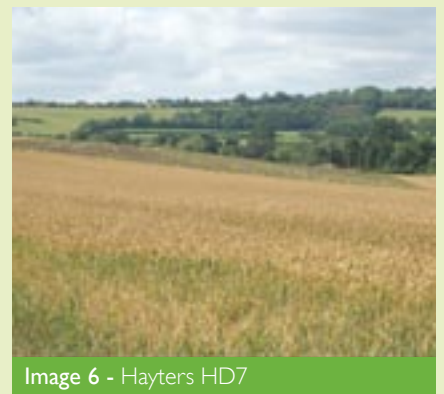
Image 6 - Hayters HD7

establishment, which would involve some form of cultivation such as ploughing. This option may also help to protect soils from erosion and reduce diffuse pollution.

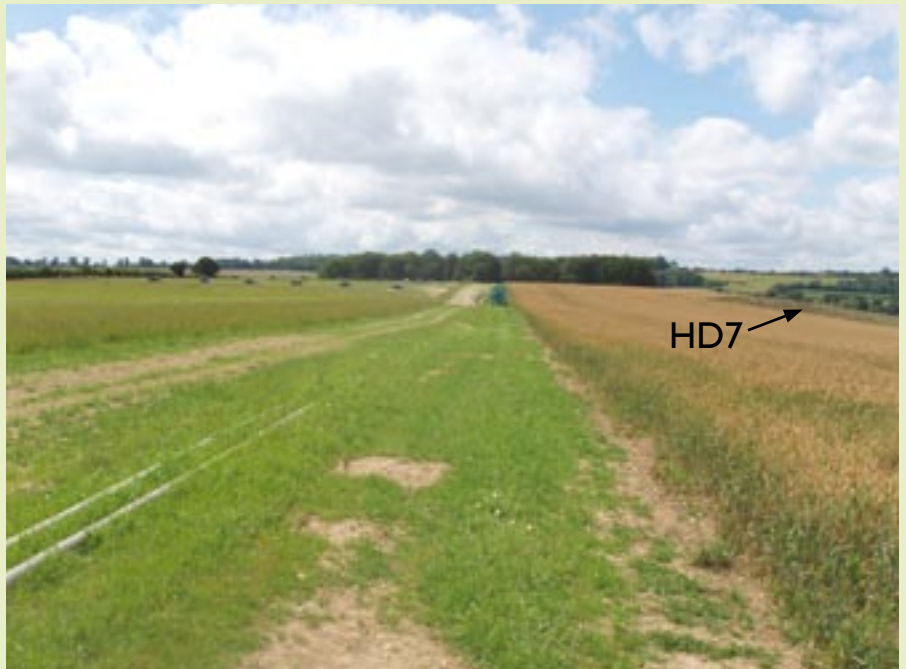
Image 8

In 2006 the field was in poppies, and in 2007 is in wheat. Pigs remain at the very top of the field where the land is less prone to run-off. This is shown by photograph 8.

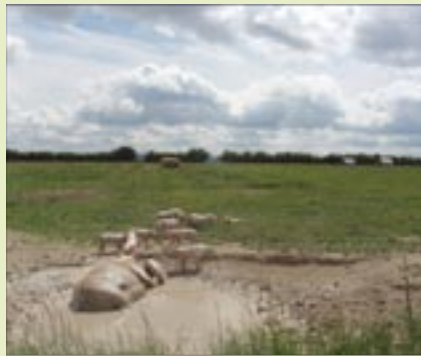
Image 9

In addition to the measures outlined above, reduced stocking density (also recommended by the Landcare Project Officer) from 10 sows per acre to 7 sows per acre has noticeably reduced poaching in fields, and consequently reduced erosion and runoff. In support of this statement, photograph 9 shows a field which has been occupied by sows for 1 year, and exhibits good ground cover:

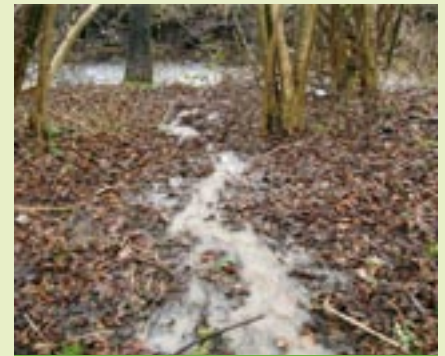
Image 10

Connectivity is also an issue at Bossington. As part of the ongoing development of the Estate HLS agreement, Landcare and ECSFDI have proposed a special project to address serious runoff (originating from steep fields and infrastructure) passing down a track and onto the road. This water then continues straight across down a track to the river; and down the road for approximately 0.5 mile before entering ditches leading to the main Test (Fig 10). This has also led to issues with mud on the road and safety concerns through flooding. The special project, to be implemented in year 3, will address the runoff through engineering work tackling both infrastructure and drainage issues.
