Location of Auger Borings

Land West of Park Lane,
Charvil, Berkshire

Agricultural Land Classification

Land West of Park Lane, Charvil, Berkshire

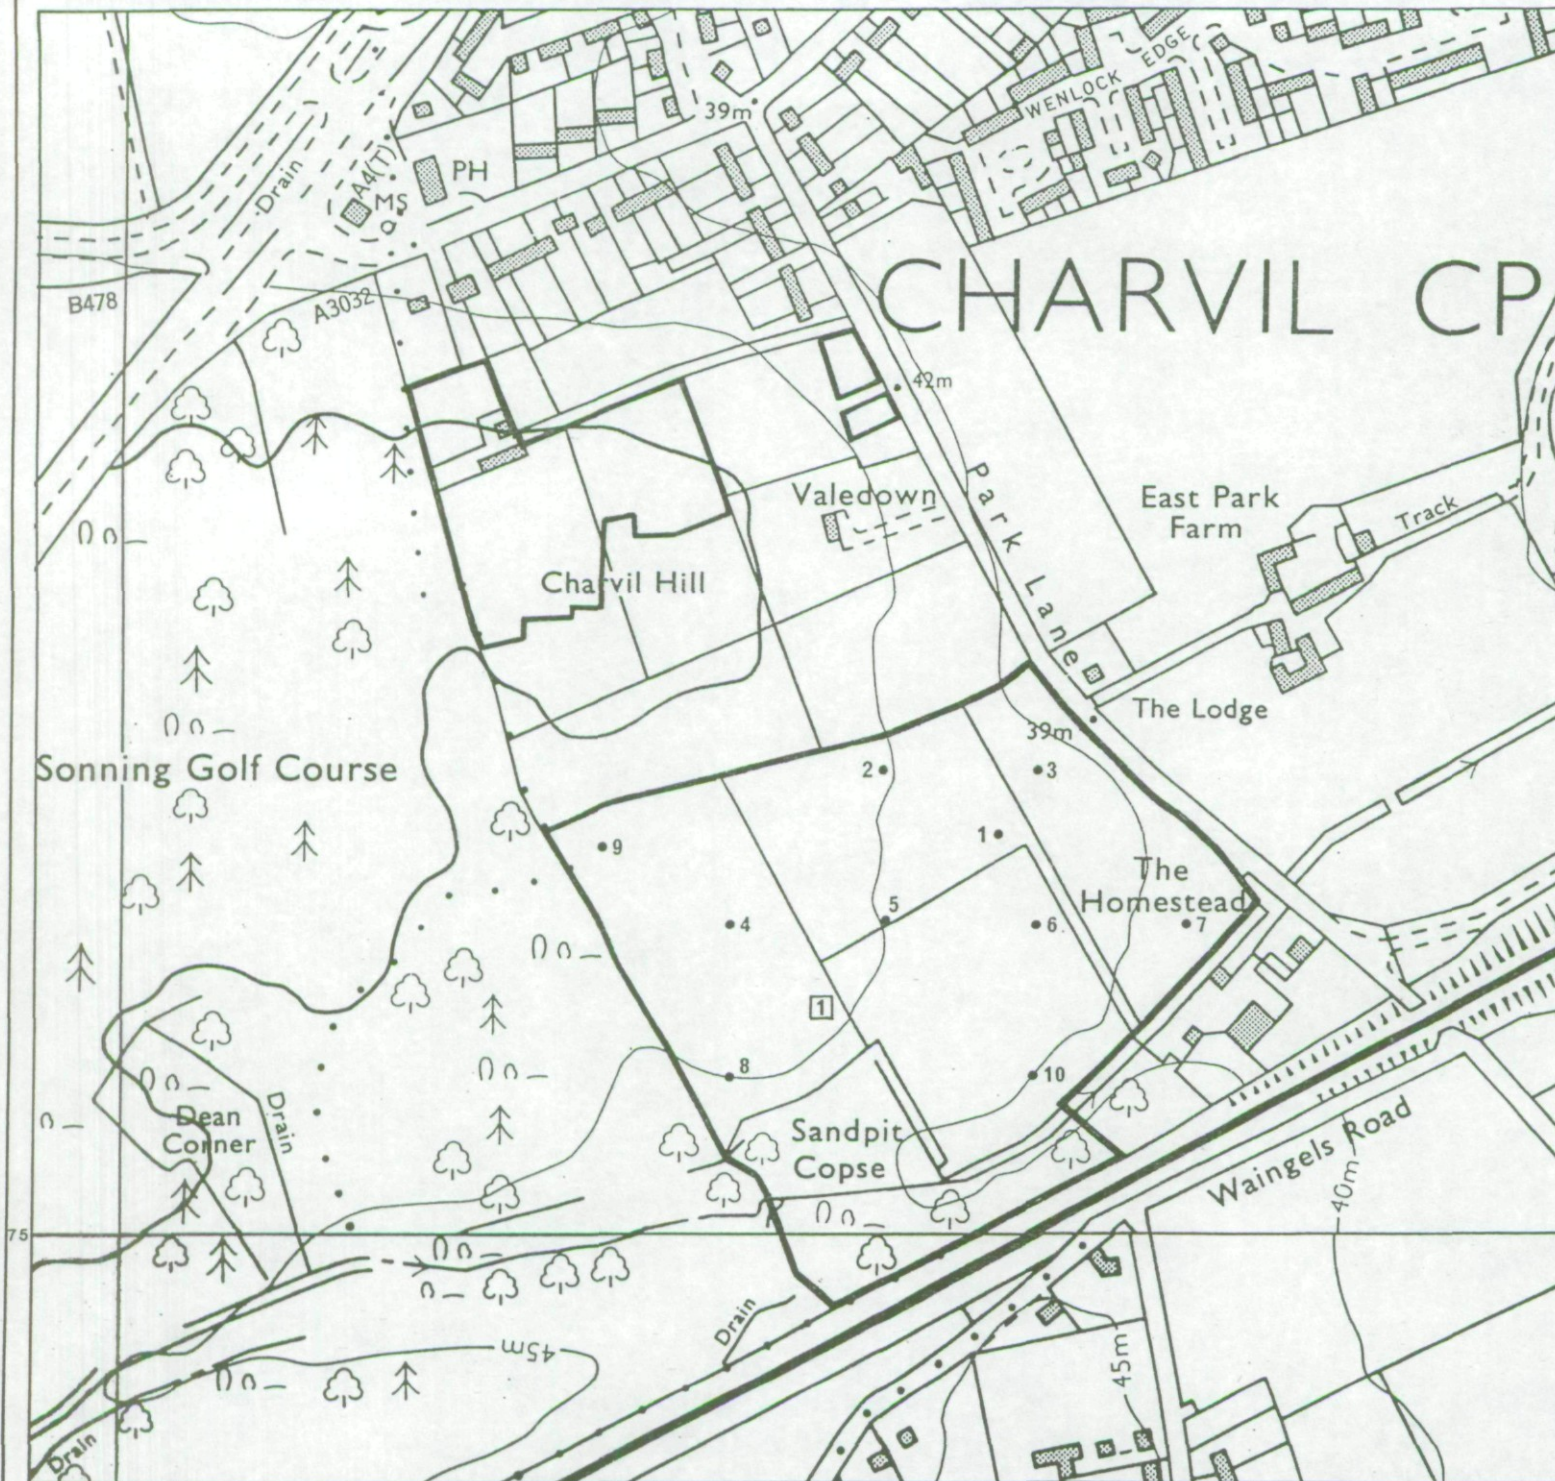
- 5 Auger boring
- ① Profile pit

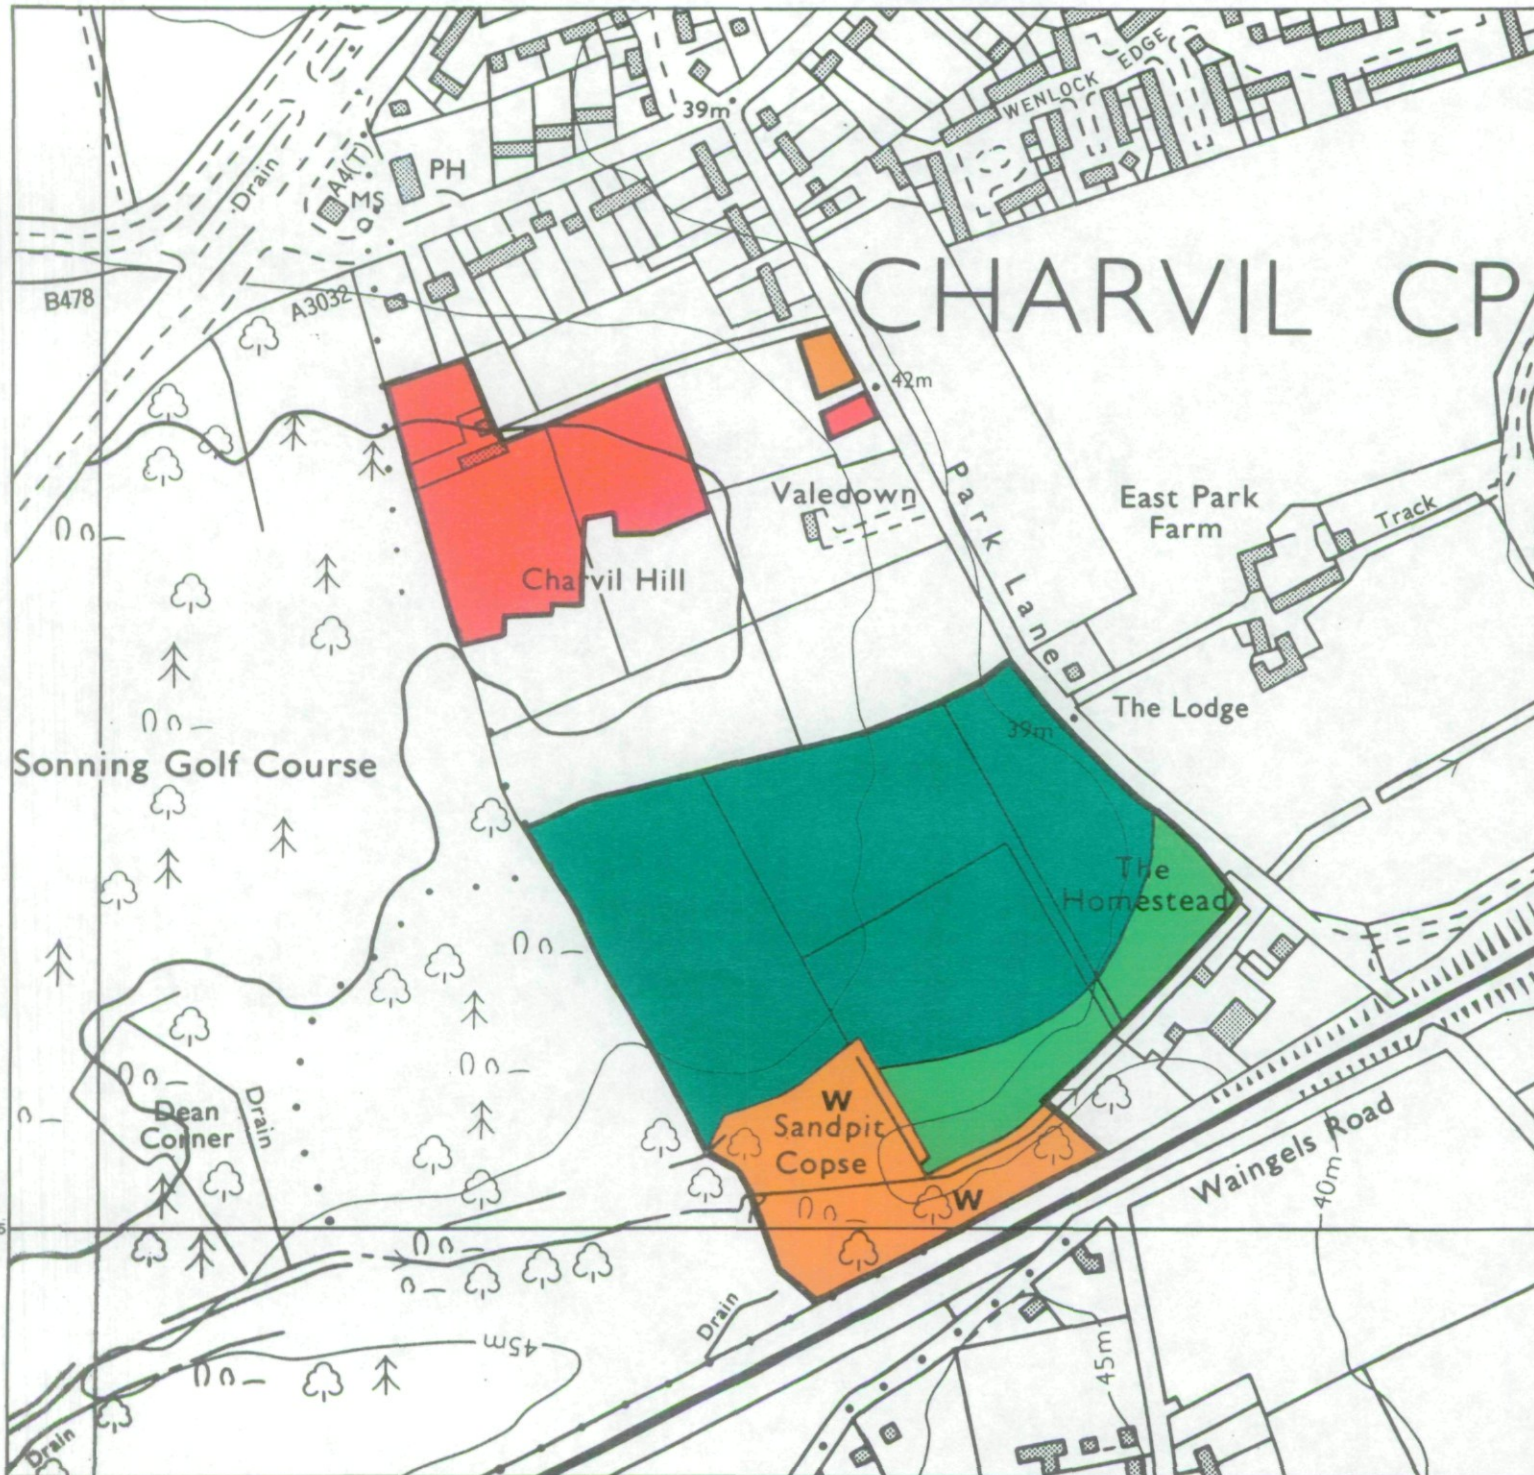
Grade	Quality	Area(ha)
1	Excellent	nil
2	Very Good	nil
3a	Good	7.4
3b	Moderate	1.4
4	Poor	nil
5	Very Poor	nil

Category	Area (ha)
Urban	2.3
Non-Agricultural	0.2
Woodland	2.1
Agricultural Buildings	nil
Open Water	nil
Not Surveyed	nil

Total agricultural land area **8.8**
Total survey area **13.4**
