# Blackdale Farm, Darenth, Kent

## Agricultural Land Classification

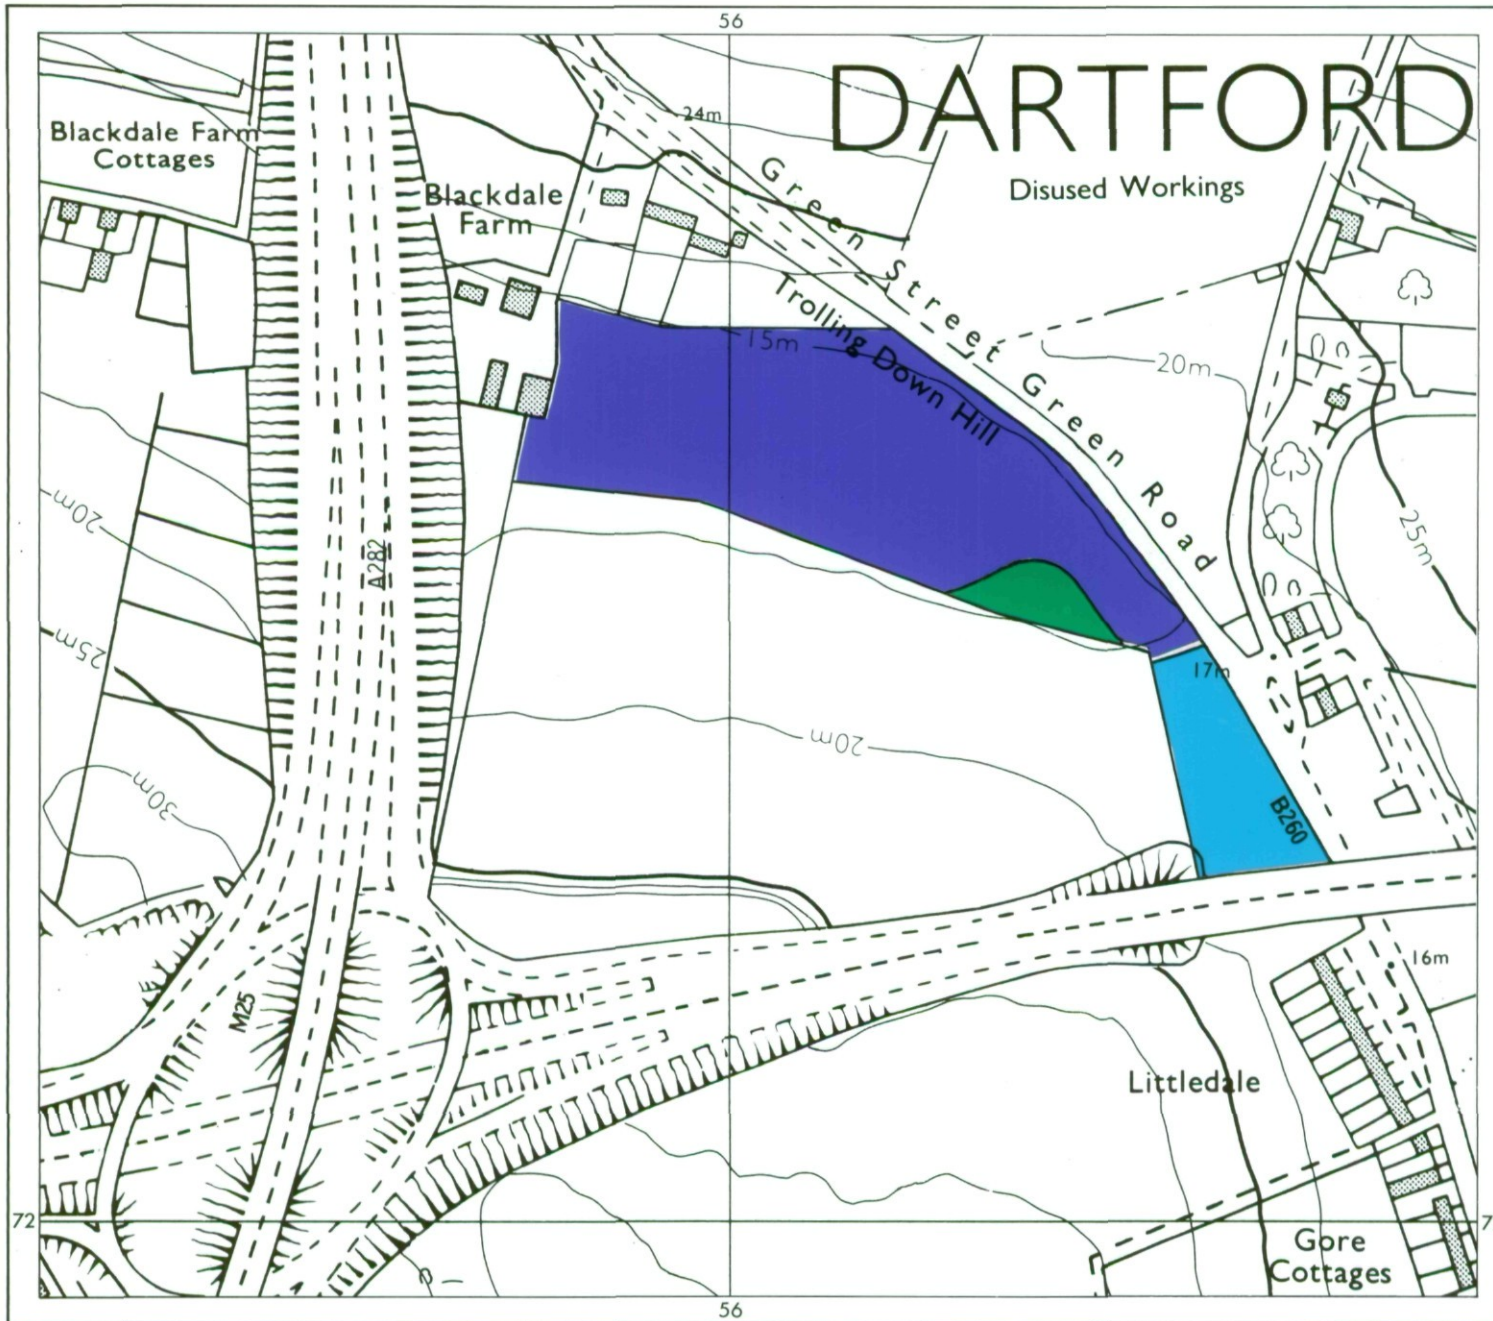
Grade	Quality	Area	% of Total
Grade 1	excellent	4.77 ha	79.8%
Grade 2	very good	0.90 ha	15.0%
Grade 3a	good	0.31 ha	5.2%
Grade 3b	moderate	ha	%
Grade 4	poor	ha	%
Grade 5	very poor	ha	%

Total area of agricultural land surveyed **5.98 ha**

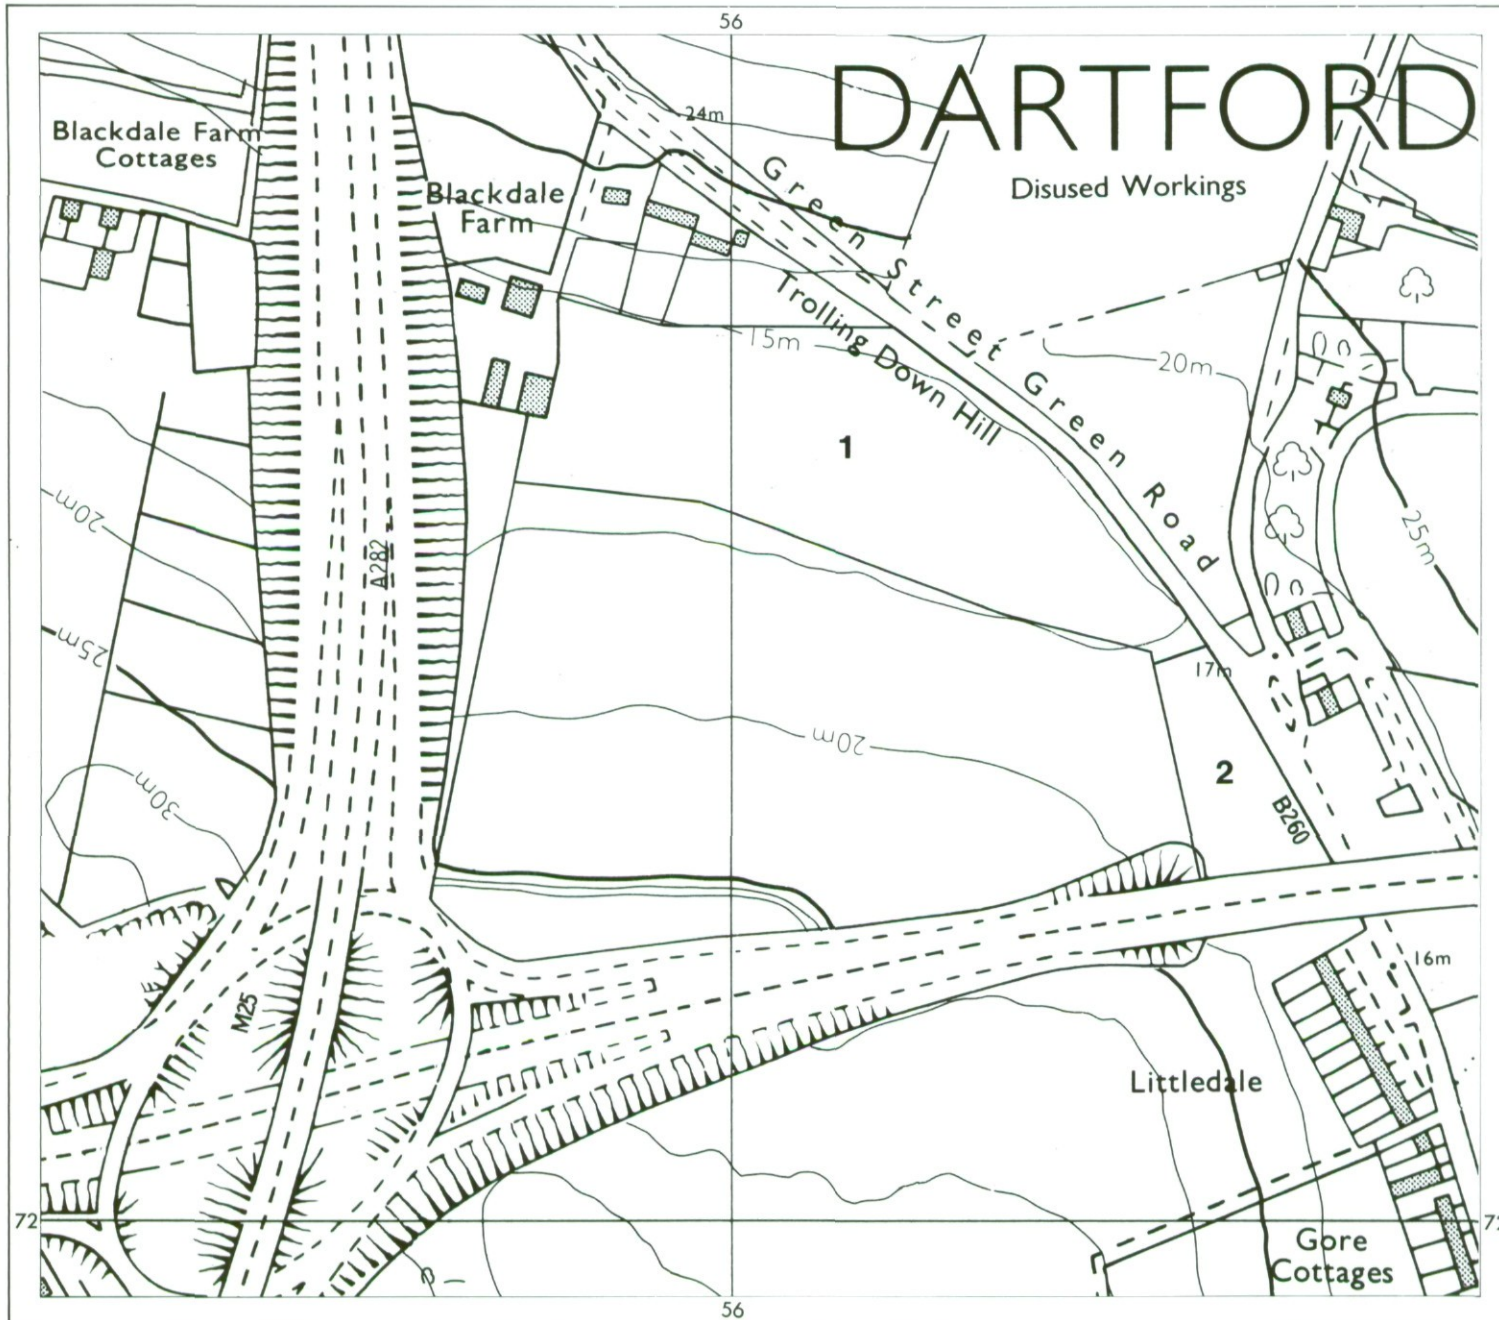
## Soil Resources

### Subsoil Materials & Volumes

Map Unit	Texture	Average Depth(cm)	Area(ha)	Volume(m <sup>3</sup> )
1	FSZL MCL	90.2	5.08	45822

Map Unit	Texture	Average Depth(cm)	Area(ha)	Volume(m <sup>3</sup> )
2	MCL	31.0	91.0	8190
	HCL	15.0		
	C	55.0

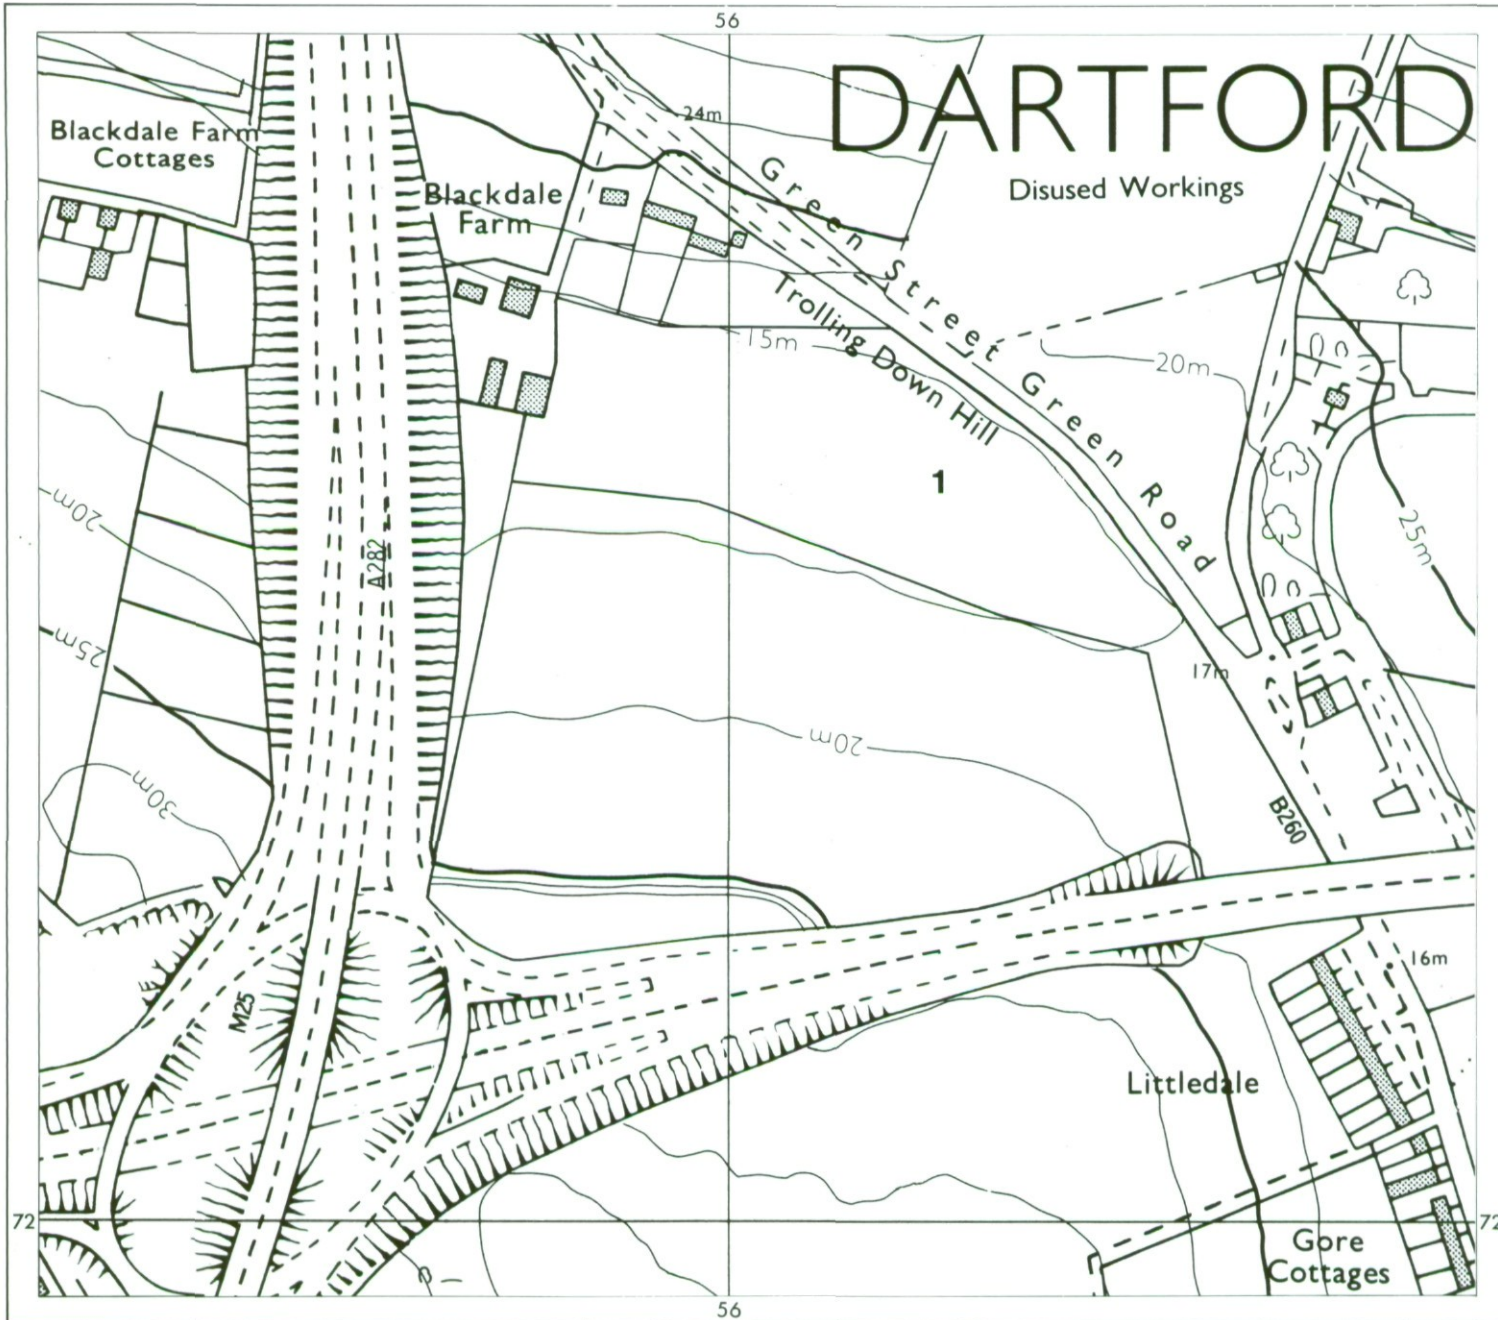
## Soil Resources

### Topsoil Materials & Volumes

Map Unit	Texture	Average Depth(cm)	Area(ha)	Volume(m <sup>3</sup> )
1	FSZL	29.7	5.98	17761

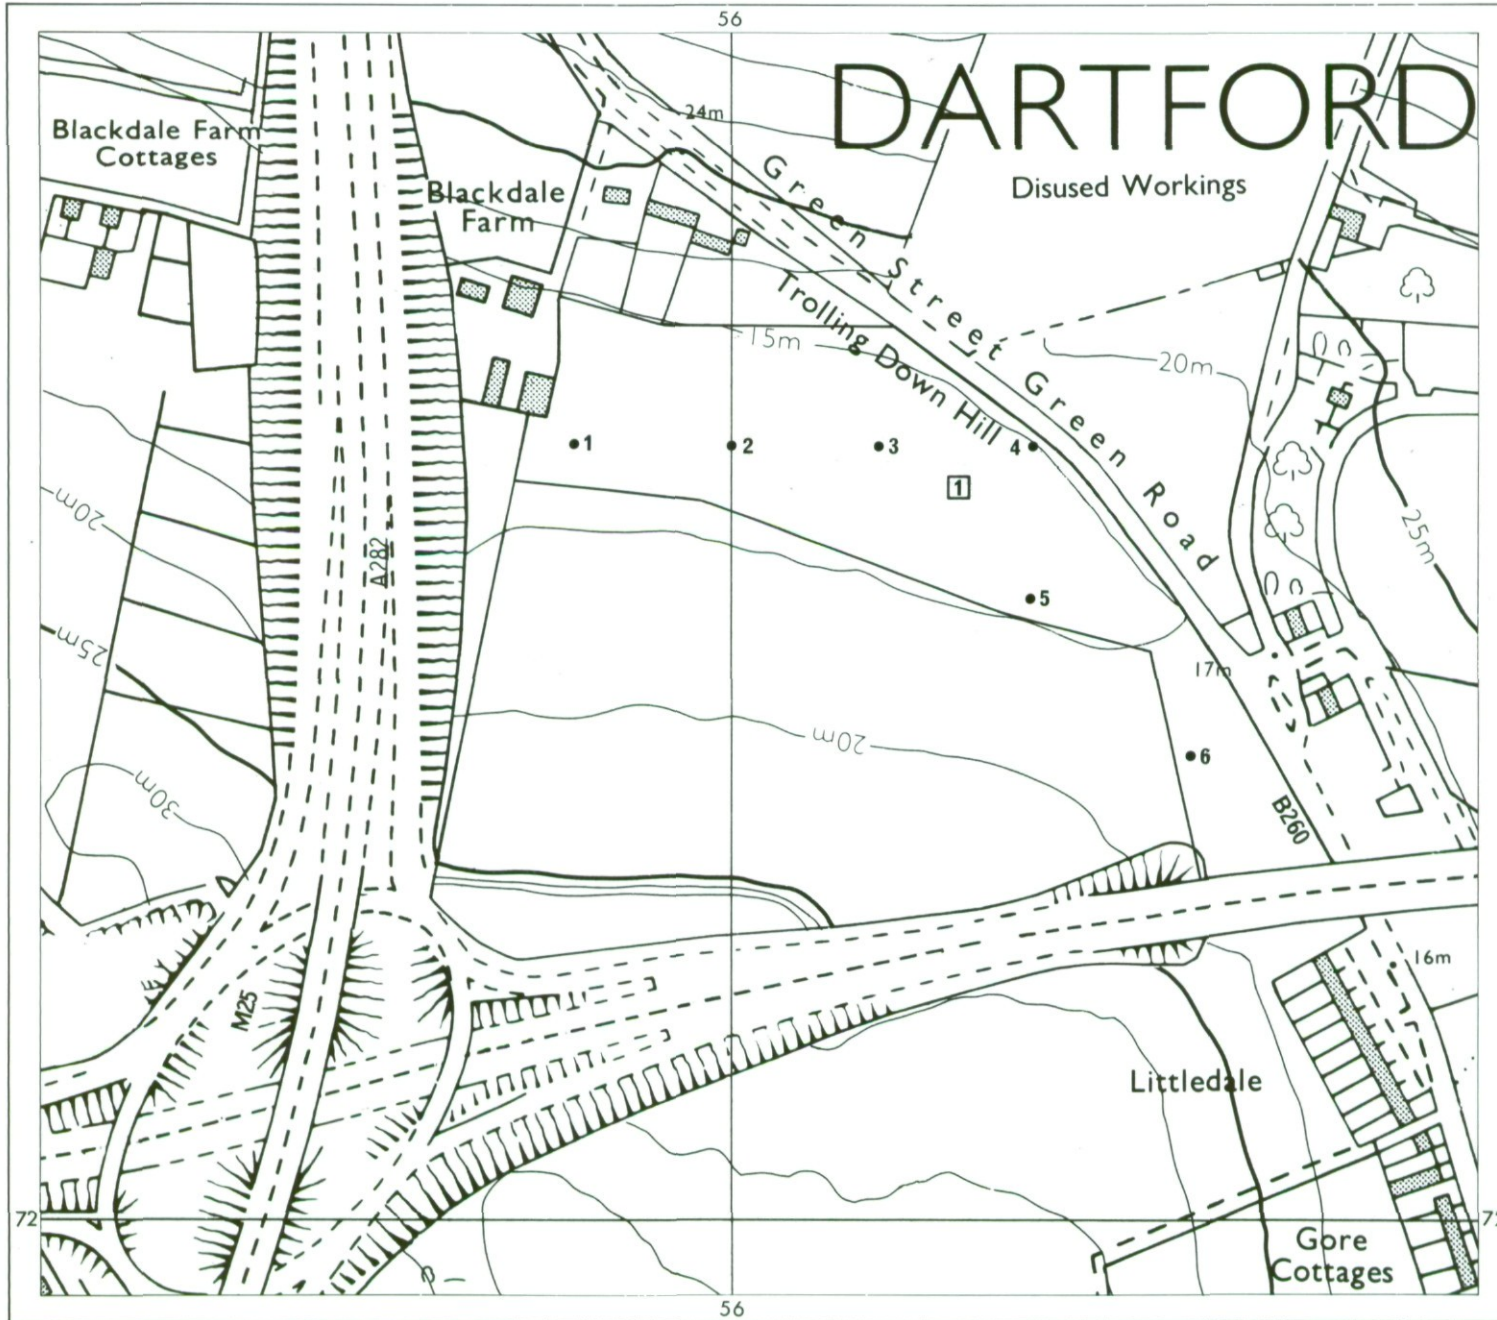
## Location of Auger Borings

- 5 Auger boring
- ① Profile pit
