Provisional Agricultural Land Classification

Survey of Restored Land
 DAISY HILL EXTENSION

**Survey of Restored Land. Daisy Hill Extension.
Soil Resources as at December 1995**

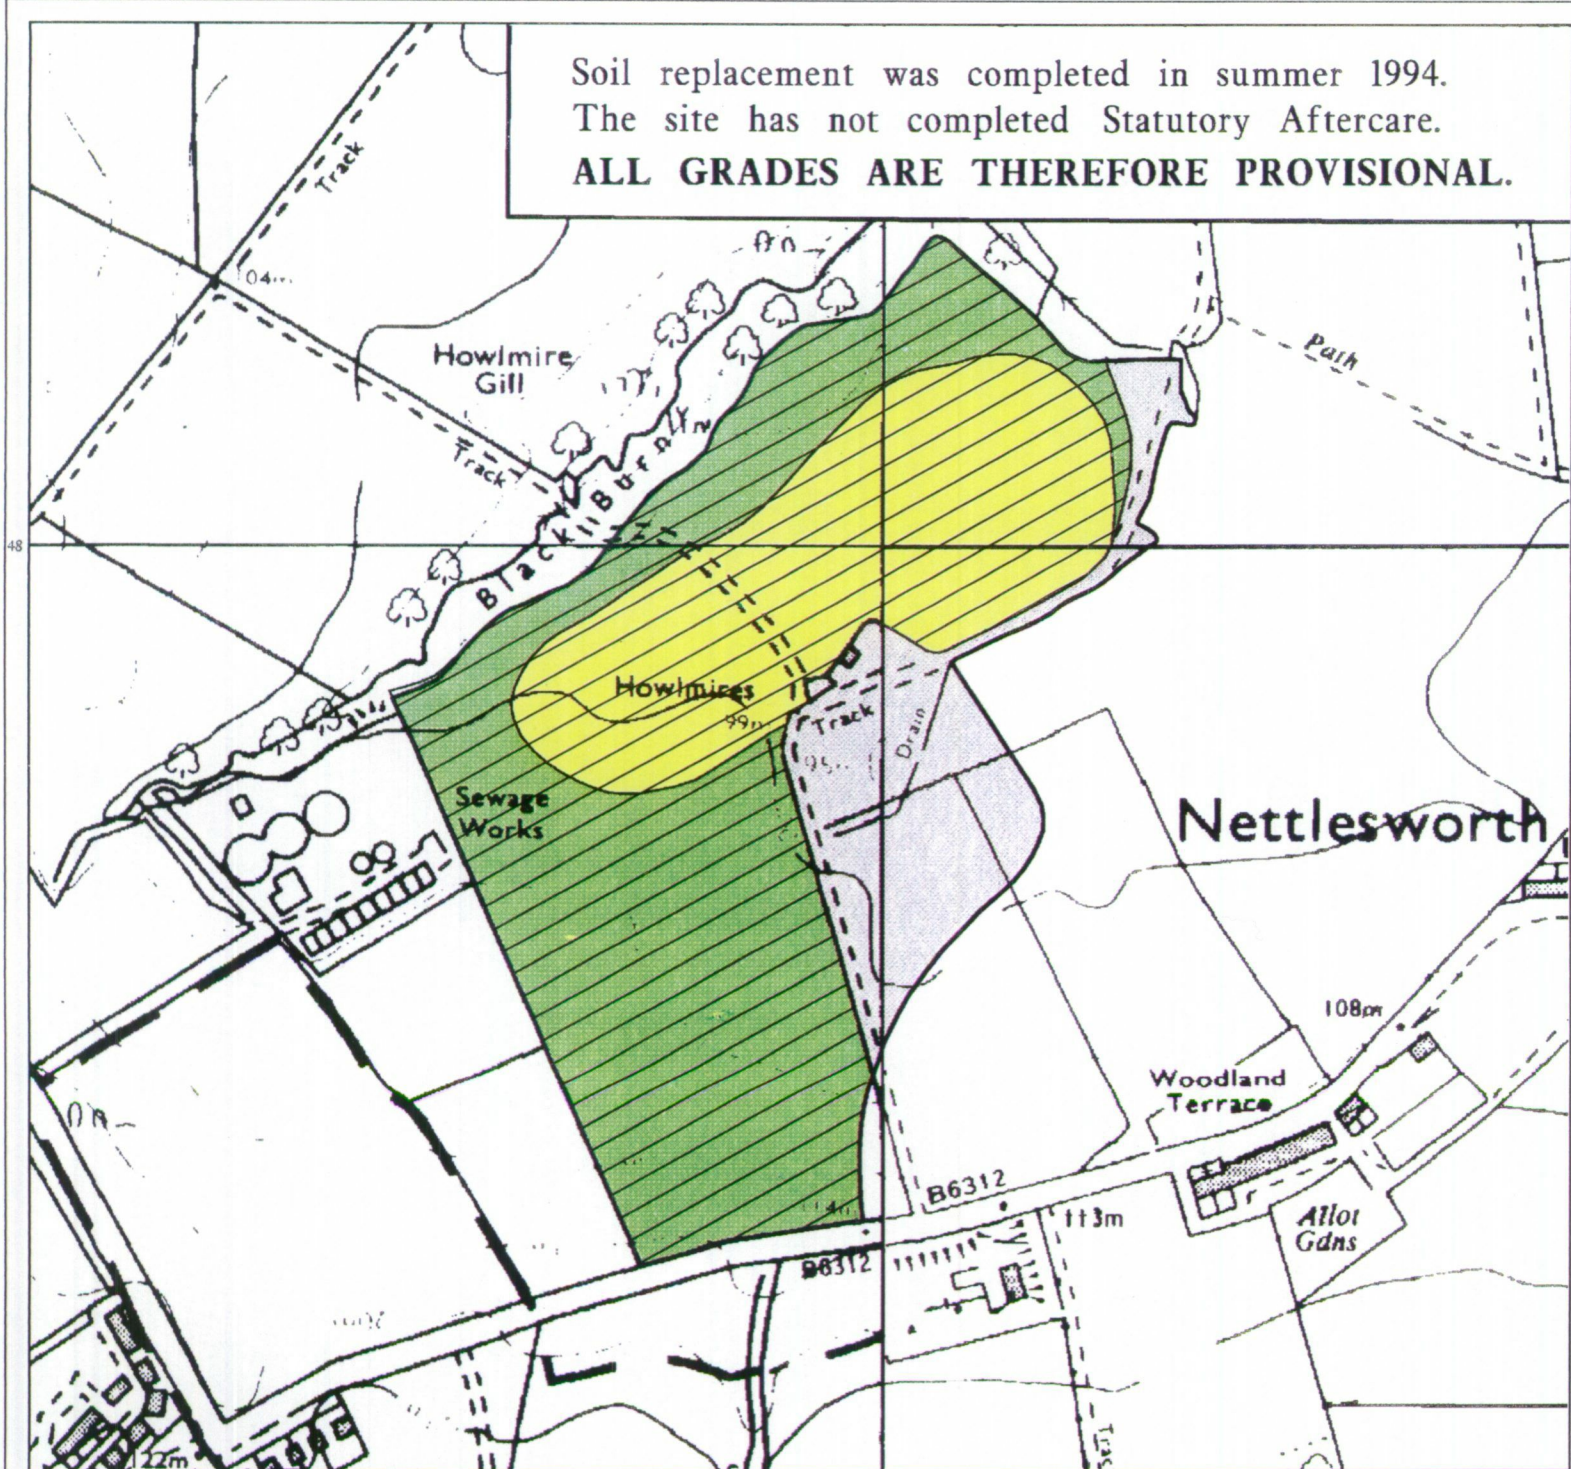
Soil replacement was completed in summer 1994.
 The site has not completed Statutory Aftercare.
ALL GRADES ARE THEREFORE PROVISIONAL.

Provisional Grades	A.L.C.	Quality	Area (ha)
Grade 1		Excellent	Nil
Grade 2		Very Good	Nil
Grade 3a		Good	Nil
Grade 3b		Moderate	9.1
Grade 4		Poor	5.6
Grade 5		Very Poor	Nil
		Agricultural land not surveyed	Nil
		Other land	3.3
Boundary of survey area			
Total agricultural land area			14.7
Total survey area			18.0
* Not present within survey area

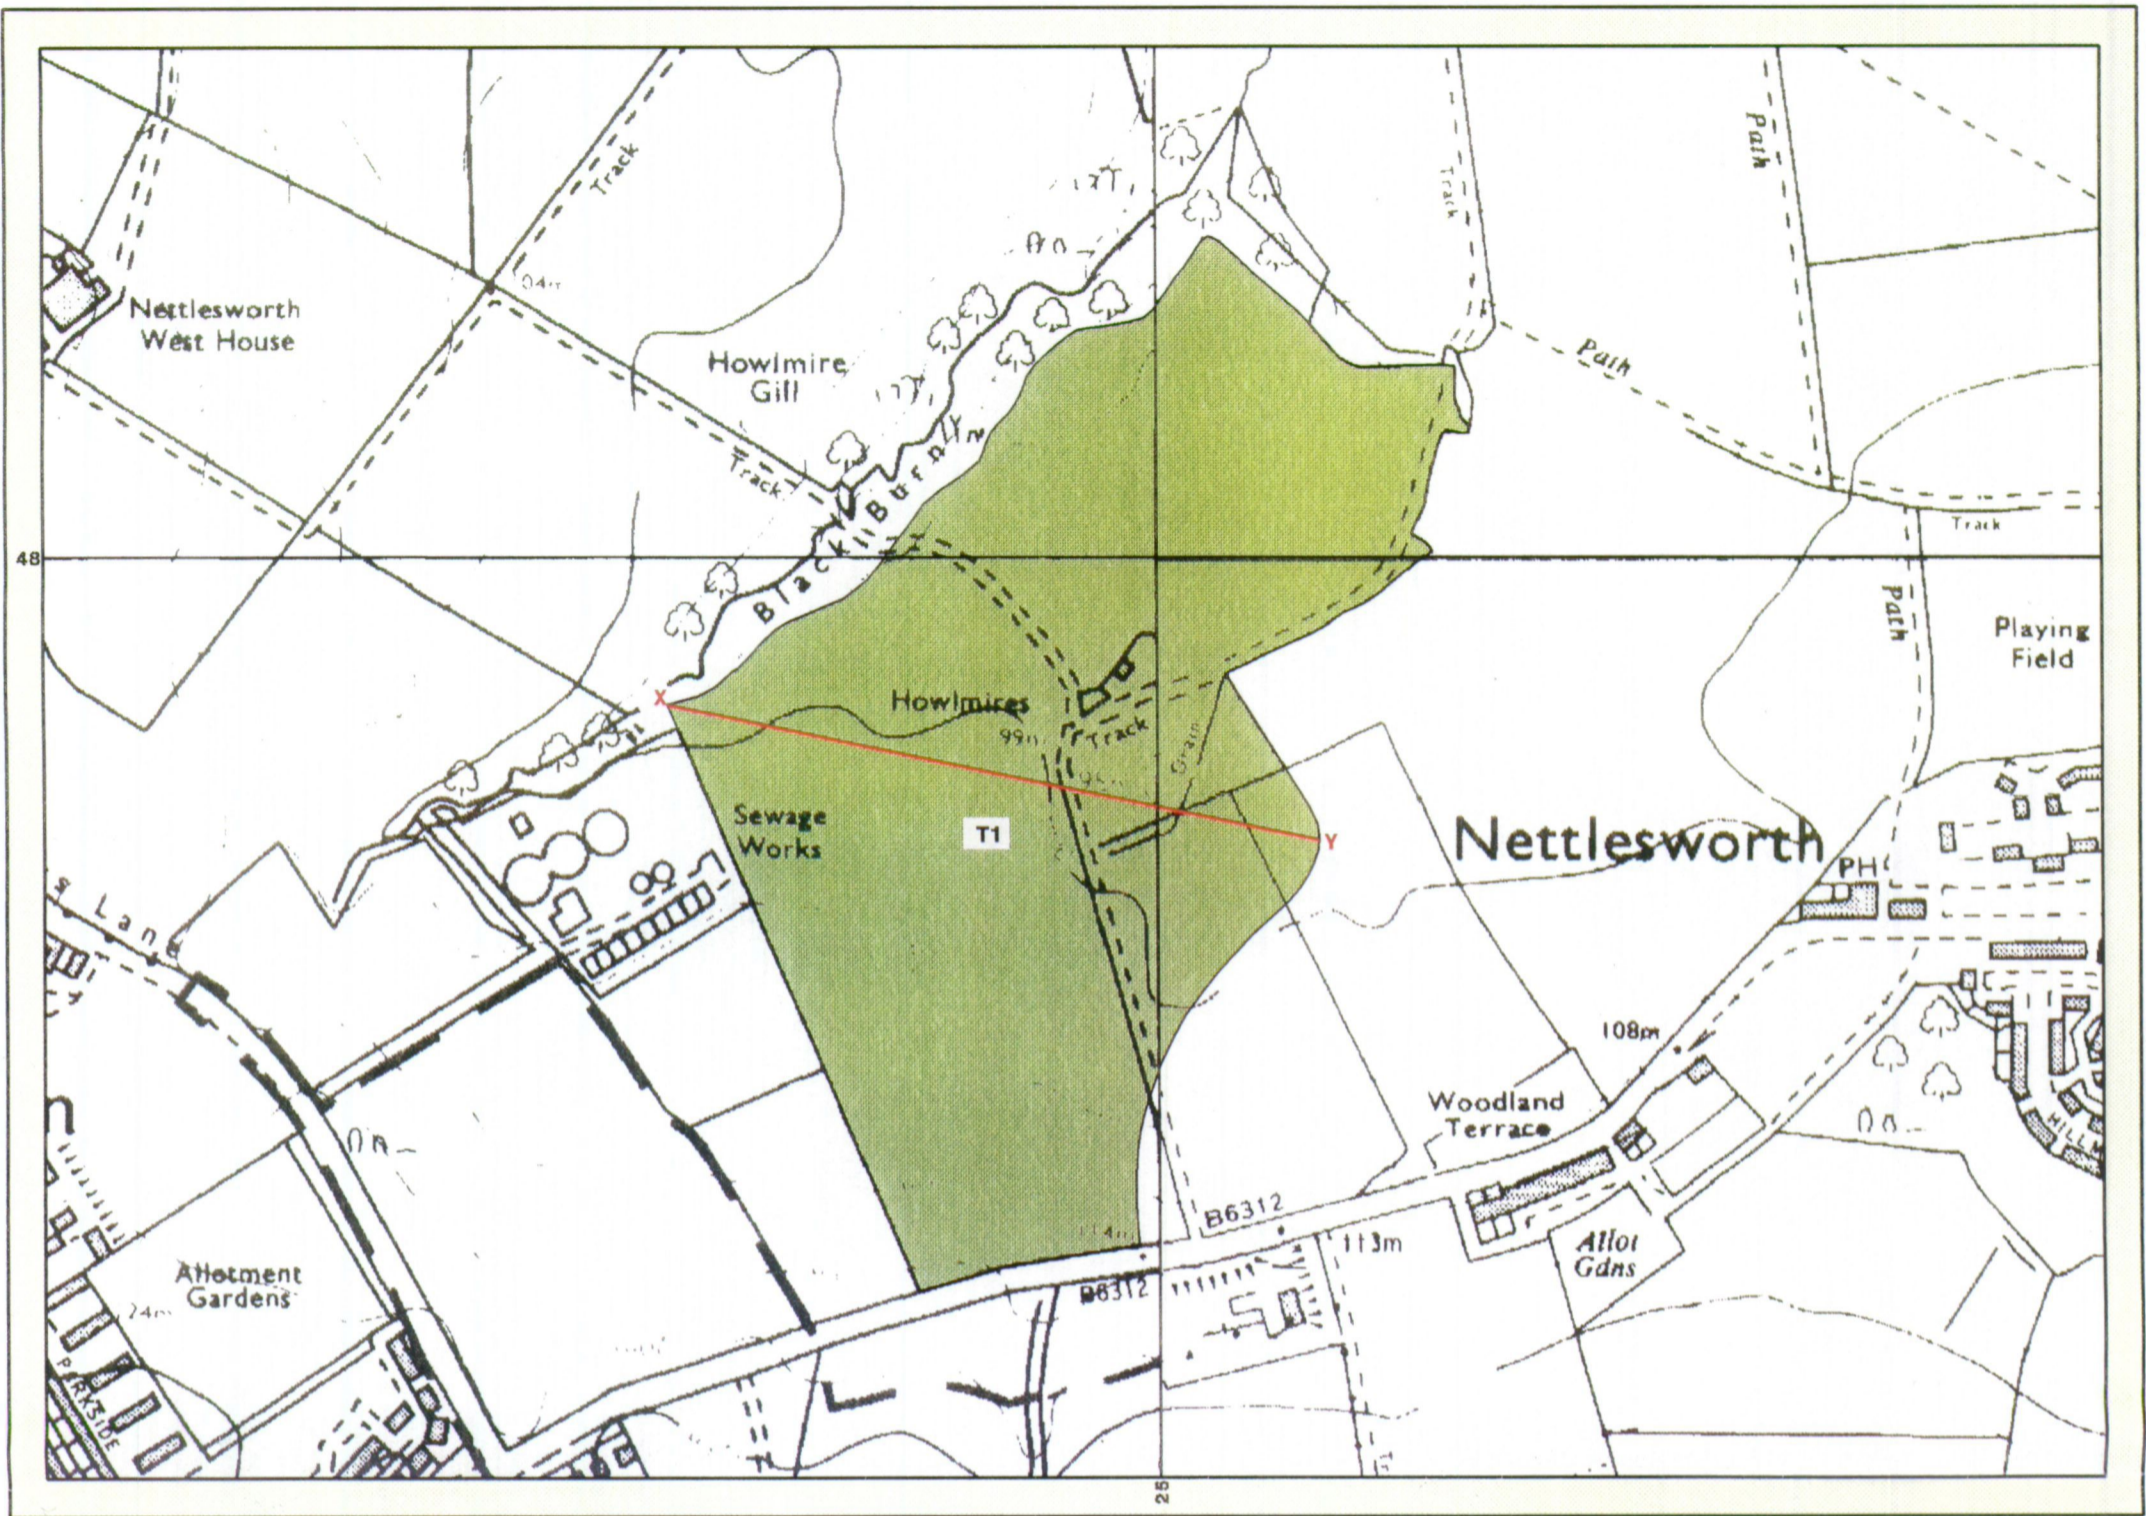
Topsoil Resource Map

Unit	Soil Texture	Soil Thickness(cm.)			Area (ha)	Volume* (000m ³)
		Min	Mean	Max		
T1	Light	20	26	40	18.0	46.8

*Volume at Mean Soil Thickness.

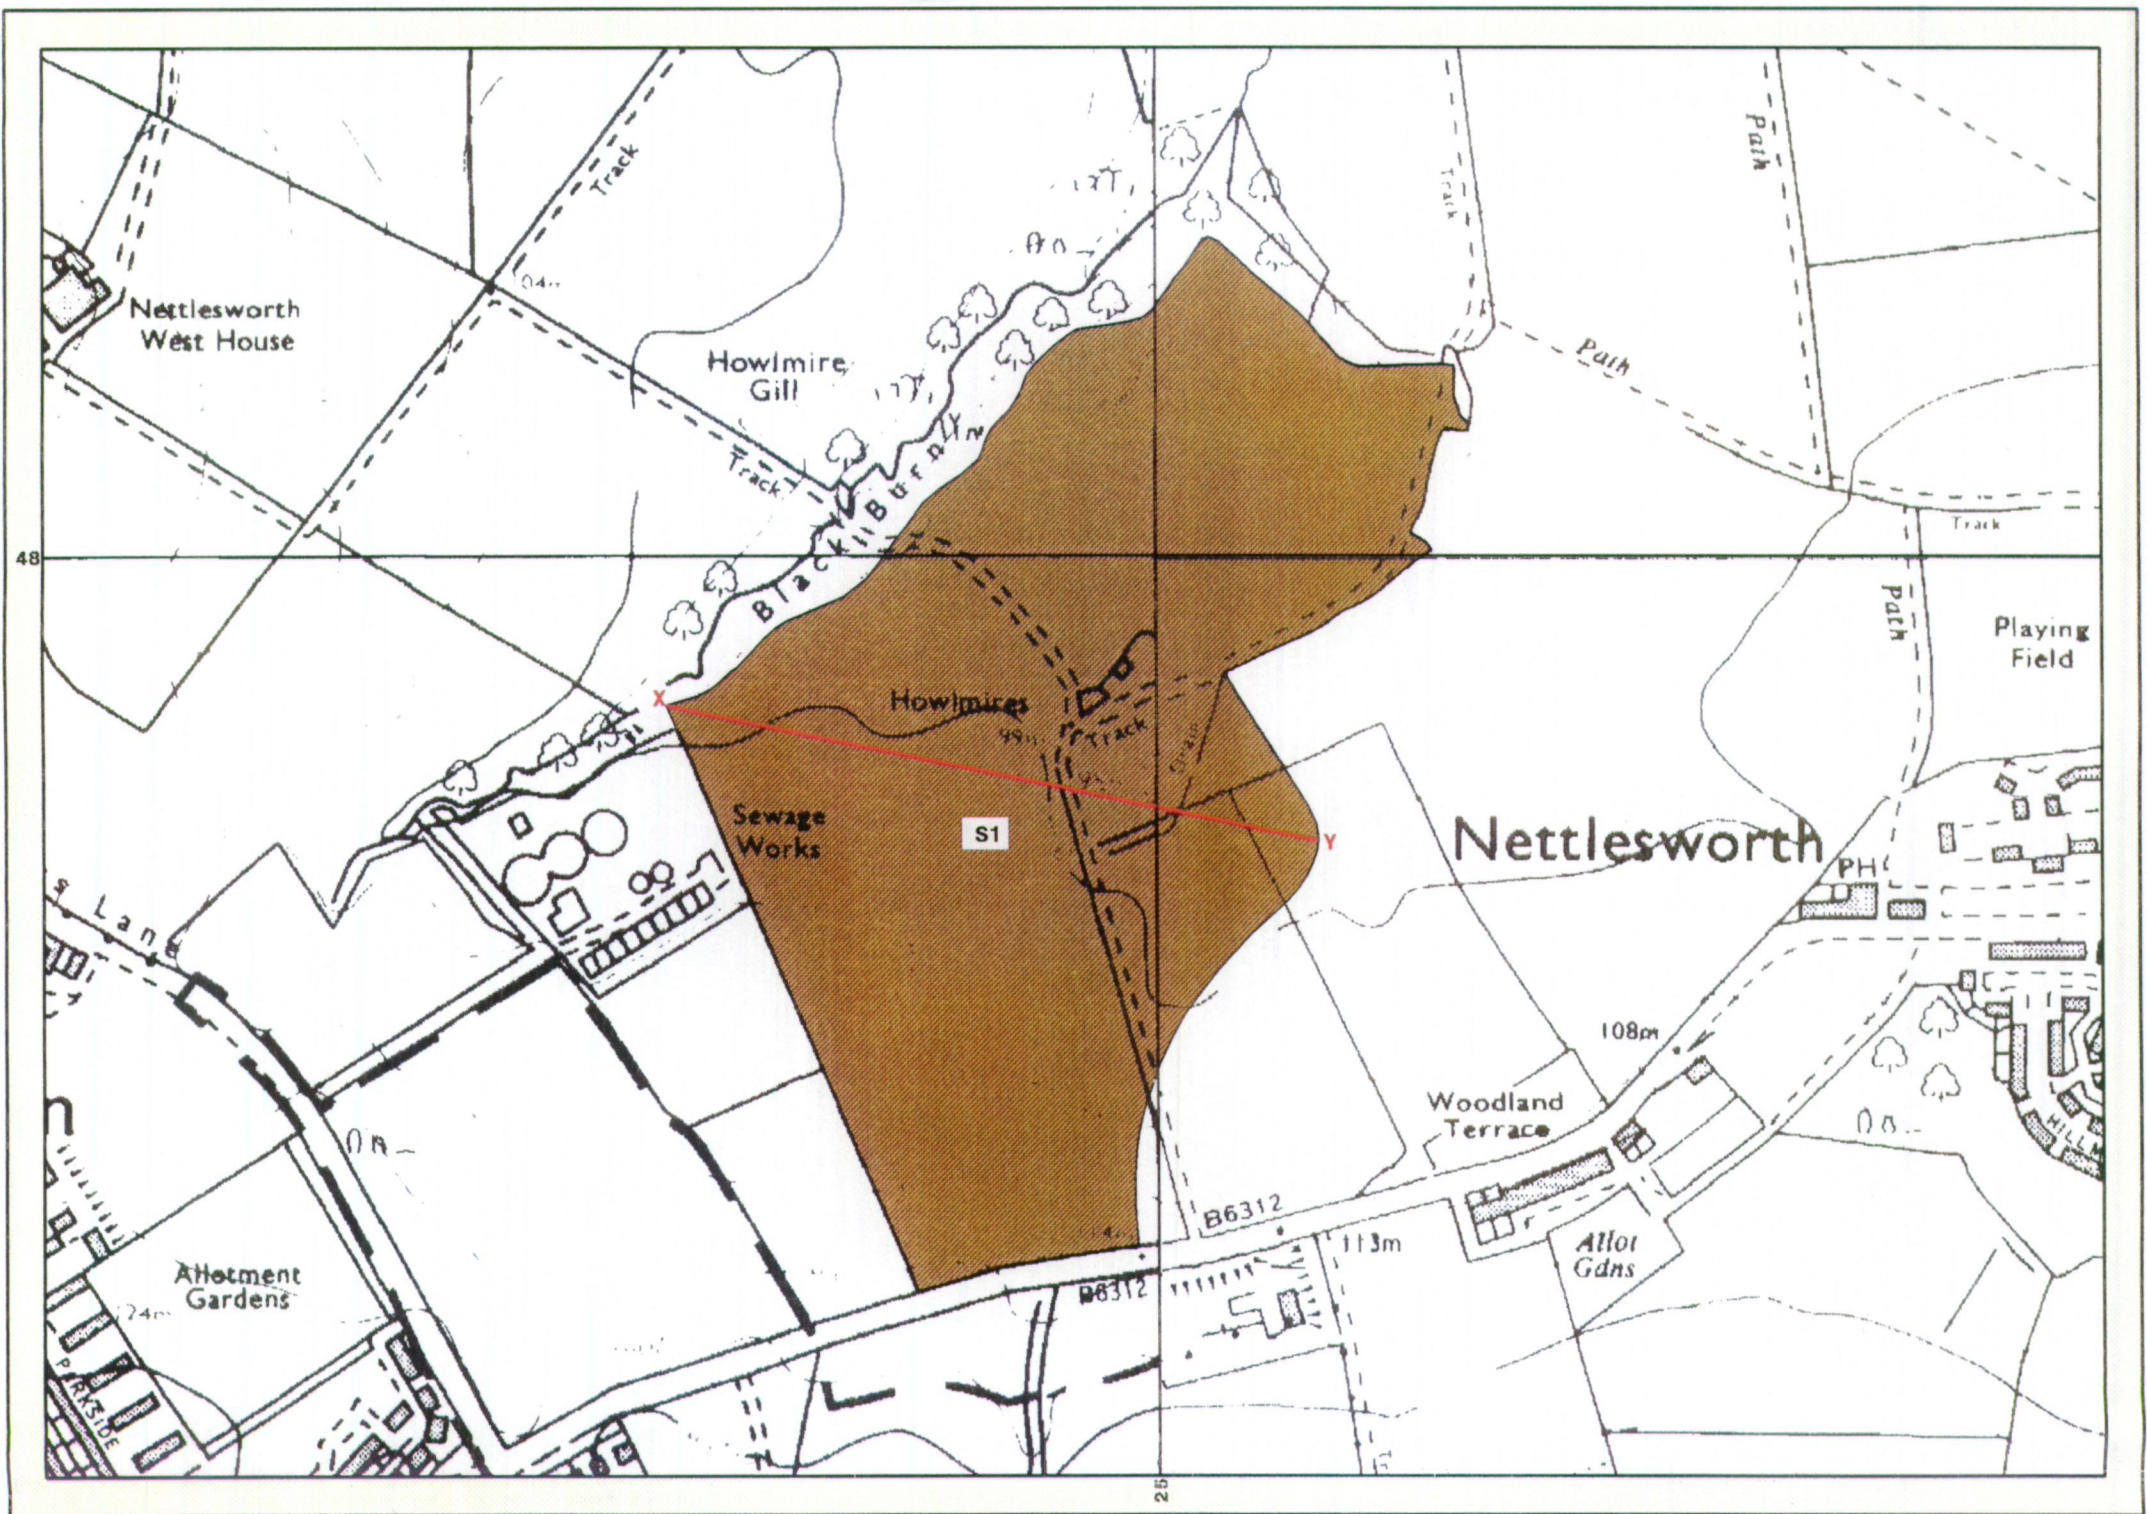
Subsoil Resource Map

Unit	Soil Texture	Mean Soil Thickness(cm.)	Area (ha)	Volume* (000m ³)
S1	Light\ Medium	74	18.0	133.2

Overburden
