Provisional Agricultural Land Classification

Survey of Restored Land.
DEWLEY MILL

Survey of Restored Land. Dewley Mill. Soil Resources as at December 1995

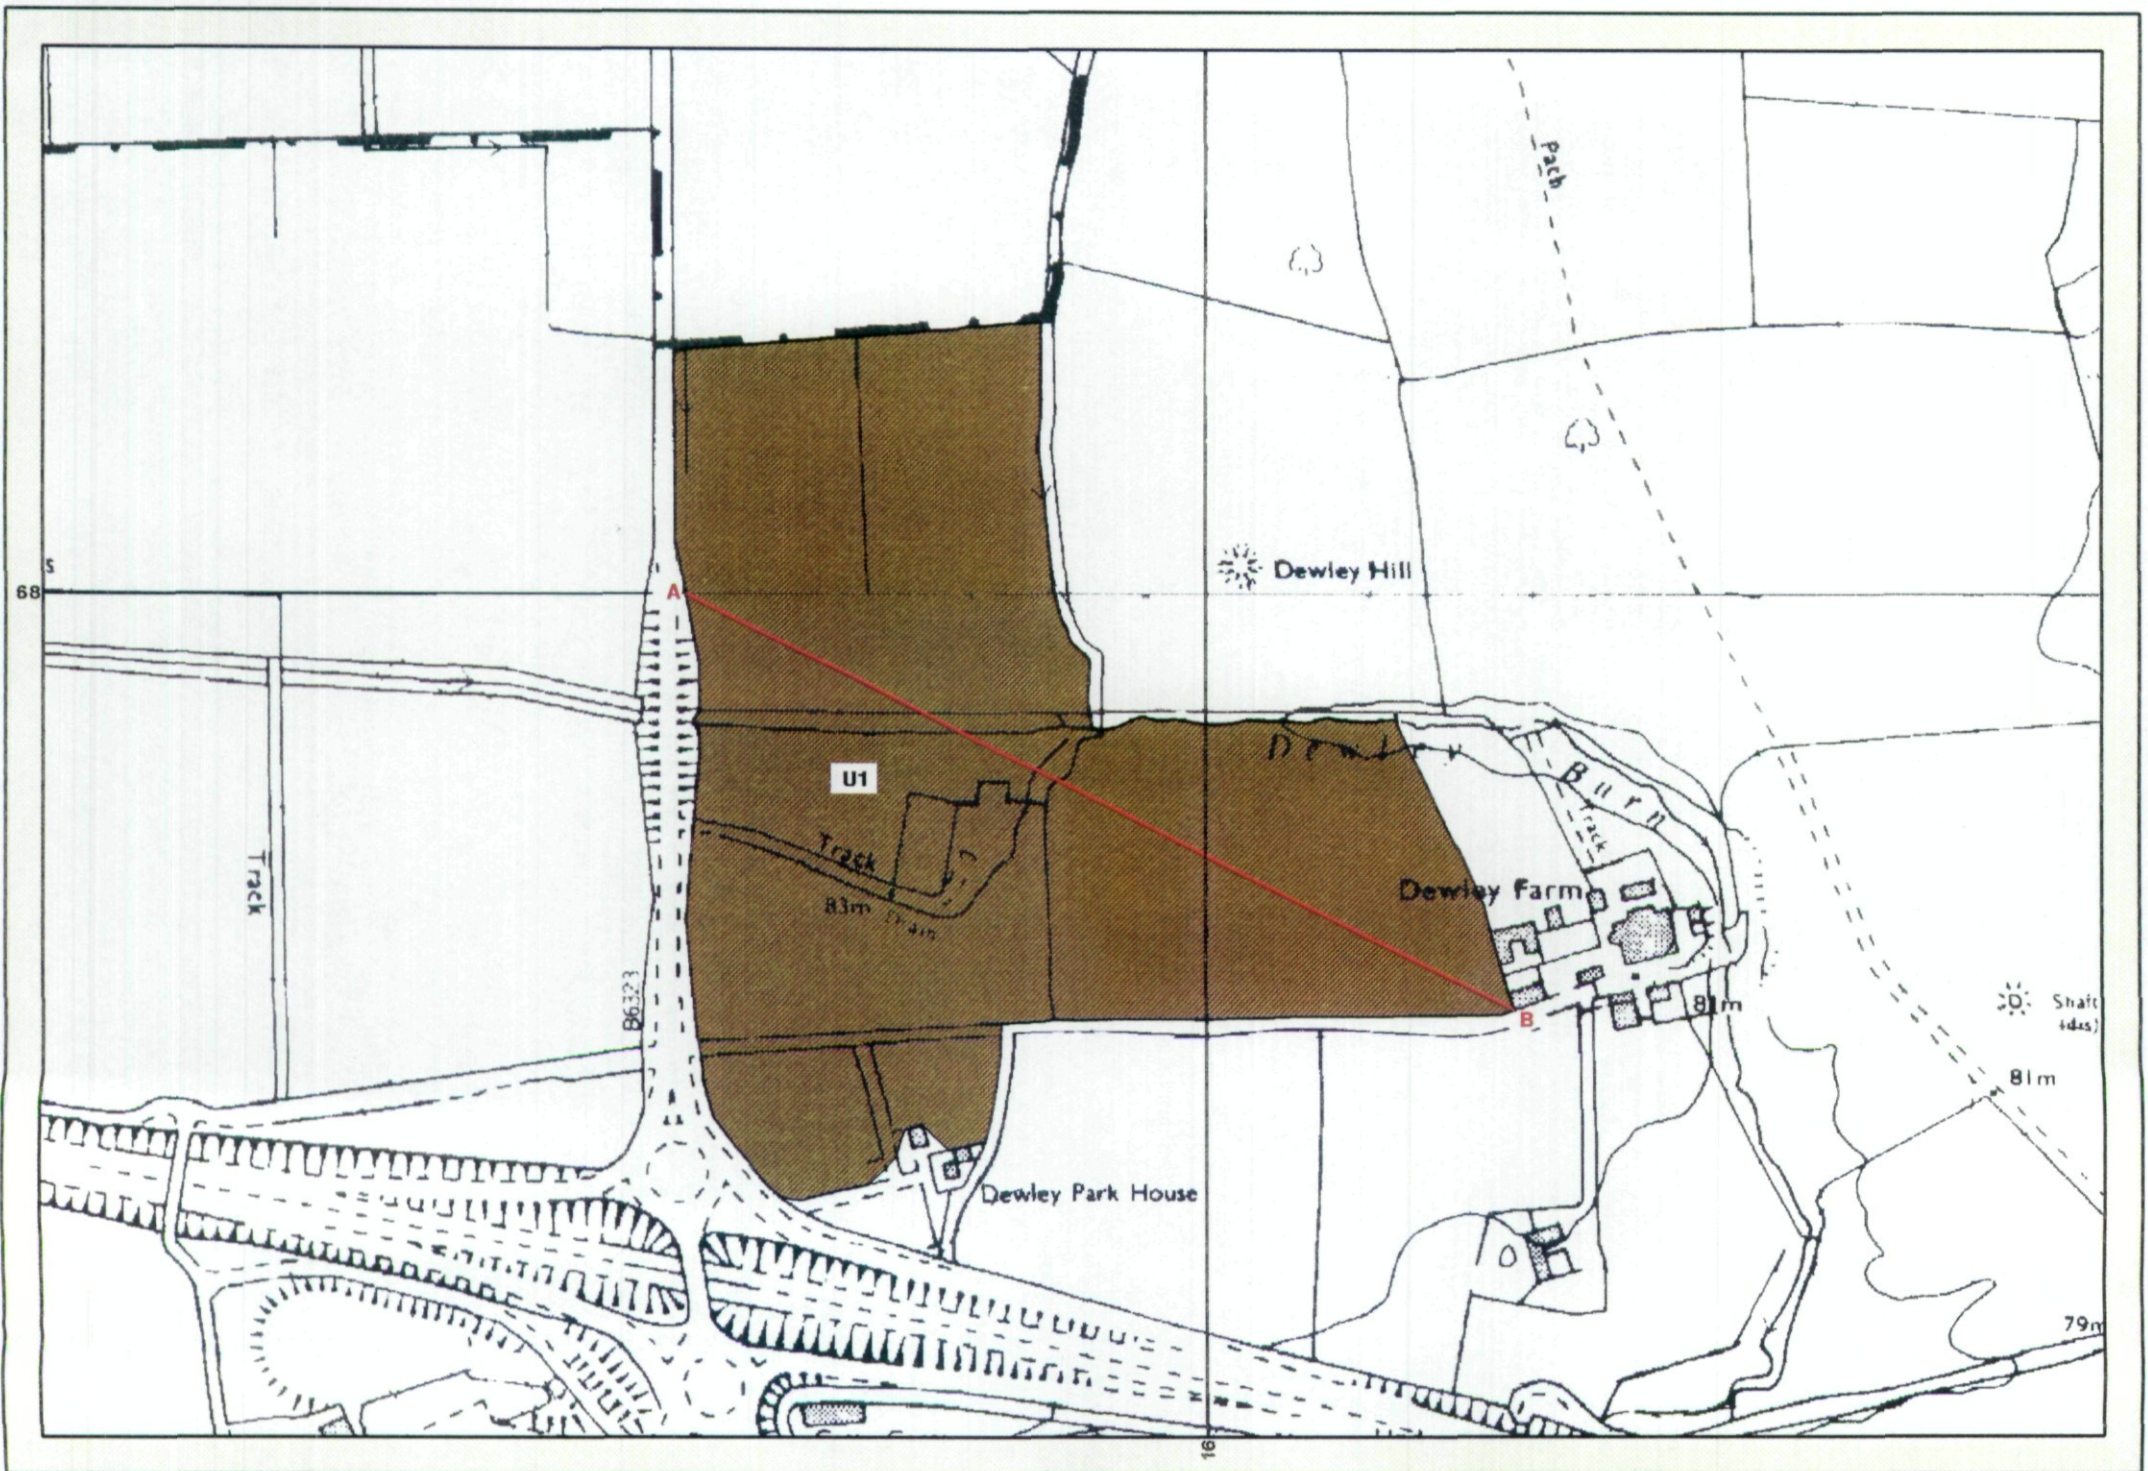
Upper Subsoil Resource Map

Unit	Soil Texture	Mean Soil Thickness(cm.)	Area (ha)	Volume* (000m ³)
U1	Medium	35	18.0	63.0
