West Penwith Ecohydrological Investigation and Characterisation – Site Visit Report

Phase 3 2020-21

Natural England Research Report NECR402

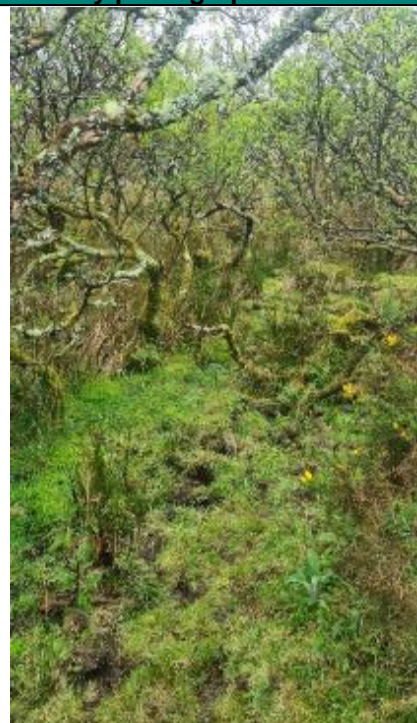
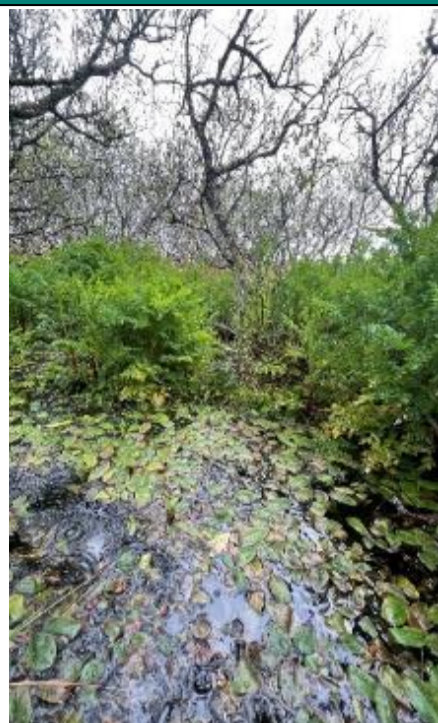
1.01 – Wet woodland habitats present within mire.

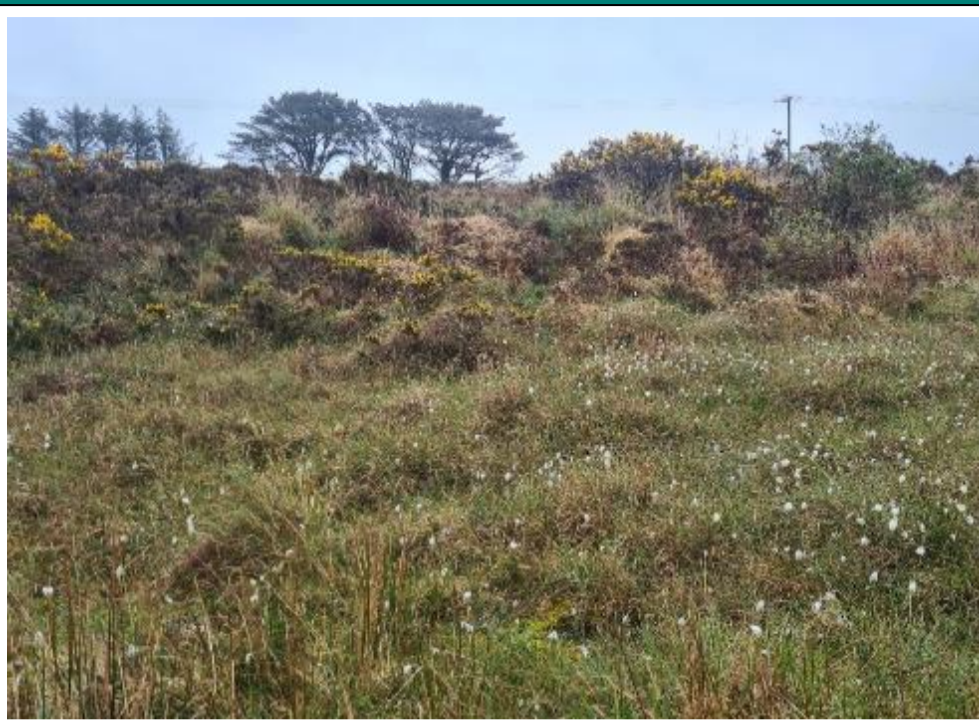
1.02 – Mosaic of wetland habitats in the mire.

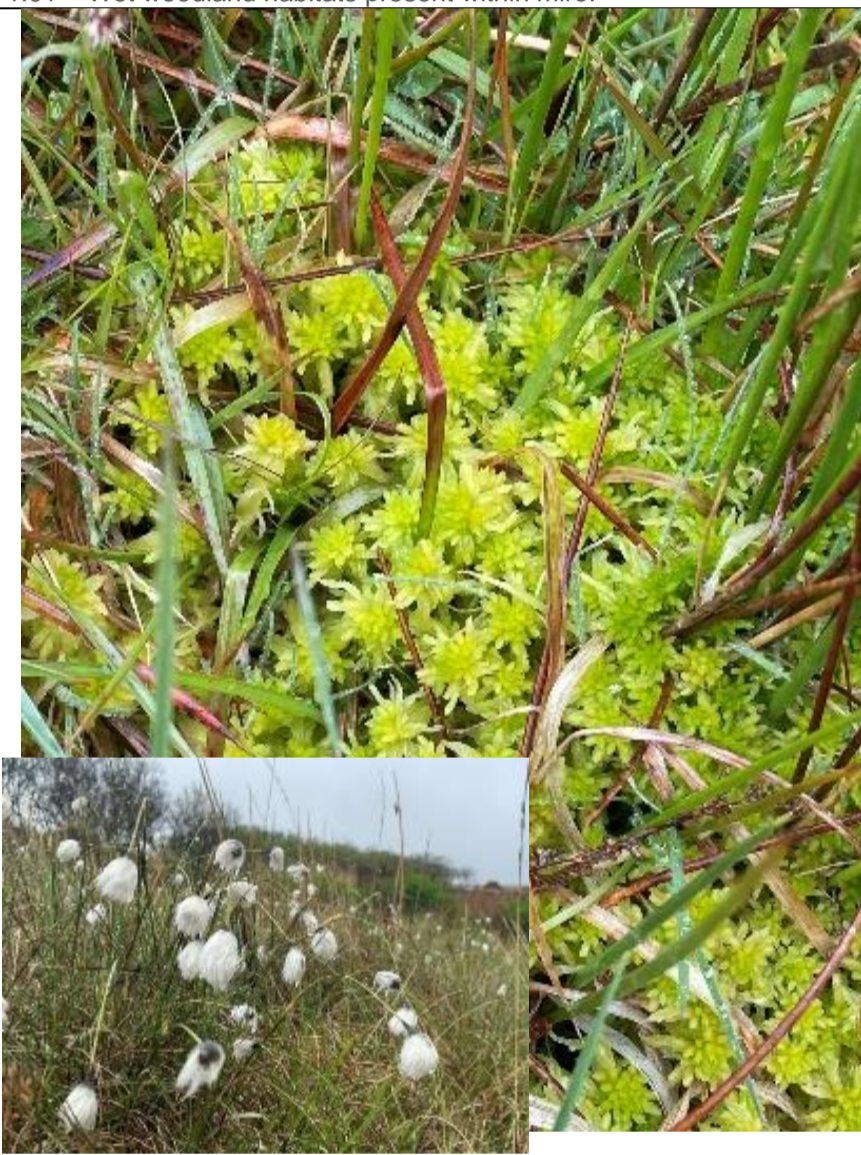
1.03 – *Sphagnum* spp. and cotton grass (inset) present within the mire.

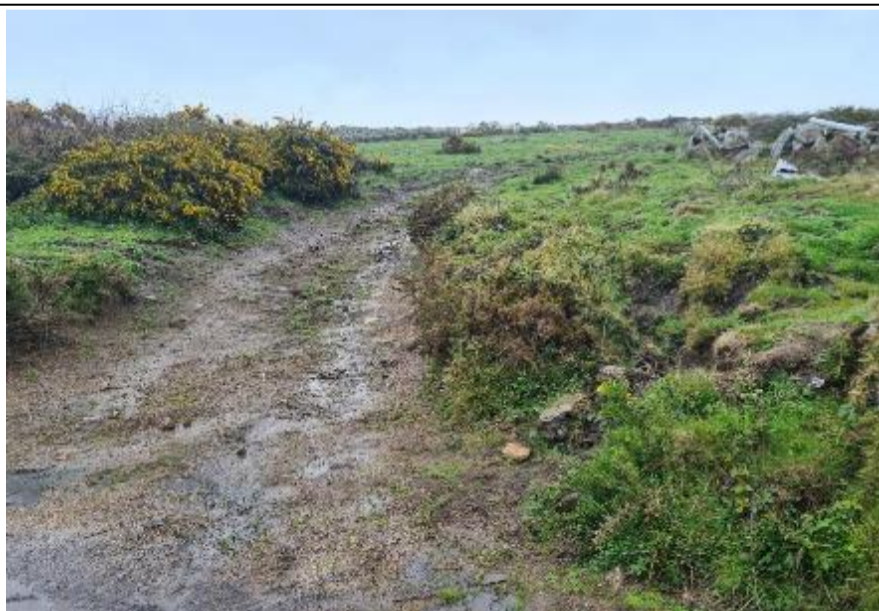
fertilisers and/or be part of arable rotation. These inputs may degrade the water quality of the mire. The greatest risk to the catchment identified was from the flow pathways that drain from the intensive cattle use on the flow pathway at the eastern, downstream end of the catchment (Photo 1.06). Therefore, the catchment risk rank remains unchanged at 'low-medium' .
Opportunities identified	-
Other risks	<i>Gunnera</i> spp. invasive non-native species (INNS) in tributary in Brook Cottage woodland. No evidence in the mire itself but <i>Gunnera</i> spp. is aquatic and could travel downstream so potential risk of invasion of mire.

1.06 – First photo taken standing on track looking up towards the flow pathway. The field in the background had cows in on the day of survey. The second photo shows the water from the same flow pathway passing under the track leading towards the mire.

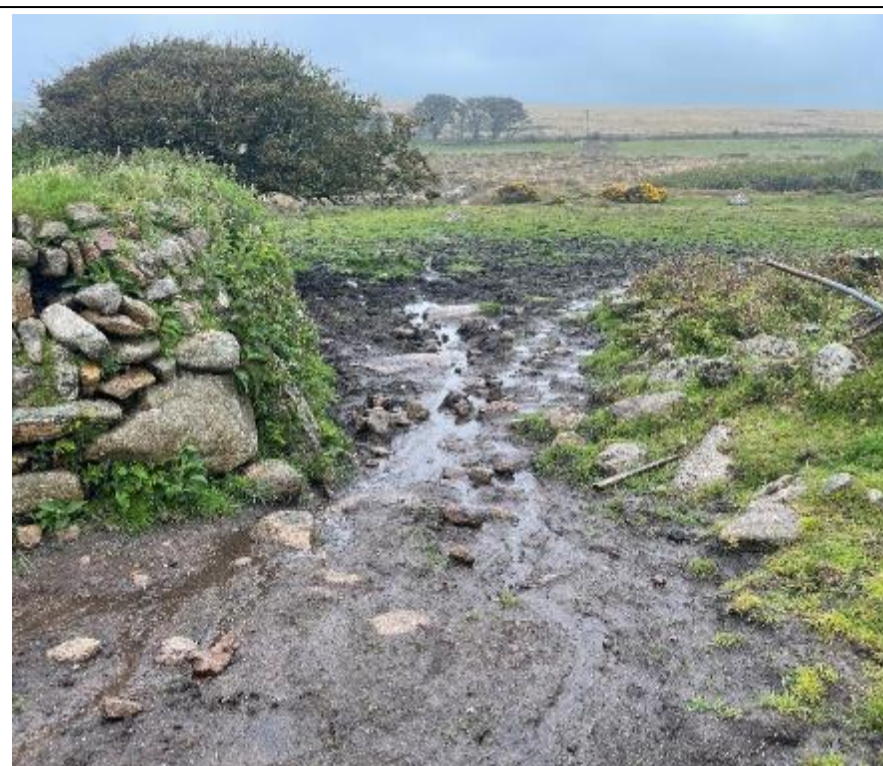
1.07 – Flow pathway through field gate on western side of the mire.

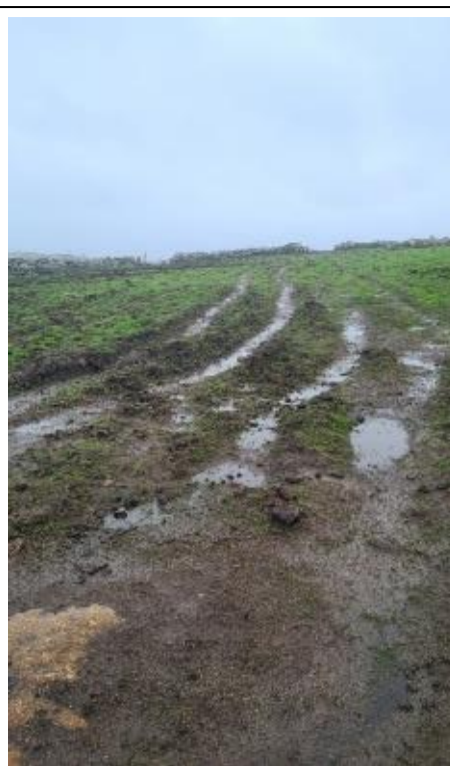
1.08 – Flow pathways through intensively managed grassland on western side of mire.

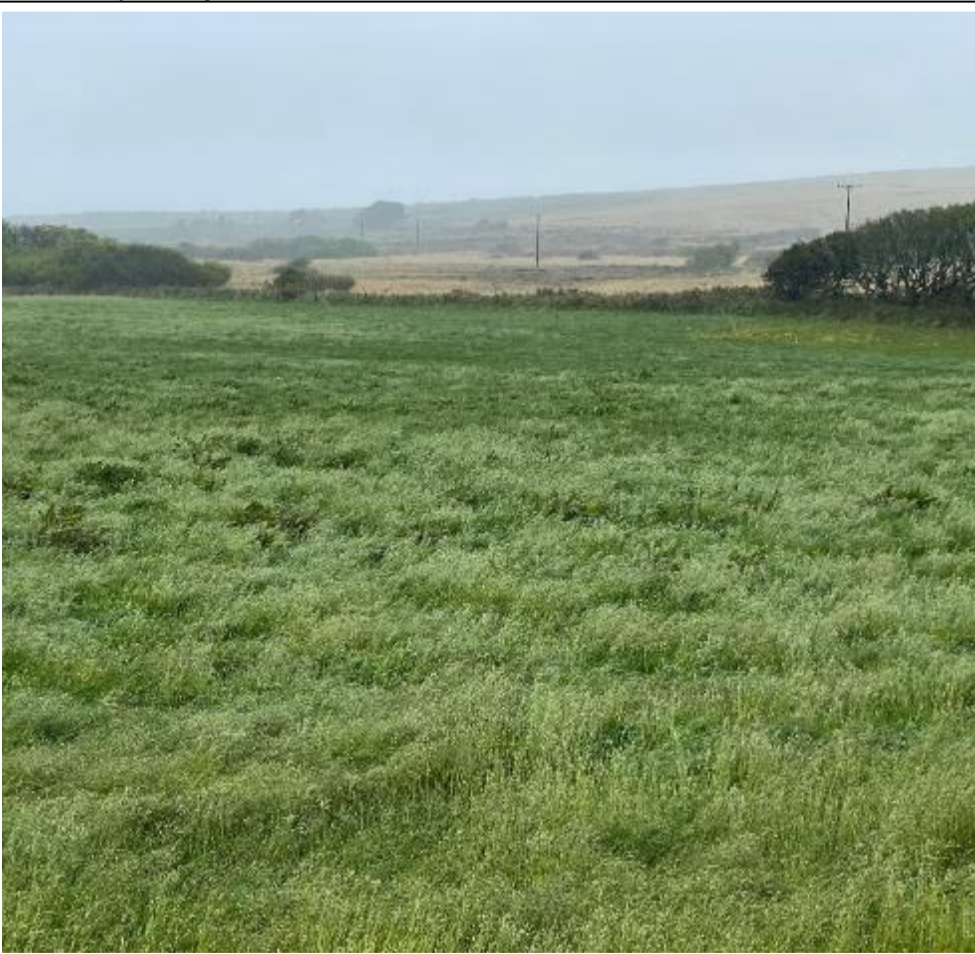
Features identified that could influence mire functioning	<p>Flow pathways in the Bodrifty catchment are concentrated and radiate out from the mire on the steep valley sides to the east and west of the mire. To the east, the two main flow pathways (Photos 1.05, 1.06) flow into a ditch alongside the track and through pipes under the track towards the mire. The northern most flow path (Photo 1.06) drains a field that was being grazed by cattle on the day of survey with evidence of organic material movement through the field gate and under the track. Downstream of the track, this flow path crossed poached and muddy ground indicative of intensive cattle holding in a field adjacent to the mire.</p> <p>Similar field poaching was observed on the western side of the mire with unmapped flow pathways flowing towards the mire through field gates (Photo 1.07). The main western flow pathways are longer than to the east, leading from the plateau at the top of the catchment down towards the mire (Photo 1.08). On the track leading to Brook Cottage there was evidence of water flowing out of the hillslope through pipe drains, crossing under the track, and leading towards the mire (Photo 1.09). Water also flowed along the track towards the mire (Photo 1.10)</p> <p>The spring that was mapped using OS data was also observed during the field survey and flows towards the mire through an underground culvert (Photo 1.11). This spring used to be the water supply for Brook Cottage, however, a new borehole has been drilled to 64 m deep to provide water supply to the cottage. The impact of this borehole on groundwater flows and levels is unknown.</p> <p>The majority of the catchment is semi-natural scrub and grassland, part of which was common land to the east. There are fields of intensively managed grassland for cattle grazing and fields used for silage, one of which was observed adjacent to the southern edge of the mire (Photo 1.12). The runoff of any fertilisers used on such fields may transport nutrients to the mire.</p>

1.12 – Silage field to south of catchment.

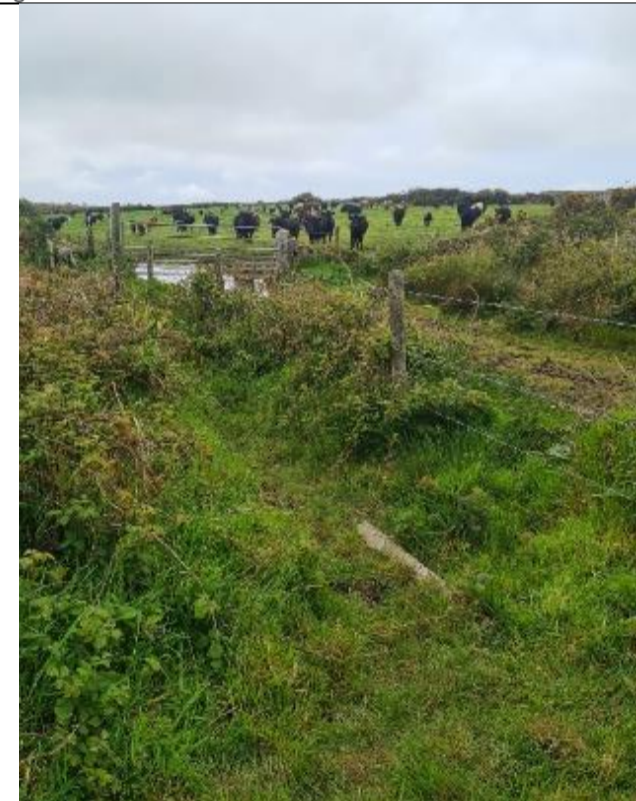
2.05 – Cows grazing fields near to Bosiliack Farm.

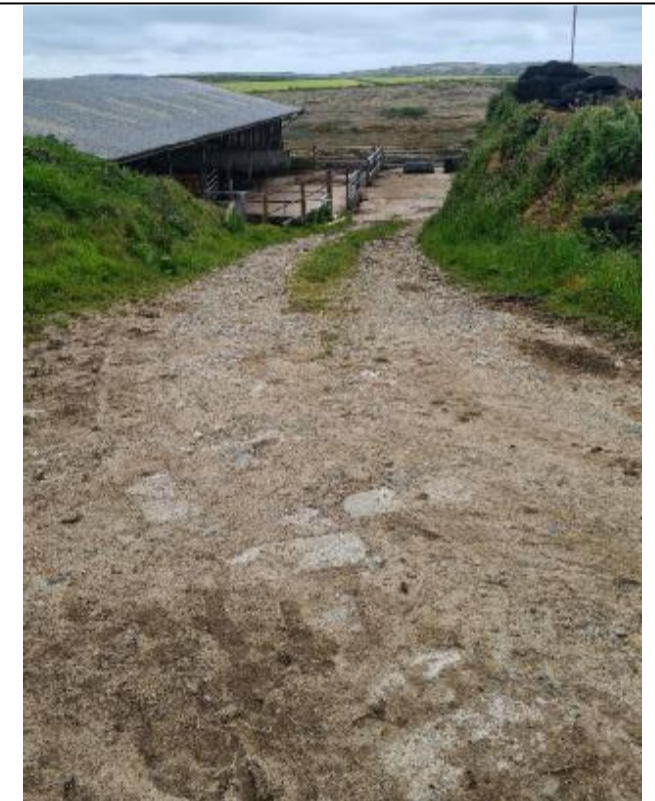
2.07 – Flow pathway flowing through farm.

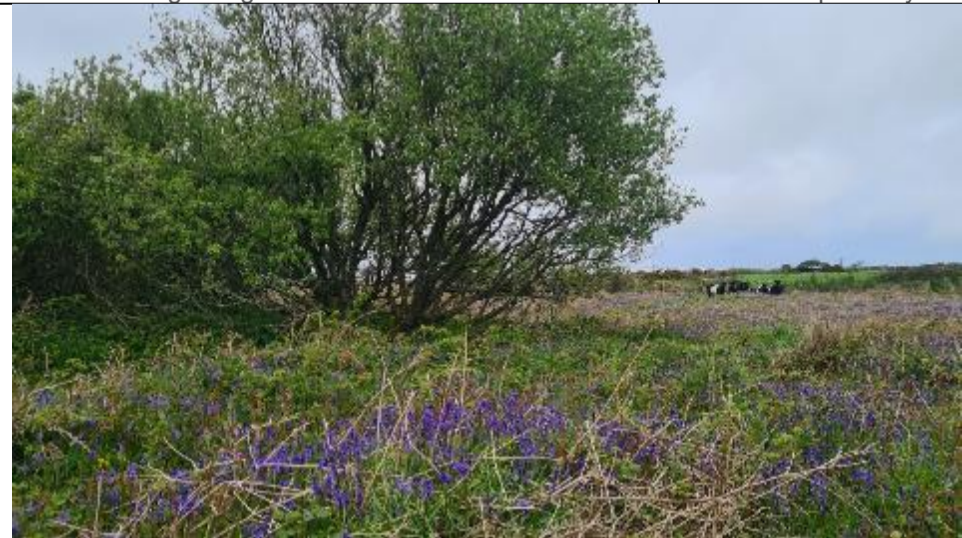
2.08 - Cows grazing rough grassland on edge of mire under HLS scheme.

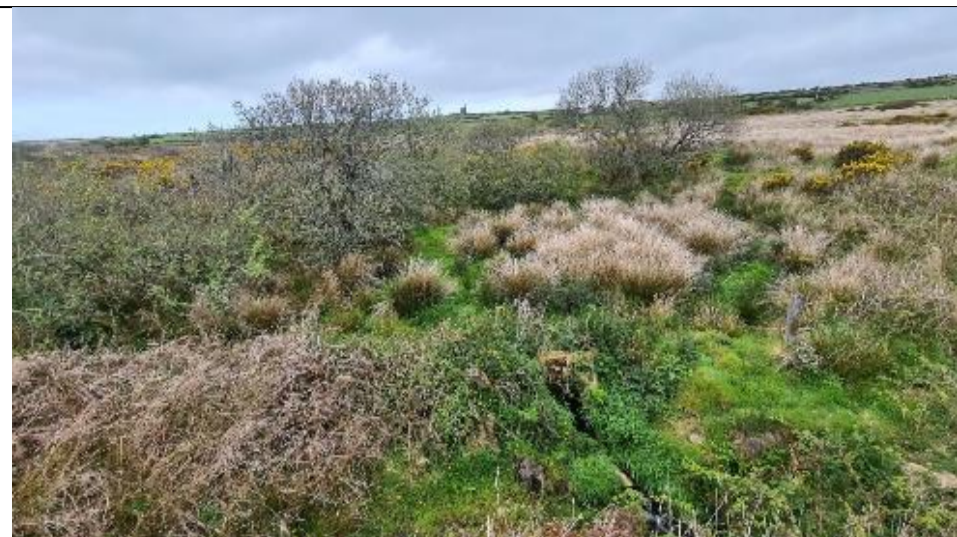
2.10 – Field drain draining mire habitat towards watercourse.

Opportunities identified	There is an opportunity to block the incised watercourse to improve the connectivity of the watercourse with the mire habitat and reduce drainage of the mire towards the stream.
Other risks	-

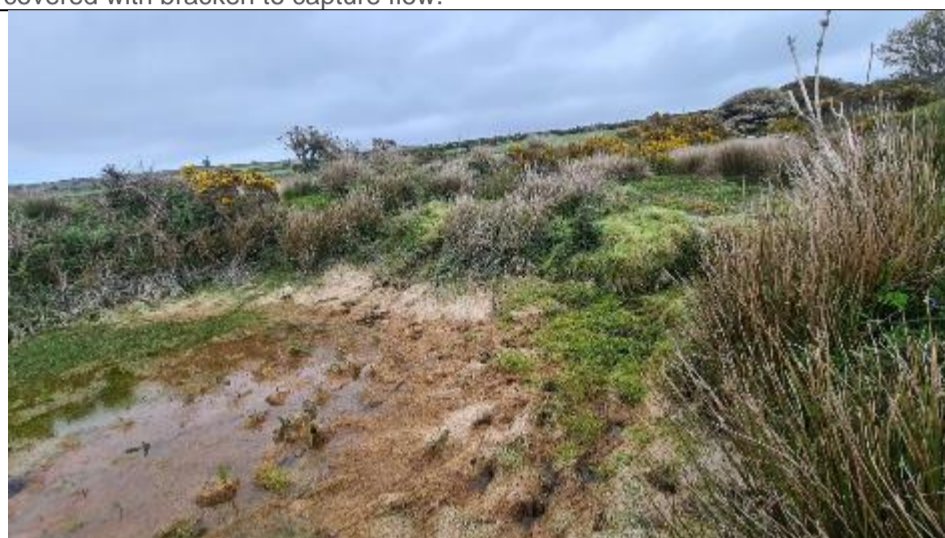
2.13 – Evidence of cattle entering spring pools.

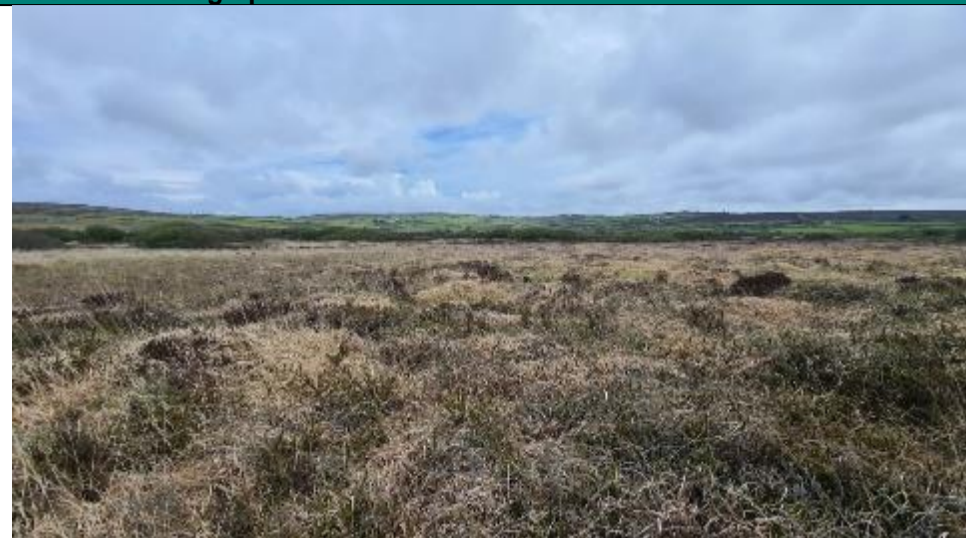
3.01 – View downslope.

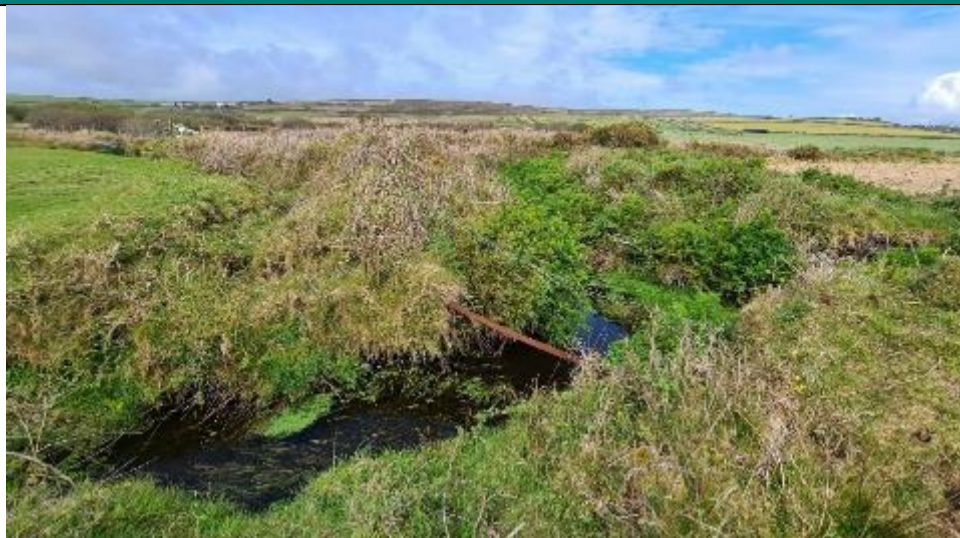
3.02 – Main watercourse on valley floor.

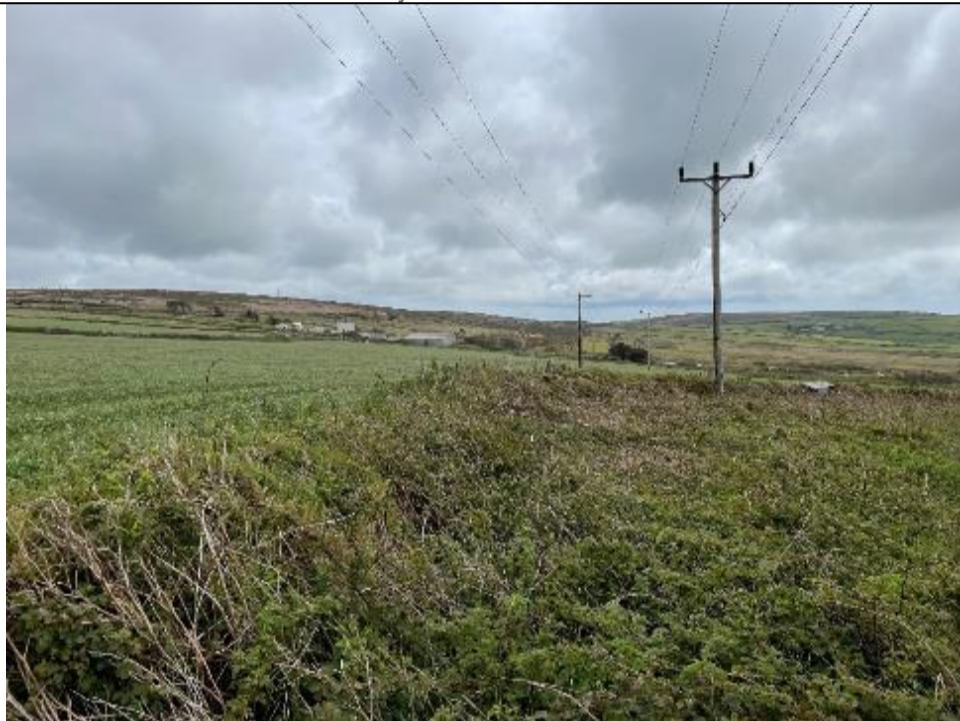
3.04 – Area around Lower Boslow (in background).

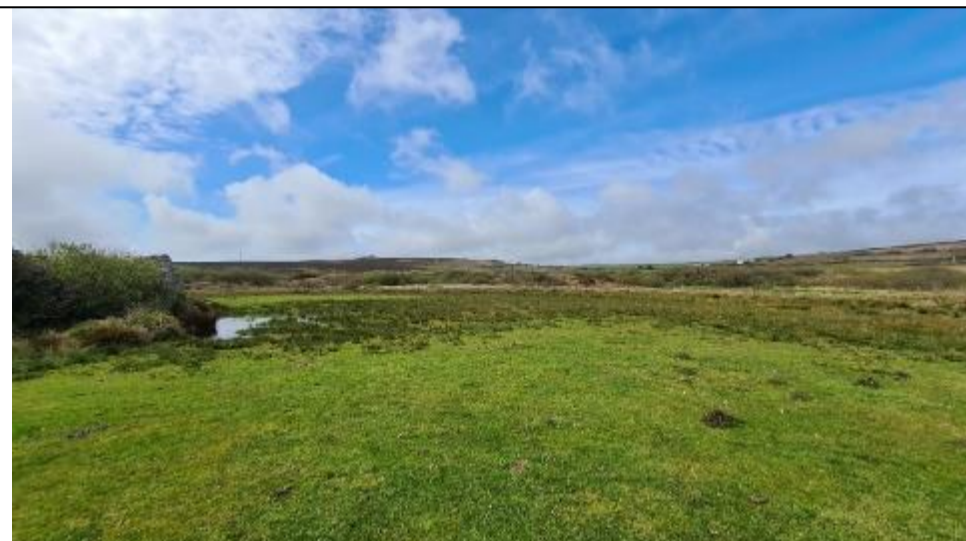
3.10 – View of habitat south of watercourse and mire habitat.

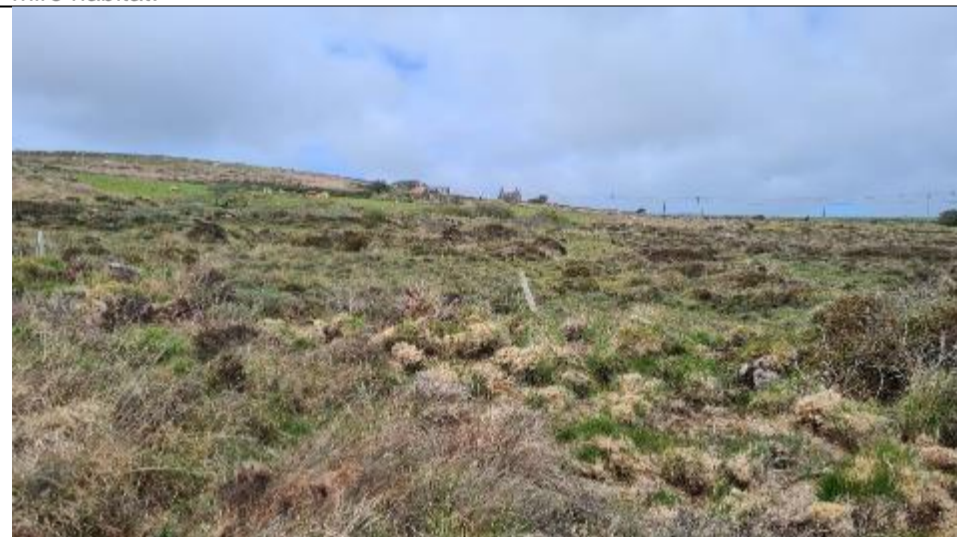
3.11 – Cattle grazing at Carnyorth Farm.

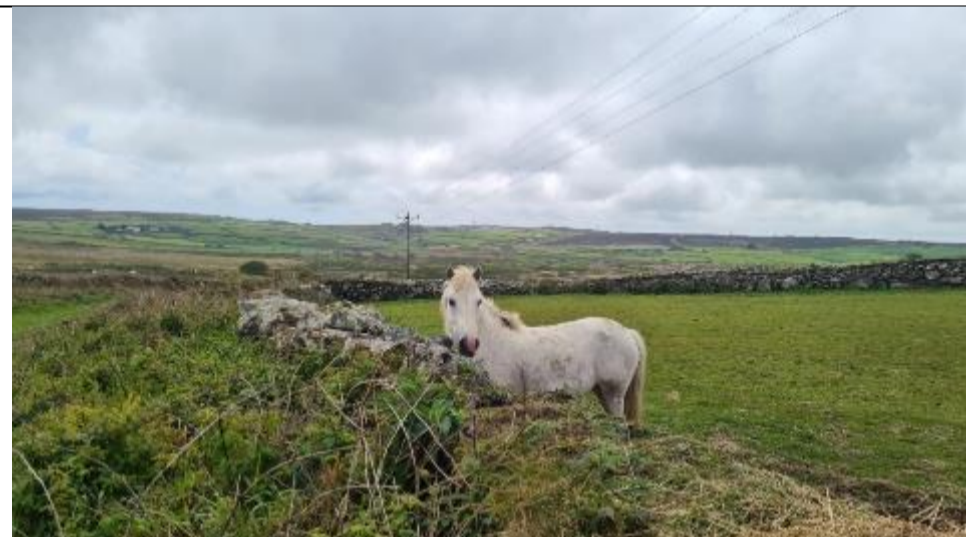
3.12 – Horse grazing around Carnyorth Farm.

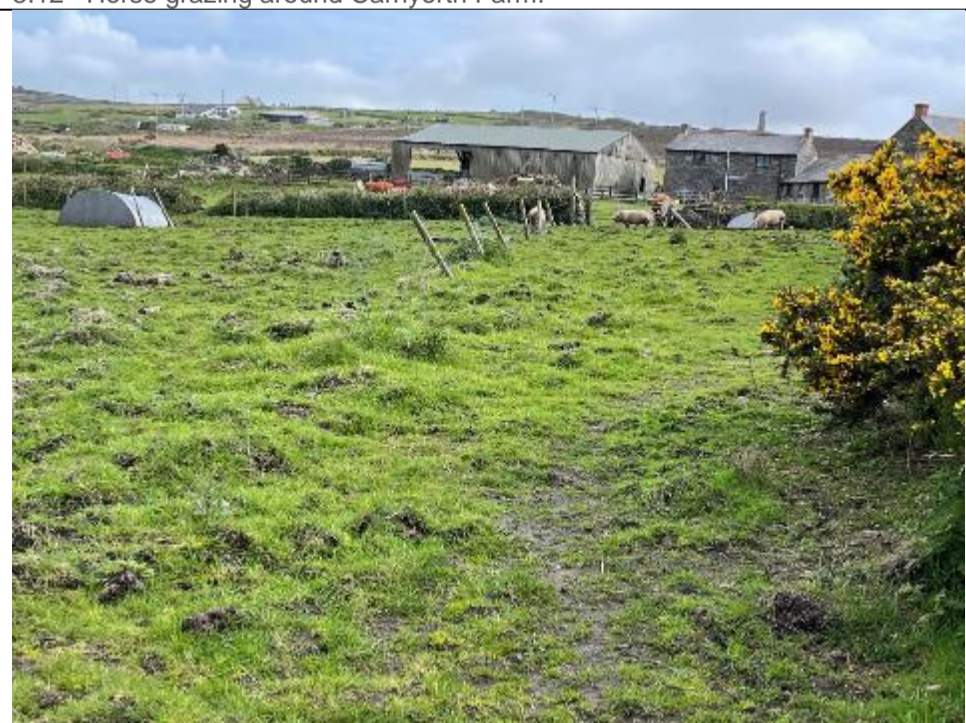
3.14 – Farmyard.

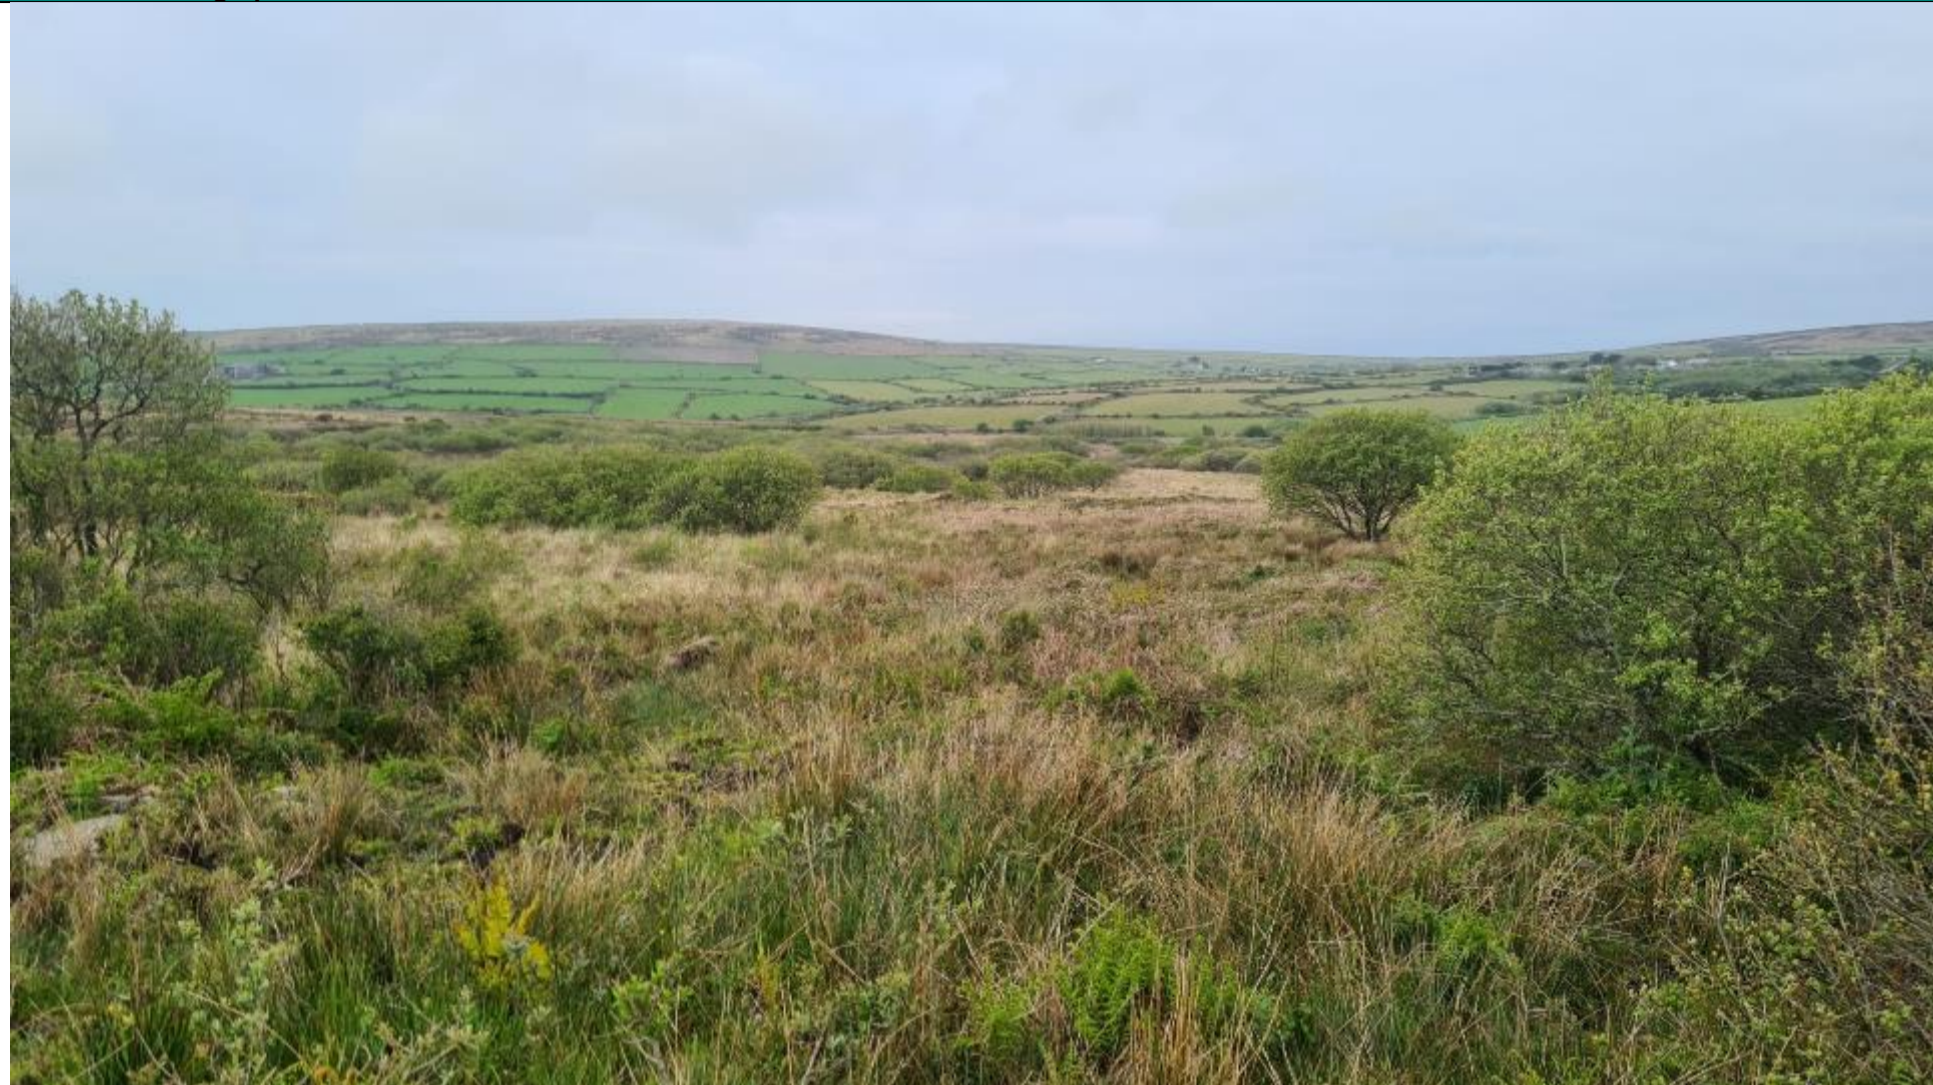
4.01 – View looking downslope across mire habitat.

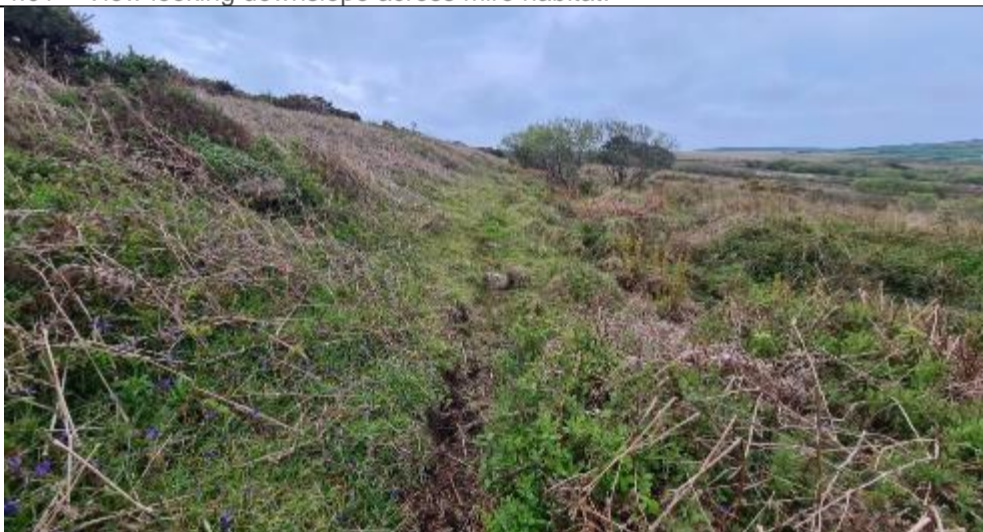
4.02 – Break of slope.

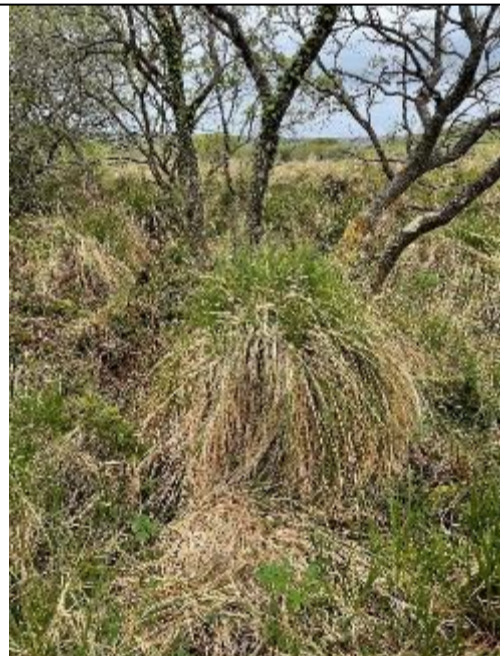
4.05 – Vegetation along flow pathway.

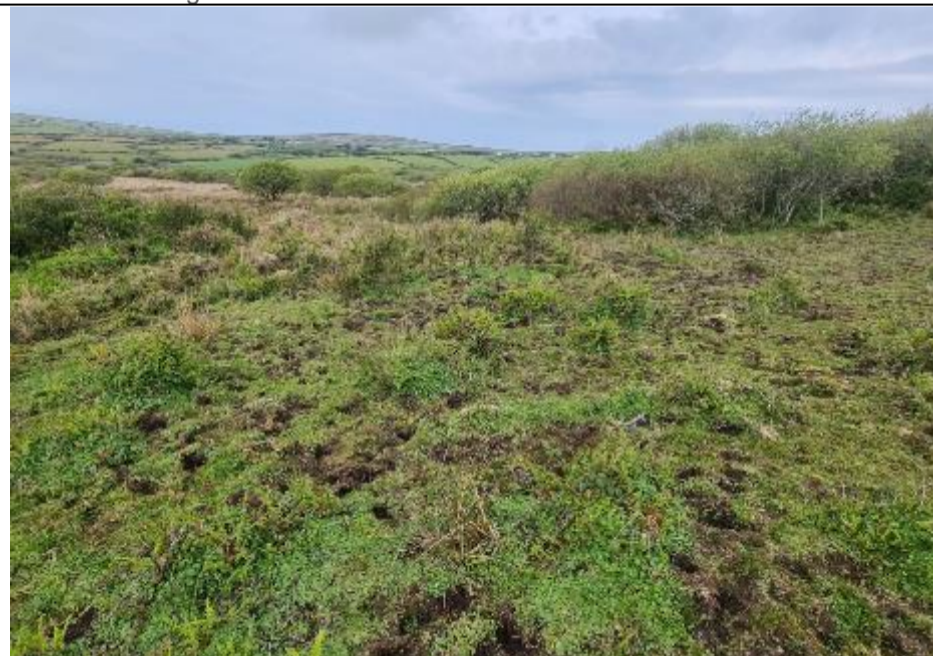
4.06 – View along southern flow pathway, showing woodland.

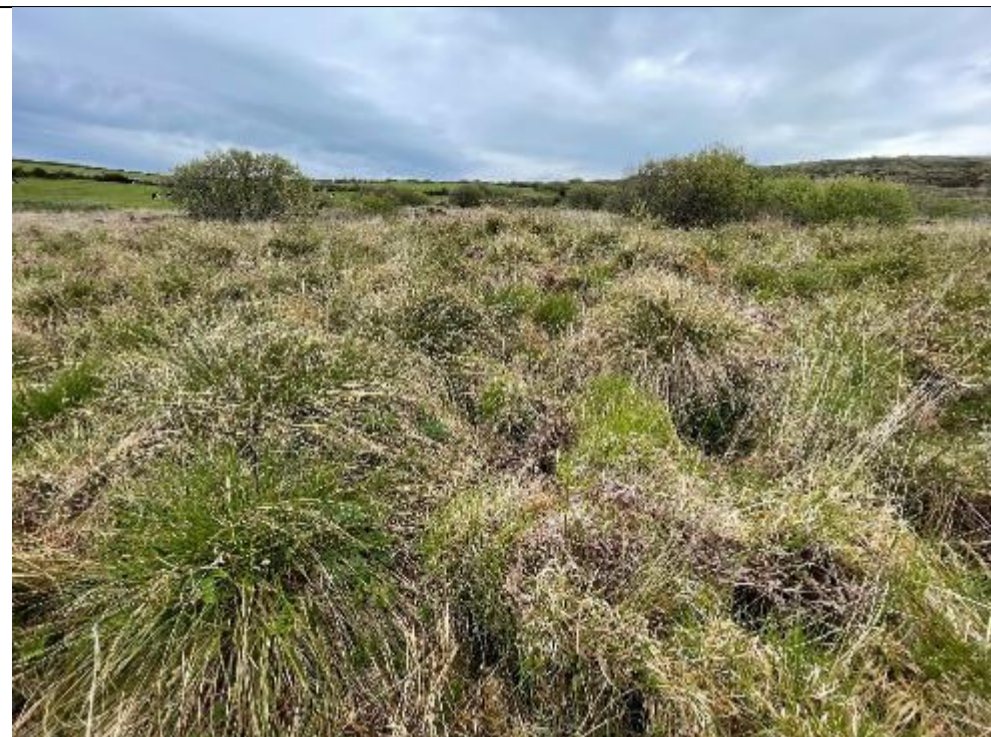
4.07 – Typical view of mire habitat in the core of the site.

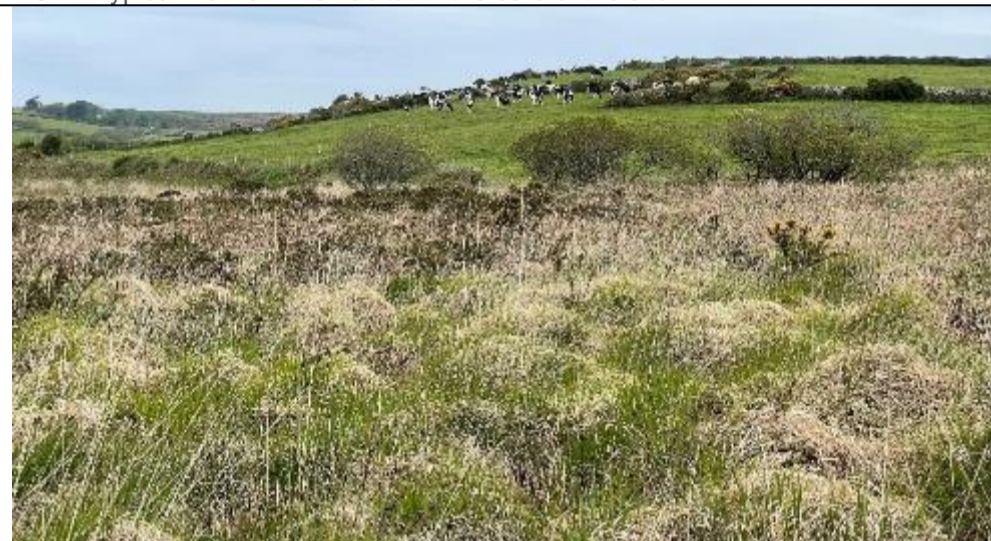
4.09 – Cattle grazing upstream of the northern flow pathways.

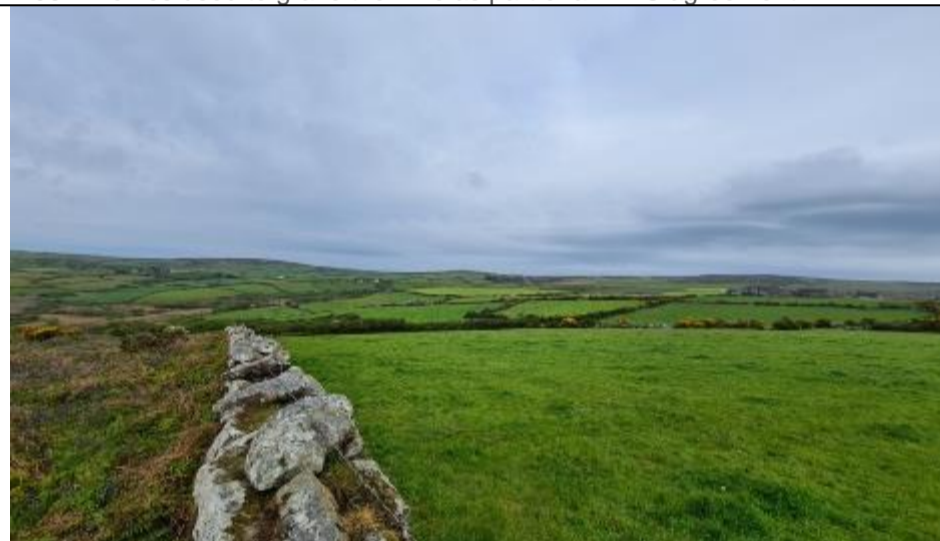
4.10 – Silage fields across the upper reaches of the northern flow pathway.

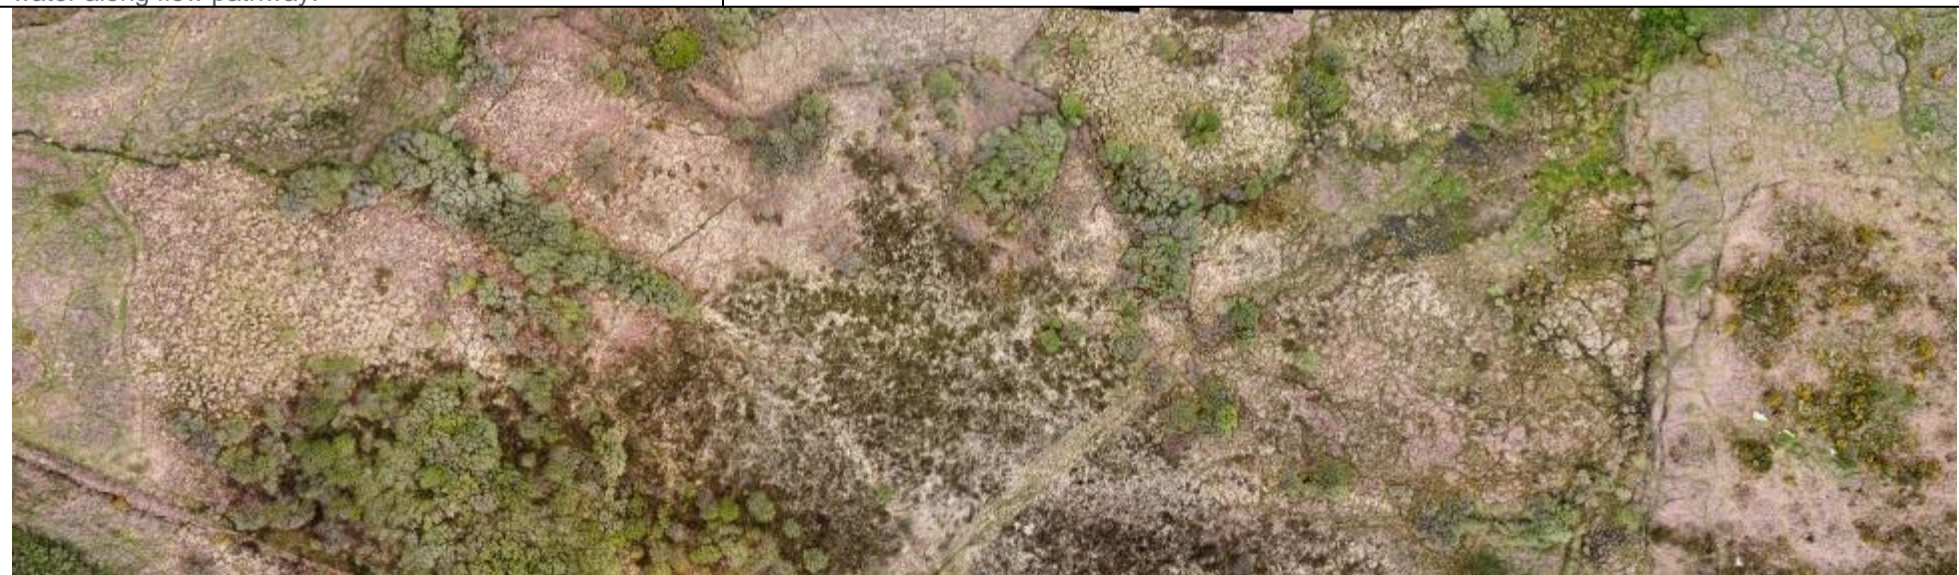
4.13. Aerial view of habitat.

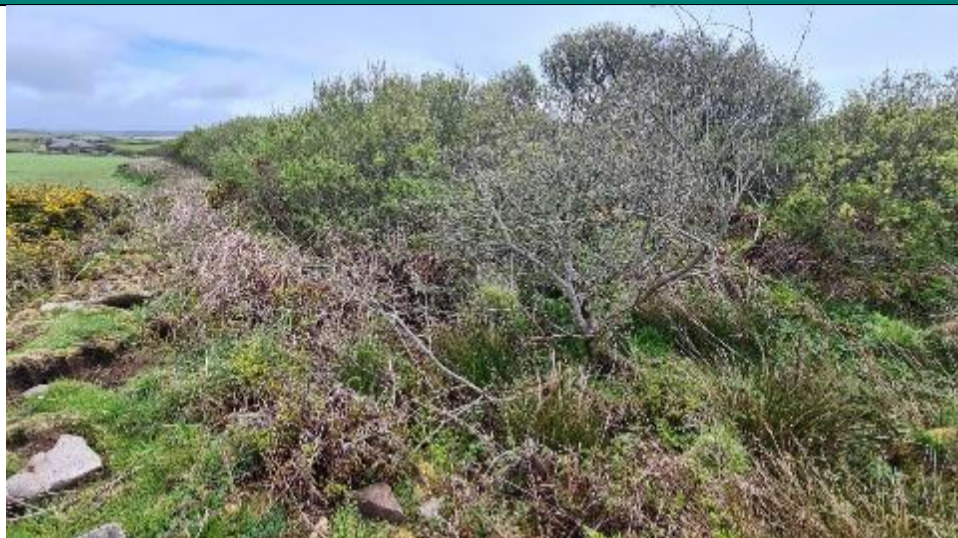
5.02 – Wet woodland on northern edge of mire habitat.

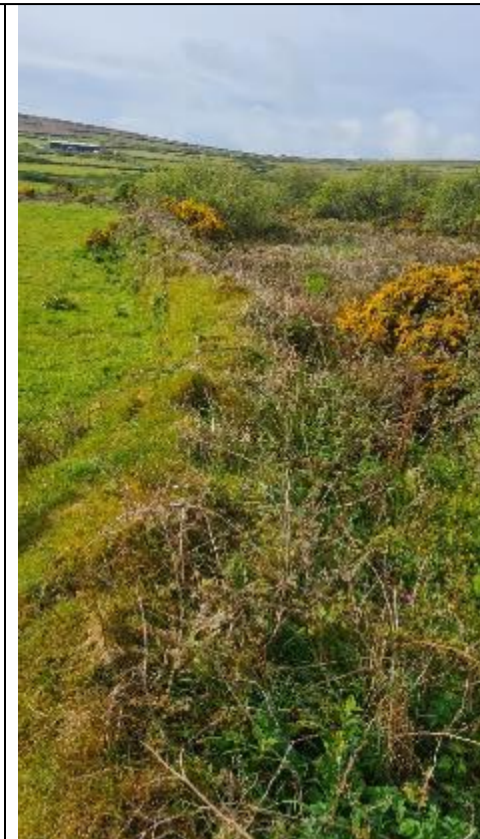
5.08 – Watercourse flowing from Trehyllys Farm towards outflow of mire.

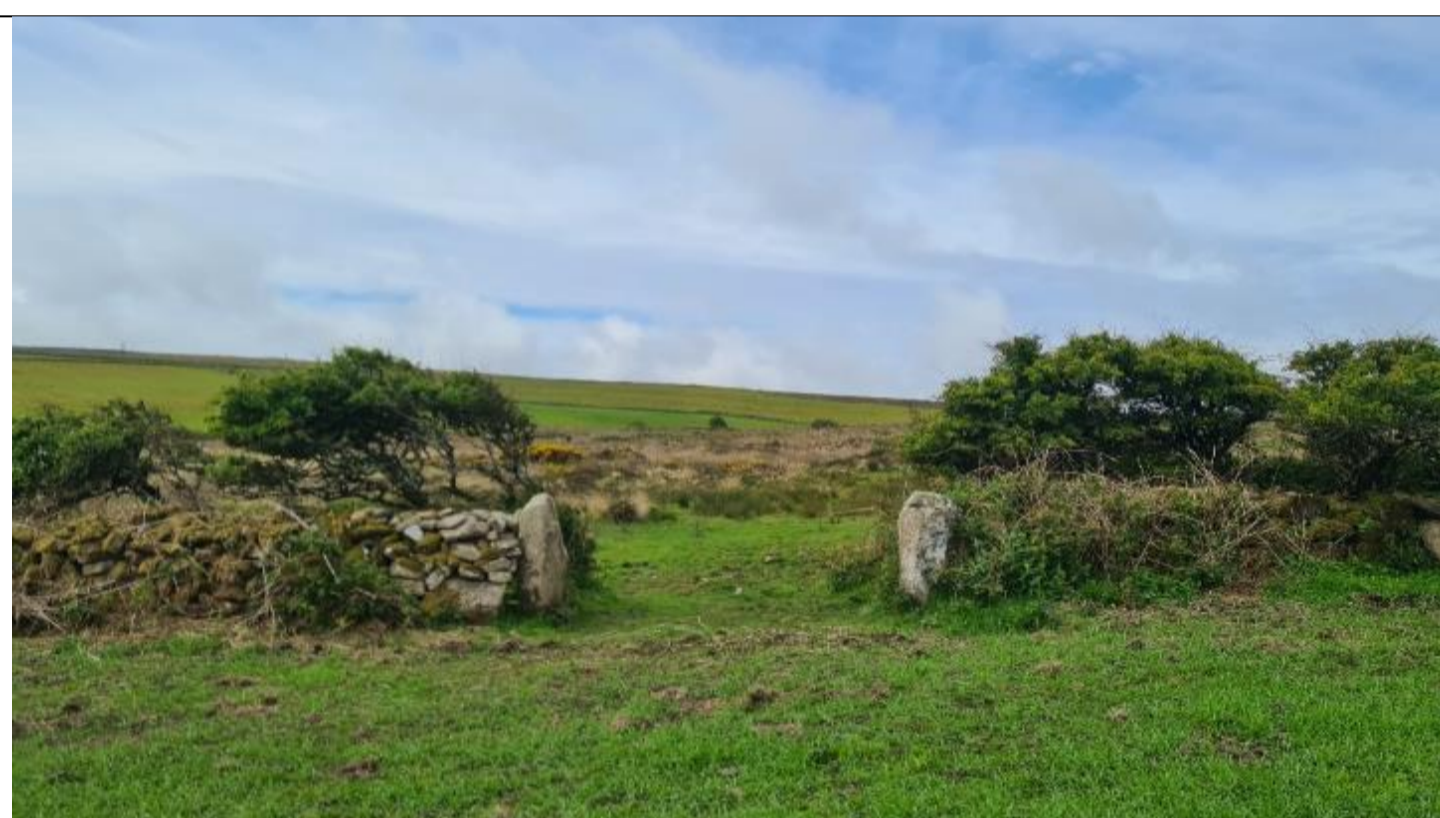
5.09 – Evidence of grazing and barley crop in fields adjacent to mire.

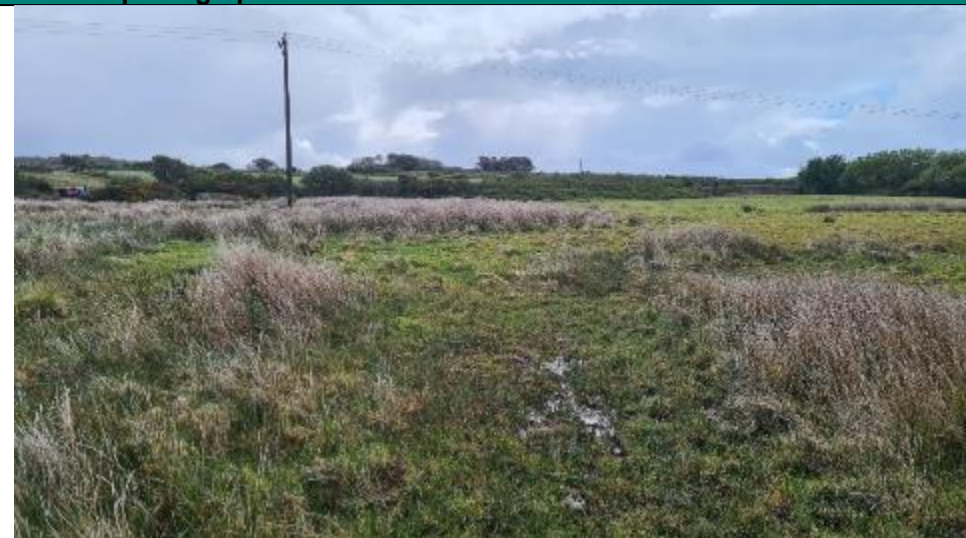
6.01 – Mire habitat dominated by rushes.

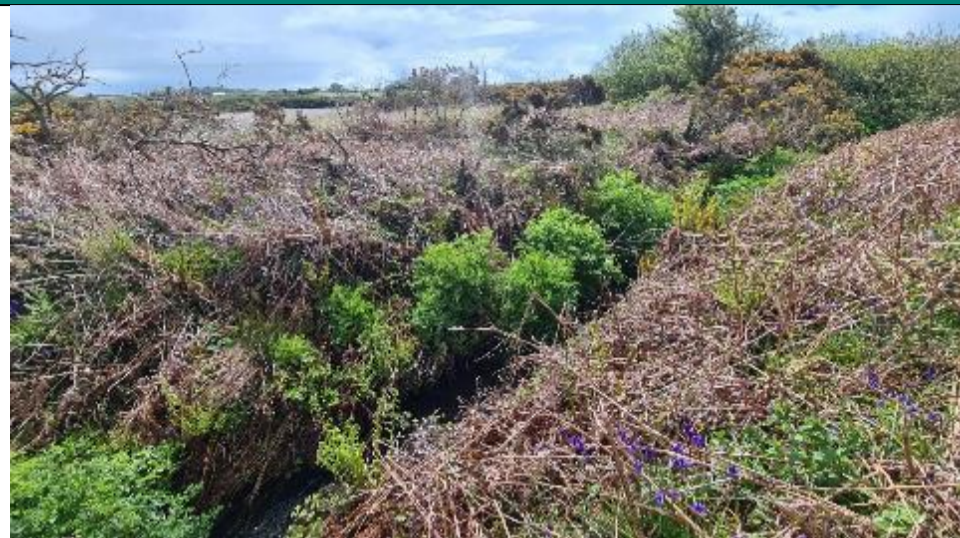
6.02 – 2 m incised watercourse running through mire habitat.

Opportunities identified	Blocking and/or re-naturalising the deepened watercourse in the mire would result in a reduction in the drainage of the mire. This would create a wetter habitat and likely both a greater extent and improved quality of the mire and stream habitat.
Other risks	-

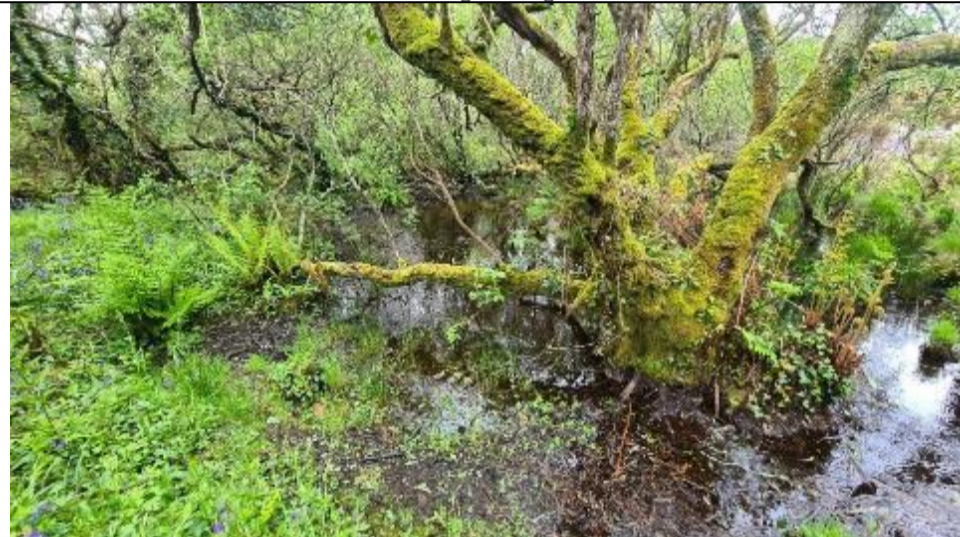
6.04 – Wet woodland area upstream of the mire.
