West Penwith Ecohydrological Investigation and Characterisation – Site Visit Report

Phase 3 2020-21

Natural England Research Report NECR402

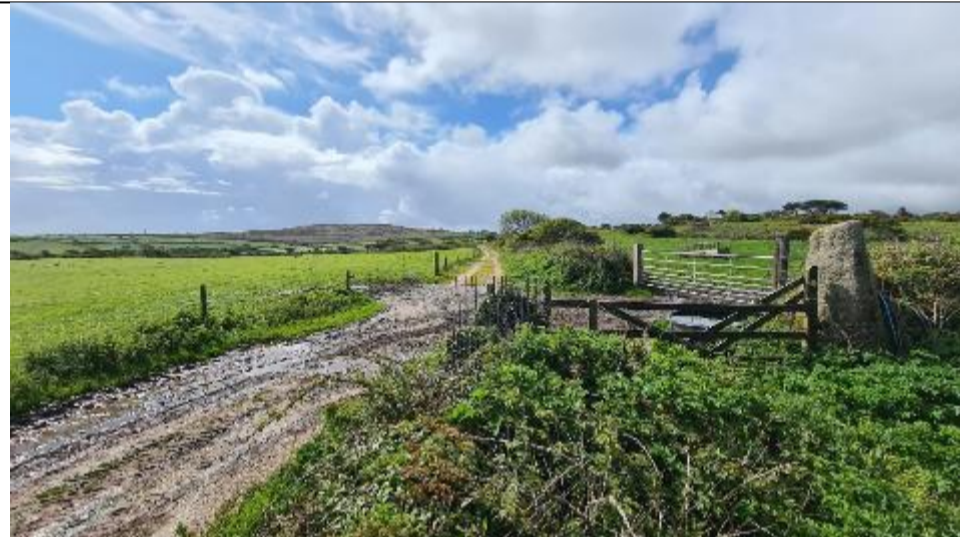
6.06 – Flow pathway running along track and into field upstream of mire.

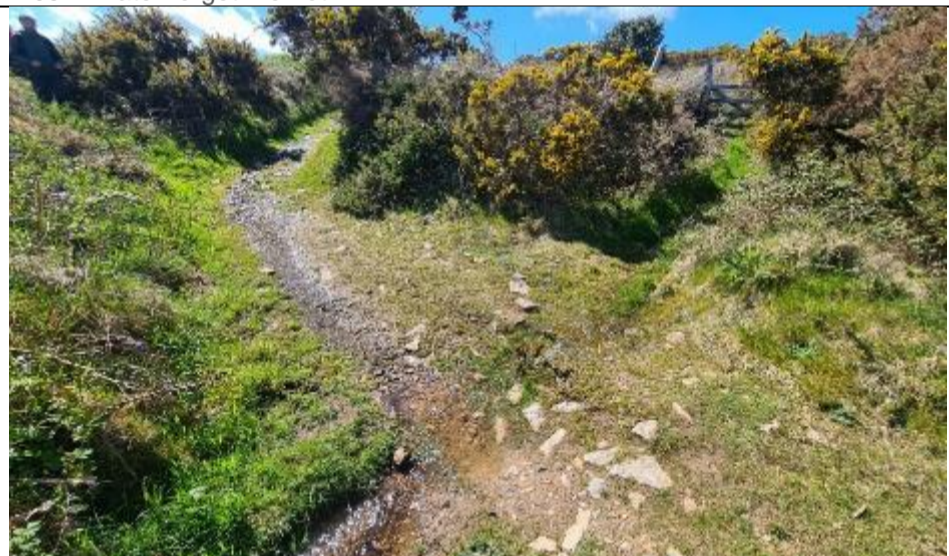
7.07 – Footpath as active flow pathway.

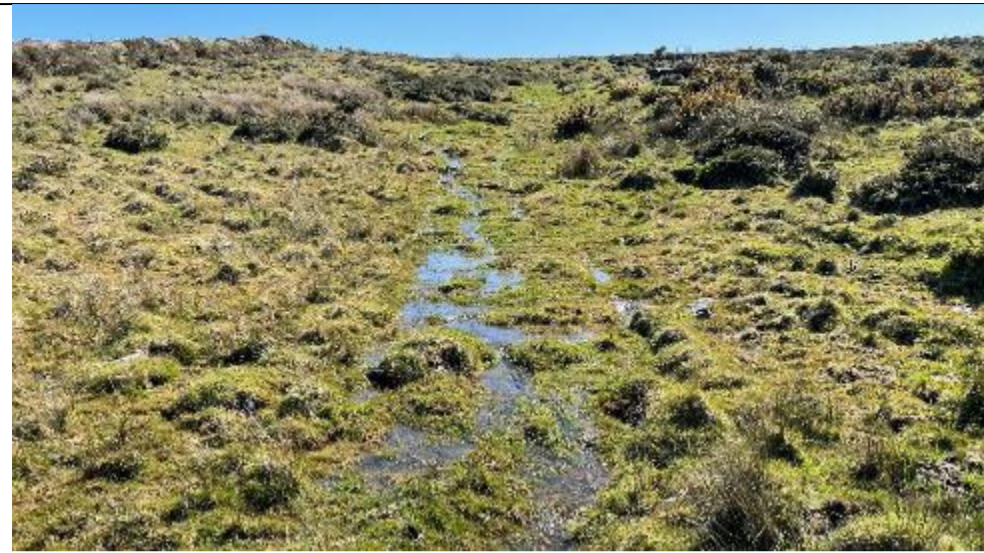
7.10 – Flow pathway leading to southern section of mire.

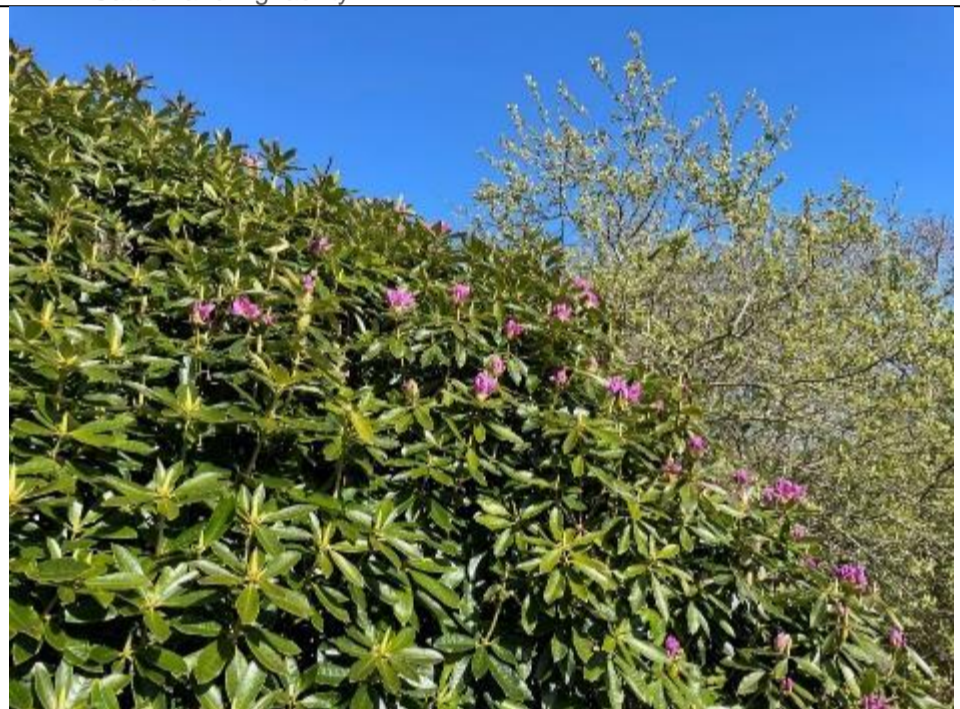
<p>Other risks</p>	<p>If increased drainage were implemented within the field downstream of the mire it could potentially lower the water table within the mire. If the watercourse downstream of the mire was deepened this could also increase the hydraulic gradient from the mire to the watercourse leading to a reduction in mire water levels within the mire. Therefore, whilst not part of the hydrological catchment, these fields may still be considered to influence the functioning of the mire.</p> <p>Invasive non-native species (INNS) are present in the valley of the eastern mire with significant and large stands of <i>Gunnera</i> spp. within the main flow pathway (Photo 7.12). The eastern mire has also been used as a tipping location (Photo 7.01).</p> <p>Areas south of the west mire have a cover of INNS <i>Rhododendron ponticum</i> (Photo 7.13).</p>
--------------------	---

7.13 – *Rhododendron ponticum*.

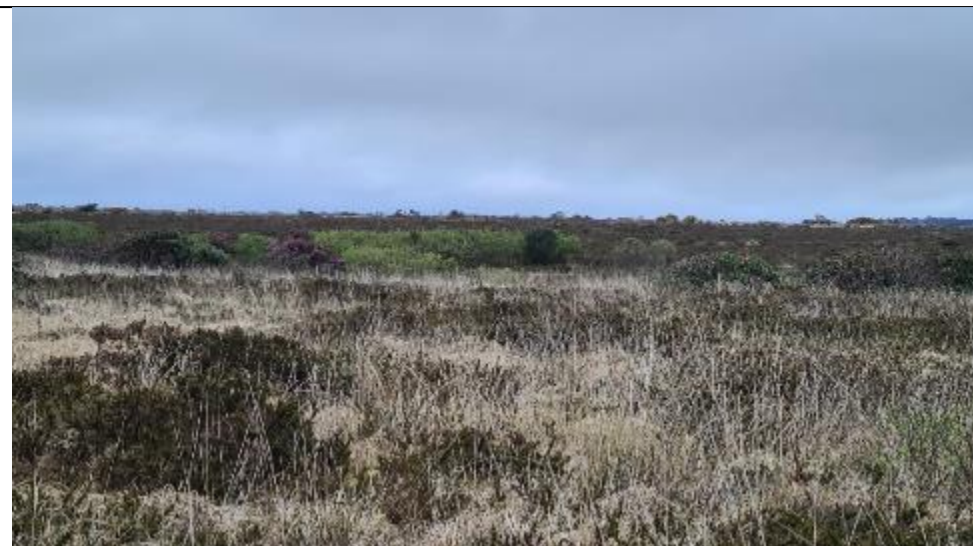
Opportunities identified	Blocking of grips and ditches present across the site that have undoubtedly been modified historically for drainage to restore extent, quality and resilience of mire system.
Other risks	<p>It is known that this area has been subject to recent unmanaged moorland fires and due regard should be given to the likely frequency of this practice and effects on mire communities.</p> <p>Several stands of the invasive non-native species (INNS) <i>Rhododendron ponticum</i> (Photo 8.03) were identified within the area mapped as mire vegetation.</p>

8.03 – *Rhododendron ponticum* within mire habitat.

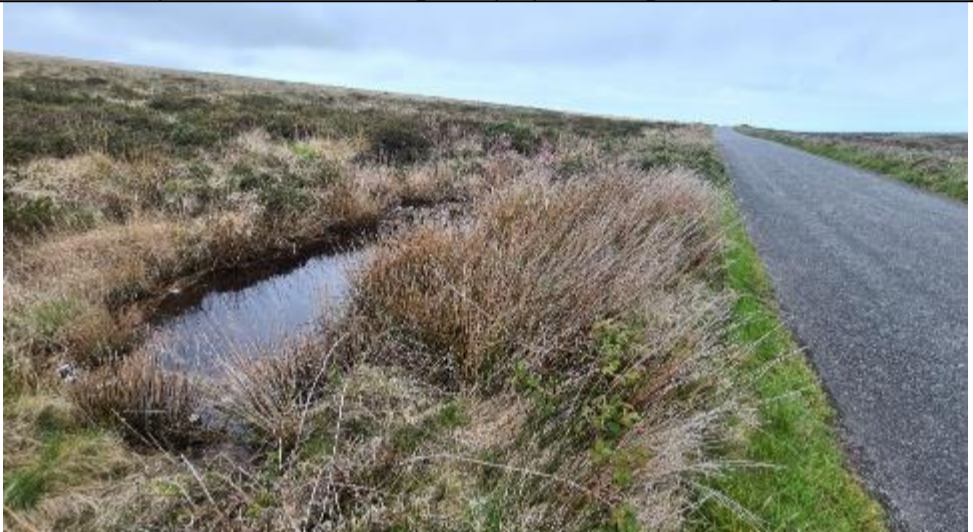
8.06 – Roadside ditch.

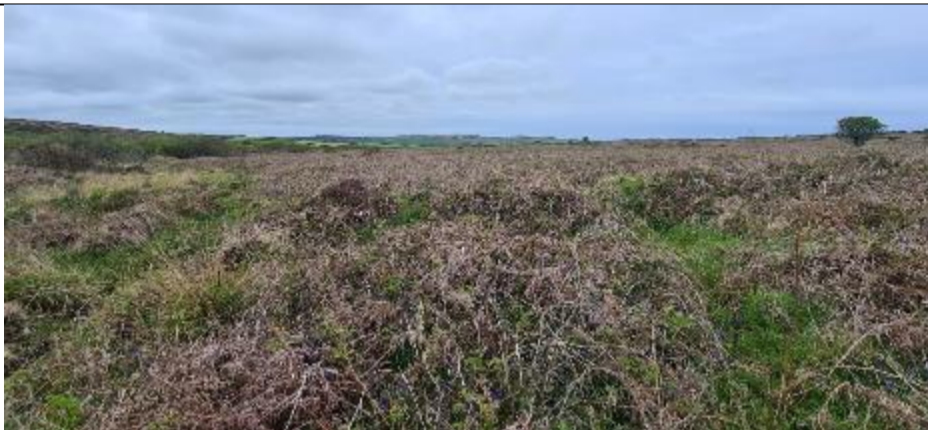
9.10 – Semi-natural vegetation on north western flow pathway leading to northern mire.

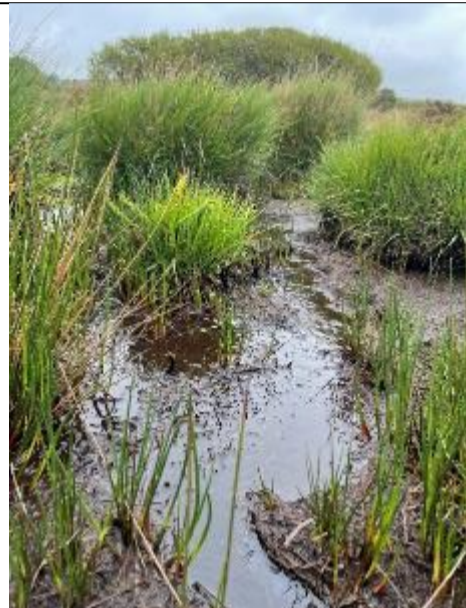
10.03 – Exposed peat.

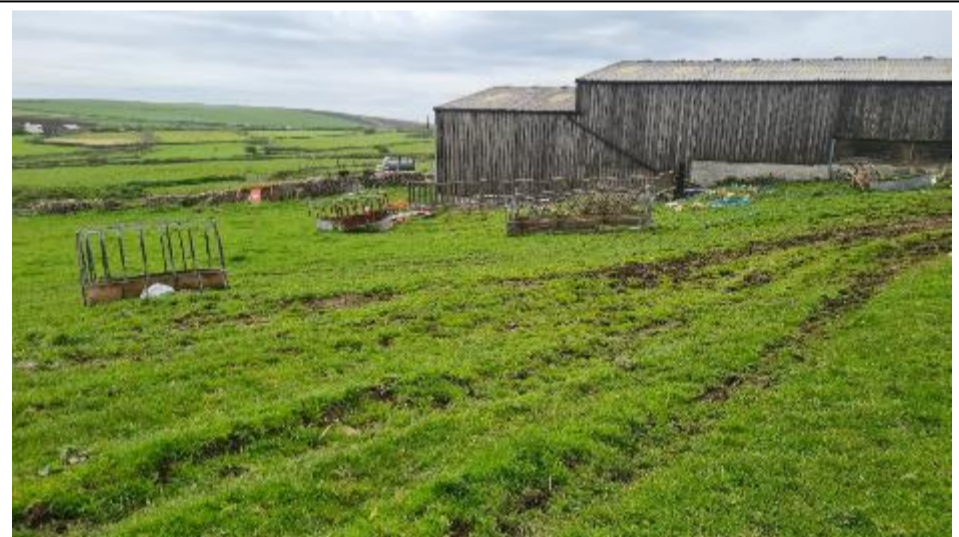
11.05 – Pasture near Middle Tregerest Farm with ring feeders next to dairy.

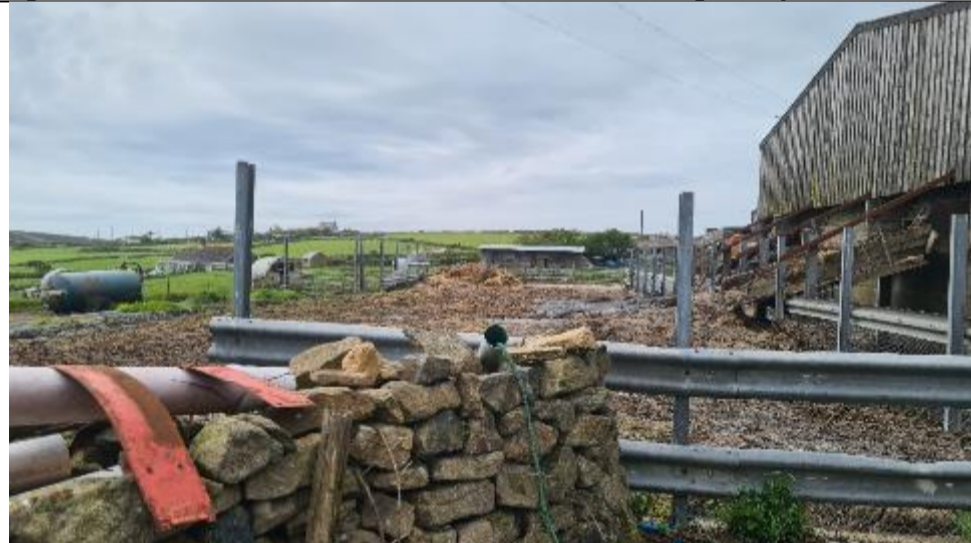
11.06 – Full slurry tank being fed directly from the dairy.

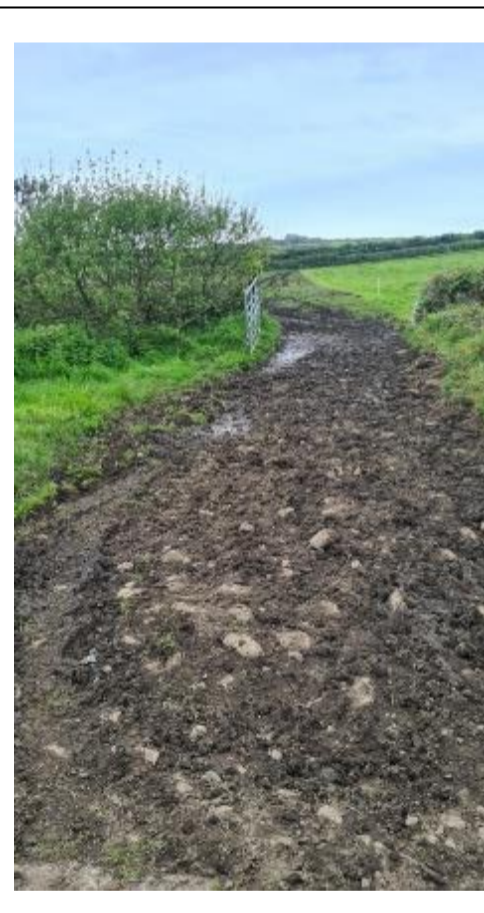
Features identified that could influence mire functioning	<p>Flow pathways in the Tregerest catchment are concentrated mainly on the steep slopes to the north and west of the mire. Hydrological pathways to the north flow directly to the mire habitat (Photo 11.04).</p> <p>To the west, pathways flow through an area with a significant dairy farm at Middle Tregerest housing ca. 160 cattle according to local landowners. Surrounding fields have evidence of some poaching (Photo 11.05) and the dairy unit itself has a large slurry tank draining to an underground pipe (Photos 11.06 and 11.07) with evidence of surface runoff from the farmyard down the slope (Photo 11.08) and along farm tracks (Photos 11.09 and 11.10). These hydrological pathways all flow in a south-westerly direction into a watercourse that currently bypasses and drains the mire habitat. A wet depression on the edge of the superficial habitat also feeds the watercourse (Photo 11.11).</p> <p>A track from Lower Tregerest Farm also acts as a hydrological pathway, observed during the site visit (Photo 11.12). Flows arise from a spring, but water showed active algal growth (Photo 11.13) and was also connected to heavily poached cattle tracks (Photo 11.14).</p>

11.14 – Muddy poached field gateway on flow pathway leading to track.
